SUPERIOR COURT OF WASHINGTON FOR KING COUNTY

EXPERT OPINION REPORT OF

DR. MARVIN R. PYLES, Ph.D., P.E.

JUNE 30, 2016

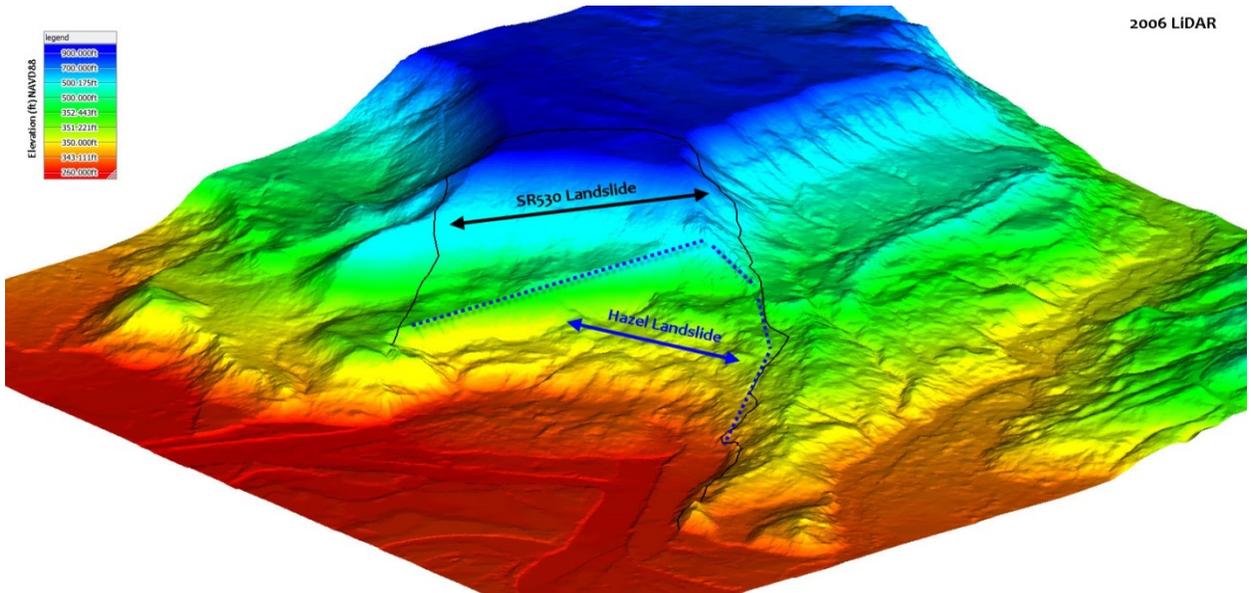
1
2 As noted in our previous reports, the Hazel Landslide is a different landslide complex from the SR 530
3 Landslide (Figure 1). The pre-existing Hazel Landslide was constrained to the eastern portion of the SR
4 530 Landslide, and had been active, at a minimum, for decades. It emanated from a much lower
5 elevation profile (its upper surface being near El. + 700 feet), and consisted primarily of prehistoric
6 landslide debris from an older, and much larger, landslide complex. The SR 530 Landslide which
7 included Hazel Landslide debris, extended to the west and north of the limits of the Hazel Landslide,
8 with its upper surface at a much higher elevation (~El. +890 feet). The majority of the soils involved
9 were intact prior to the failure of March 22, 2014, not having experienced any previous landslide
10 disturbance. These two landslides appear to have different footprints, different soil compositions,

12
13 **Figure 1: Overview of Hazel Landslide complex vs. SR 530 Landslide.**

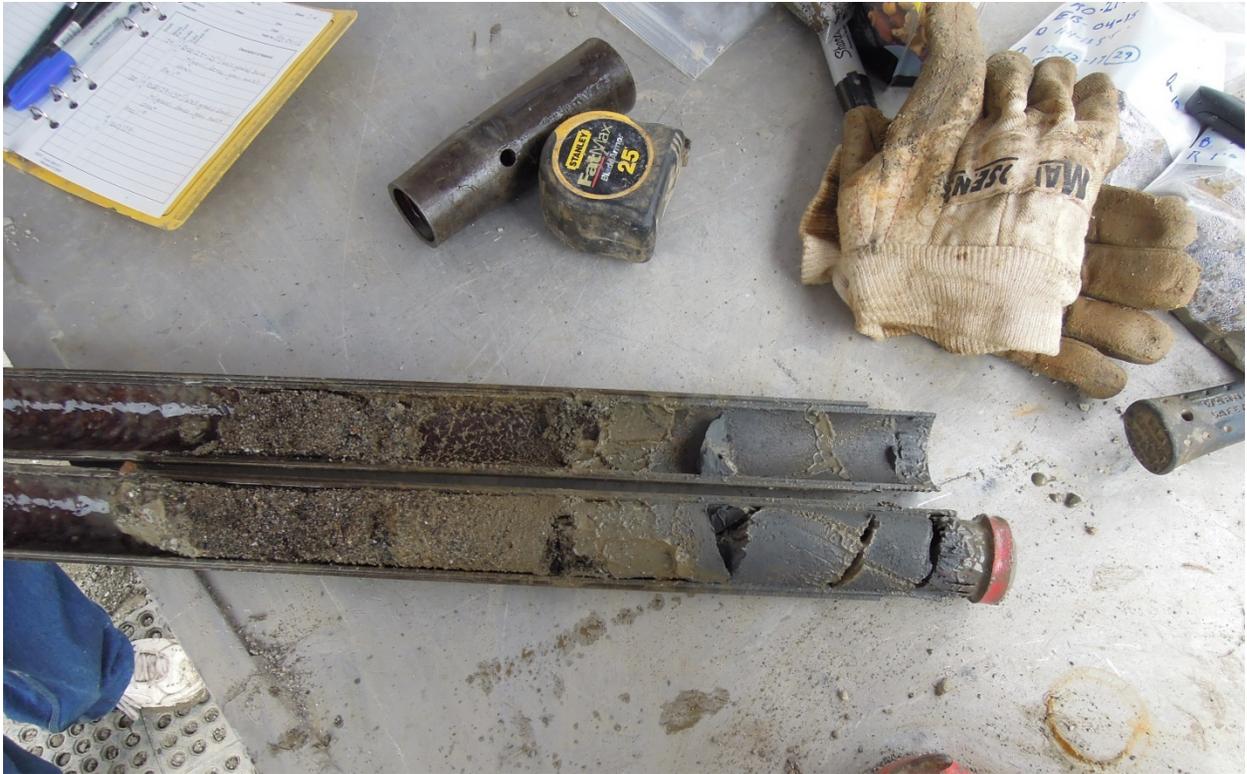
Figure 3: Surface of rupture delineated at contact of recessional sand and glacio-lacustrine silt and clay in boring EB-04si-15.

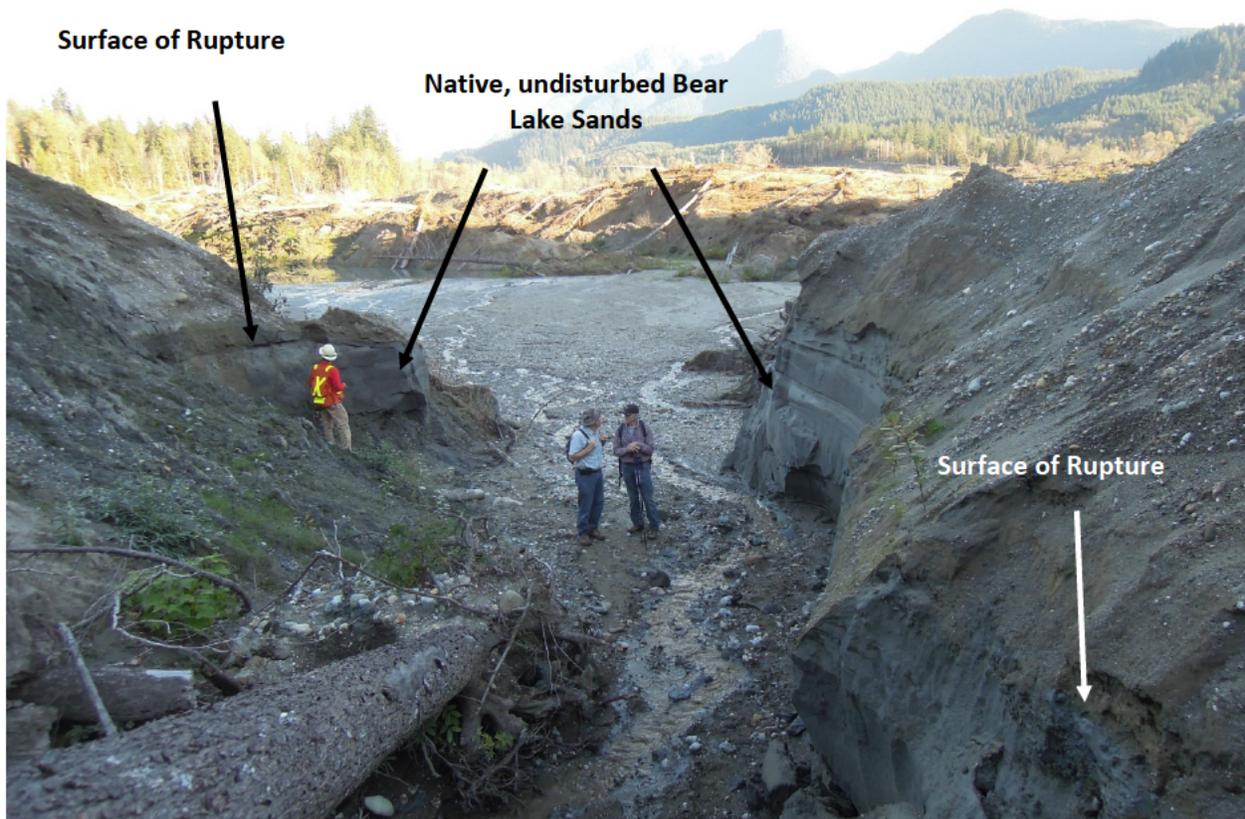
18 In the exposures in the lower western source area (Figure 4 & Figure 5), the surface of rupture is located
19 on and barely within the Bear Lake Sand, transitioning upslope within a few tens of feet into the
20 lowermost portion of the glacio-lacustrine silt and clay. In some exposures of the SR 530 Slide Surface of
21 Rupture, Recessional Outwash is found on undisturbed Bear Lake Sands or on horizontally laminated
22 fine-grained glacio-lacustrine unit. At other exposures, other stratigraphic units were exposed in
23 contact with the Bear Lake Sands. These exposures were all located above El. +310 feet.

1
 2 **Figure 4: View of surface of rupture exposure with clay shear zone at top of Bear Lake Sands (photo taken on**
 3 **10/23/2015 at 48.282N;121.848W, looking SW).**
 4

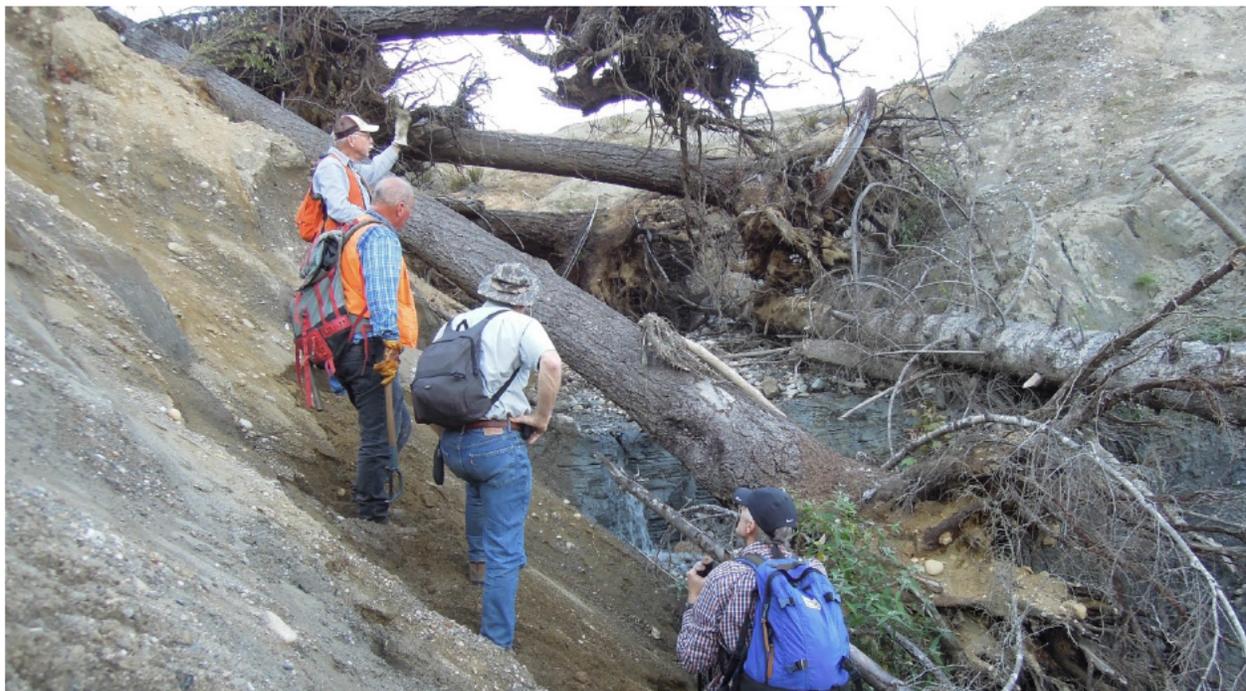
5
 6 **Figure 5: View of glacio-lacustrine silt and clay exposure of surface of rupture (photo taken 10/23/2015 at**
 7 **48.282N; 121.848W, looking N).**

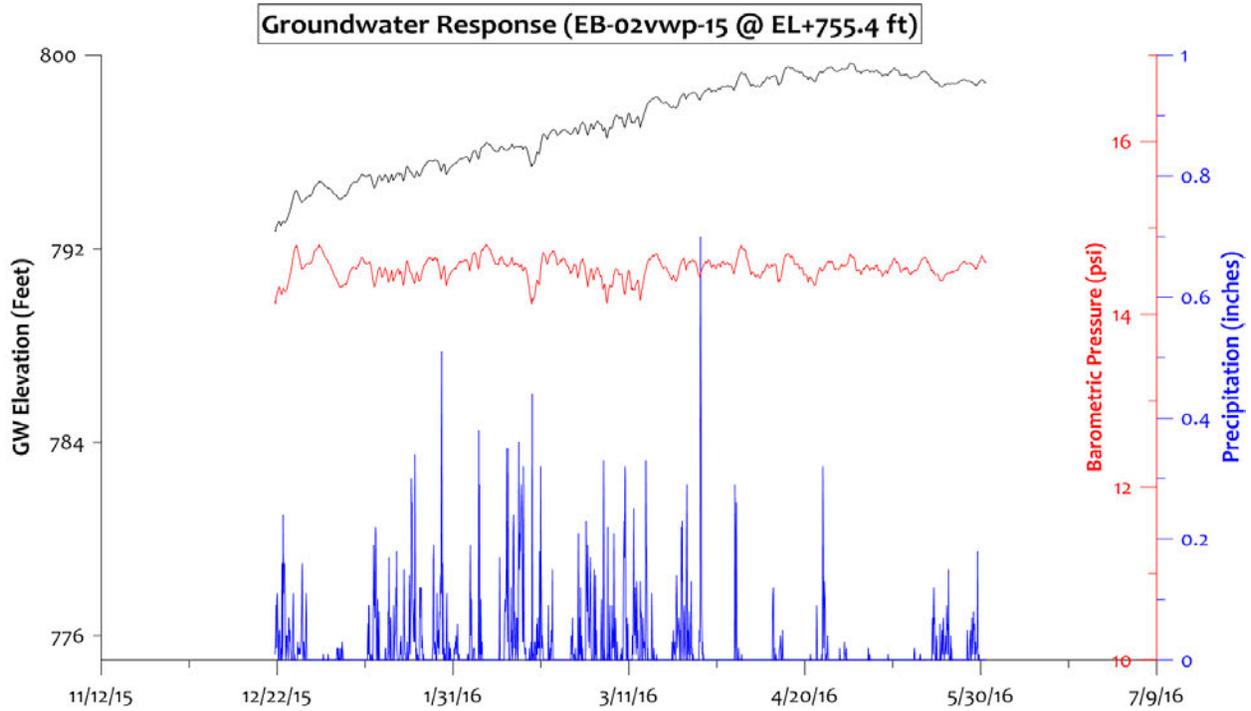
27 Groundwater monitoring performed on Whitman Bench shows that there is no immediate response in
28 the unconfined aquifer following precipitation events. We observed a gradual seasonal fluctuation in
29 the groundwater data (Figure 9), where the groundwater level increases in elevation, reaches a peak
30 value, and then starts to decline. Immediate responses in groundwater elevation due to barometric

3
4 **Figure 9: Seasonal 'increase' in groundwater elevation.**

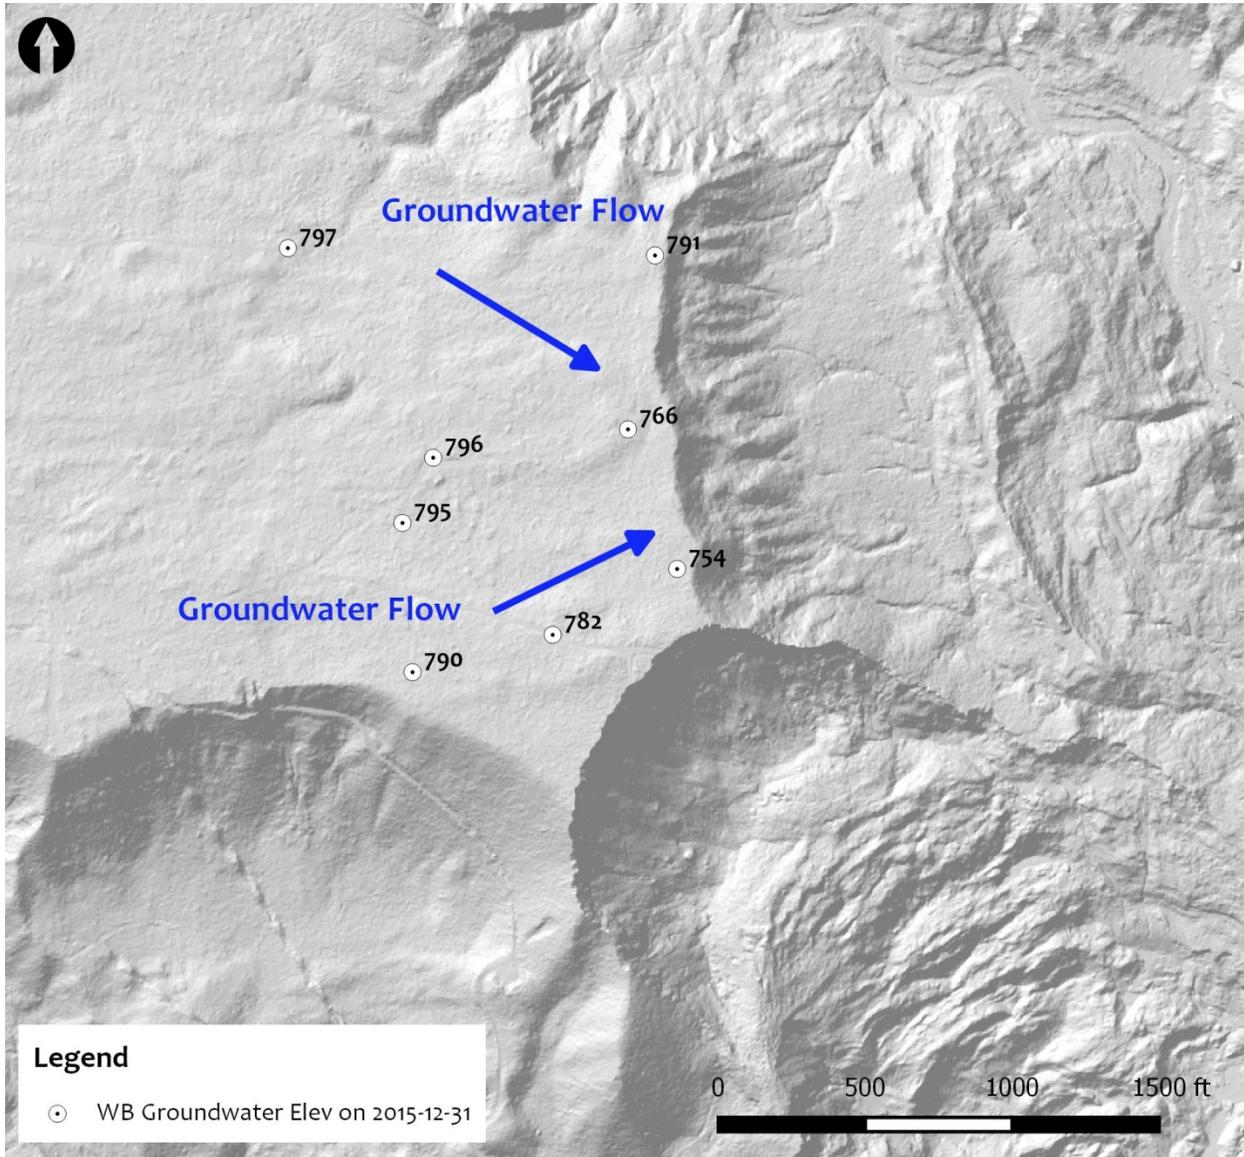
1 The groundwater monitoring data collected to date suggests that shallow groundwater percolating
2 through the recessional outwash gravels and sands flows off to the east, concentrating to the center of
3 the Upper Headache Creek Basin. The groundwater data does not support flow towards the SR 530
4 Landslide main scarp. Therefore, the Miller-Sias model (6) (7) of assumed groundwater flow is not
5 supported by site-specific data.
6

7
8 **Figure 12: Groundwater flow based on elevations of groundwater surface from instruments installed in Whitman**
9 **Bench (elevations reported at noon on 12/31/2015).**
10

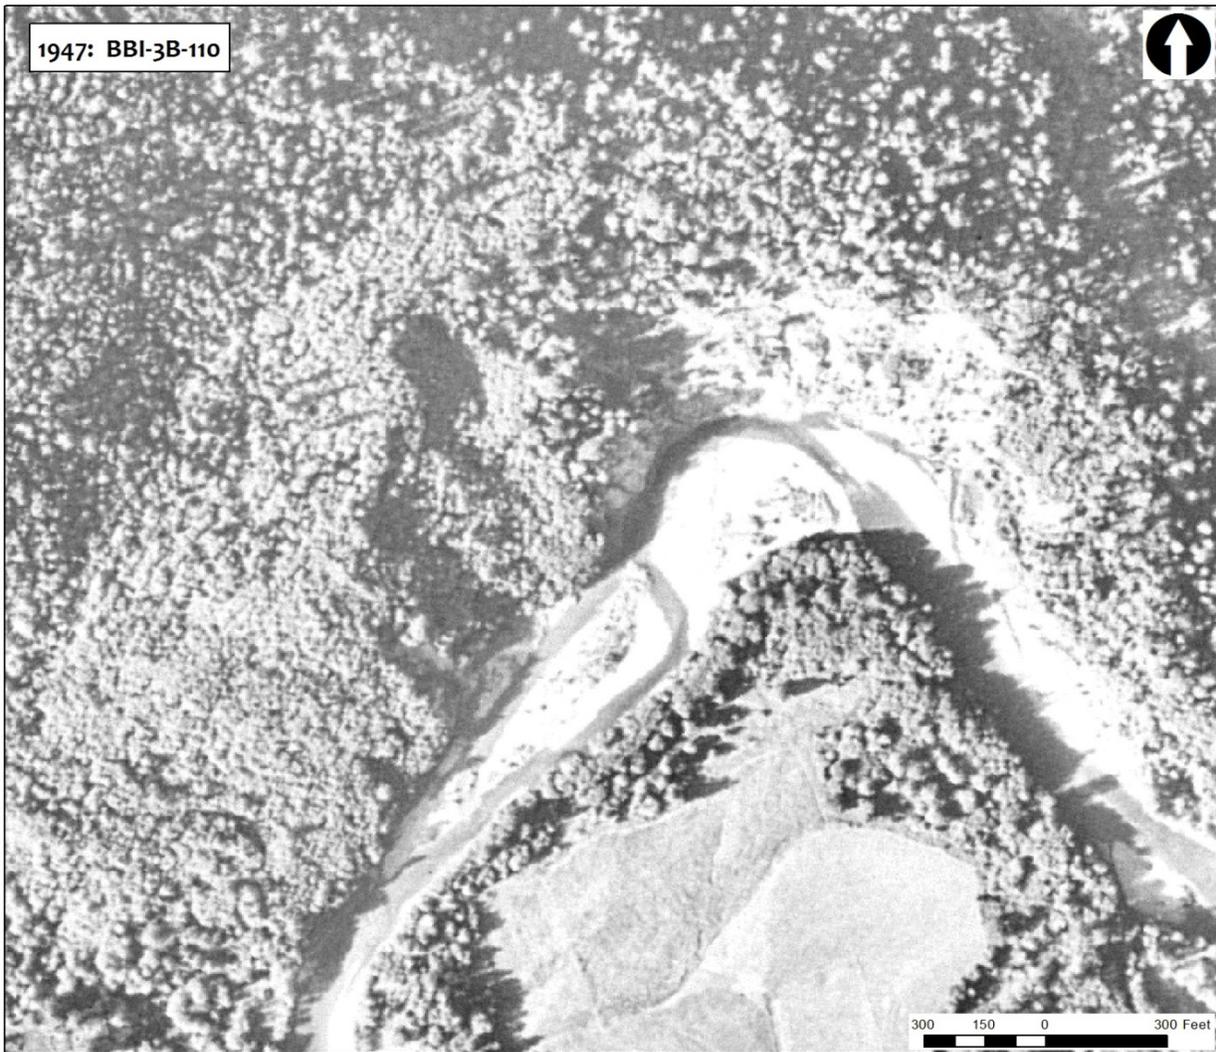
12 **Figure 15: Aerial photo from 1947 showing active deposition of material eroded from Slide Creek that has forced**
13 **the river to the southern shore, with a pioneer channel reforming at the base of the Bear Lake Sand deposit.**
14

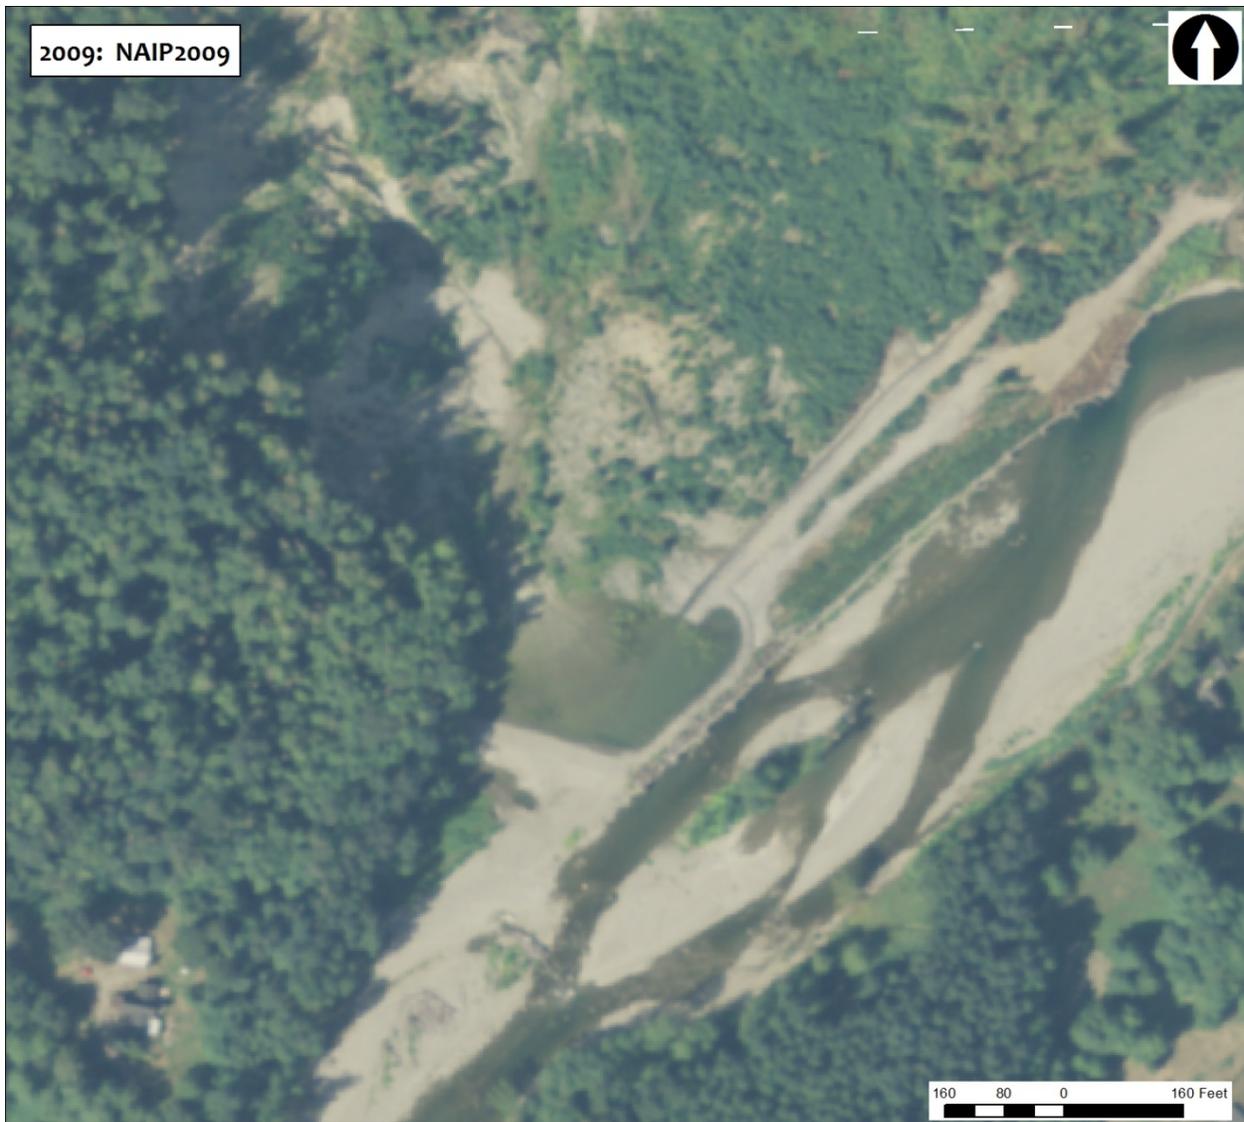
2 **Figure 20: Close up view of active sediment deposition observed in the 2009 aerial image.**

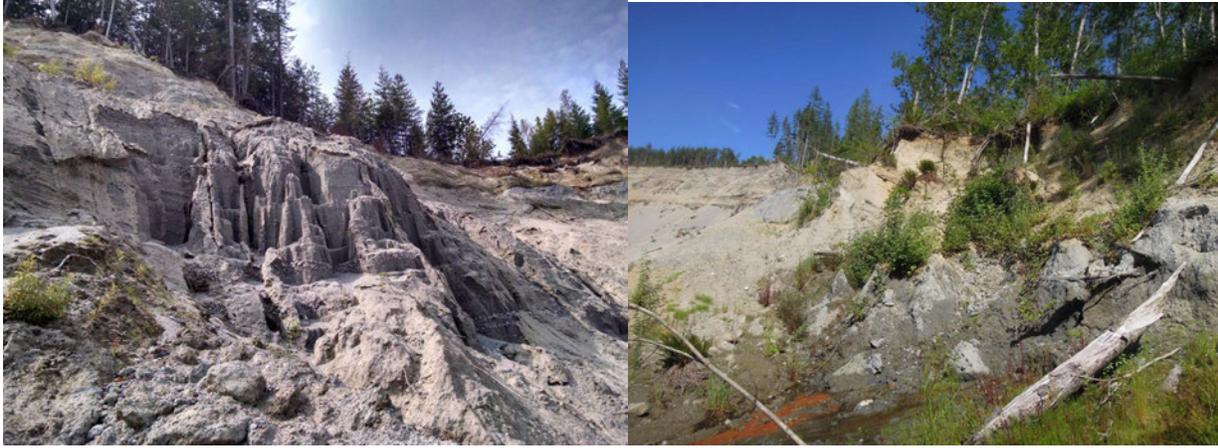
1 the Hazel Landslide is dominated by cohesionless soil types (e.g., non-plastic coarse sands and gravels);
2 whereas the eastern side of the Hazel landslide is dominated by cohesive soil types (e.g., plastic silts and
3 clays). Photographs of representative soils in each side of the Hazel landslide are shown in Figure 27.

4
5 **Figure 27: Western side of the landslide complex shown at the left and eastern side of the landslide complex**
6 **shown on the right.**

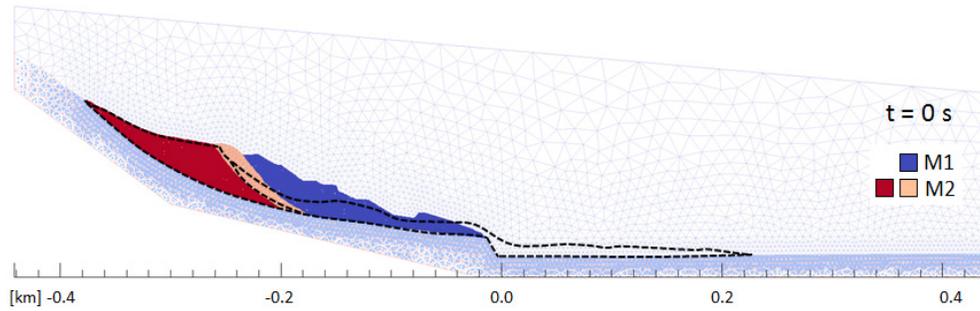
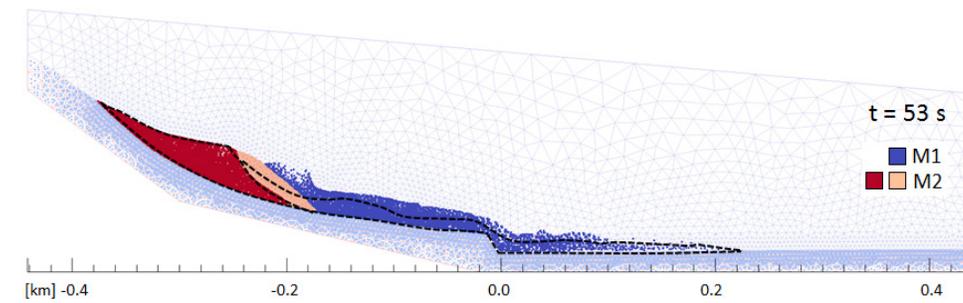
24
25 The adopted MPM model was able to capture the observed distance of the 2006 Hazel Landslide runout
26 (Figure 28). Moreover, the MPM model that was calibrated to capture the observed distance of the
27 2006 Hazel Landslide runout was also able to capture the general characteristics and runout distance of
28 the SR 530 Landslide (Figure 29). Therefore, the actual runout distance of the SR 530 Landslide is
29 captured well with these analyses, which are, in turn, consistent with the 2006 Hazel Landslide analyses.
30 We are confident that the MPM model is capturing the basic physics involved in the slope runout
31 problem using reasonable estimates of soil stratigraphy, slope and surface of rupture geometry, and
32 engineering properties of the component materials.

5 **Figure 28: (a) Initial landslide geometry, and (b) final landslide geometry for the 2006 Hazel Landslide runout.**
 6 **The observed final topography of the 2006 Hazel Landslide runout is indicated with a dashed line (Appendix K).**

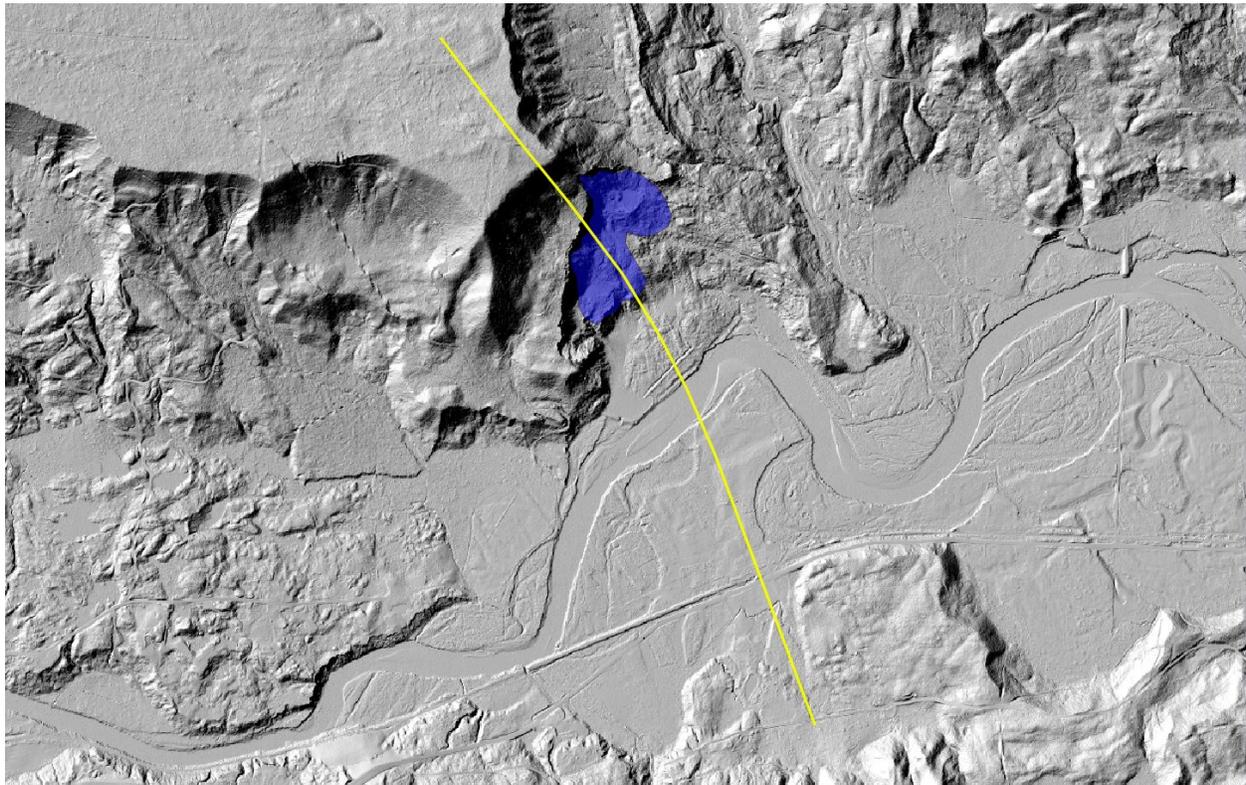
Approximate Extent of M-1 Movement During the SR-530 Slide Event.

Two scenarios are possible for the initiation of the March 22, 2014 SR-530 Slide. The first scenario involves additional minor movement of the Hazel Slide material sitting in the source area above the BLS cliff. This may have removed sufficient lateral support from the toe of the remainder of the mid-slope bench to initiate movement of a large portion of this ancient slide deposit on the pre-existing failure surface P-2. For purposes of this report, such minor movement of the 2006 slide debris in the source area is designated M-1.

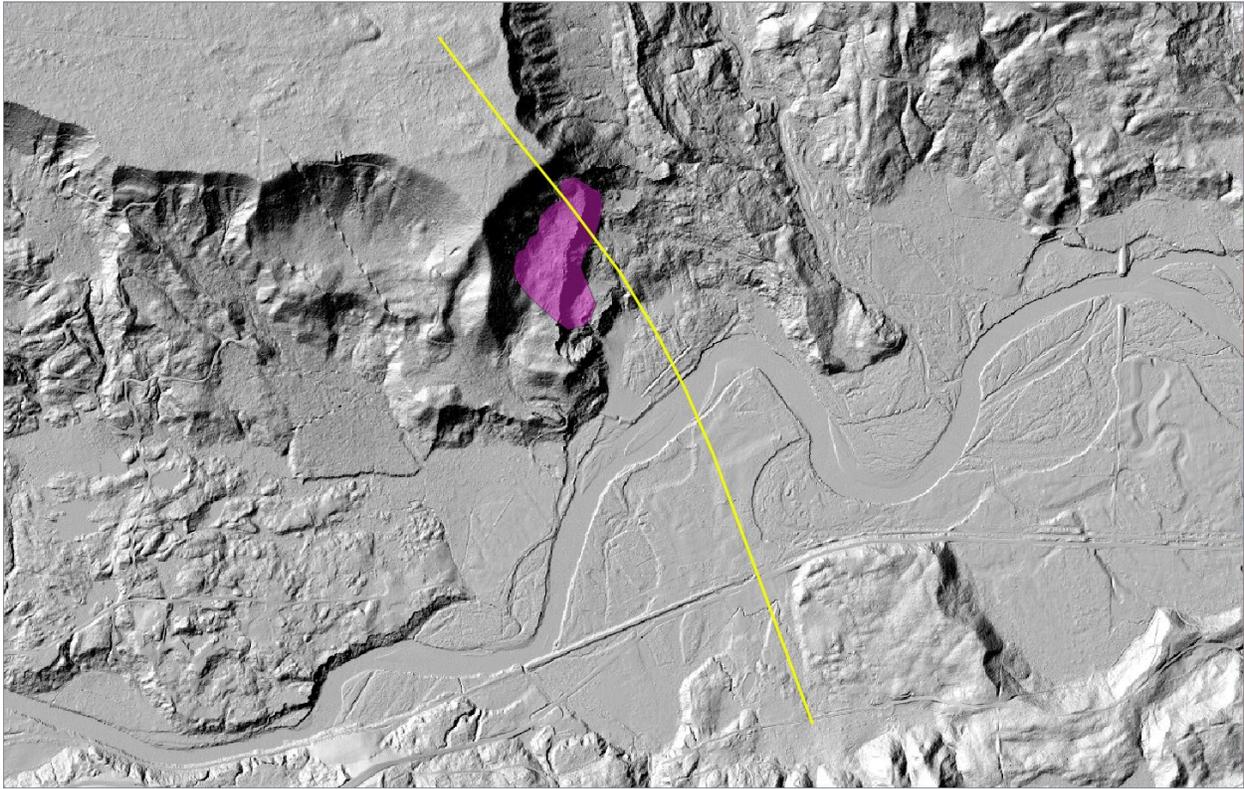
Approximate Extent of M-2 Movement, Involving the Central Portion of the Former Mid-slope Bench

Regardless of the actual scenario involved in initiation of the movement of large portions of the remainder of the mid-slope bench, this movement appears to have occurred largely on the steeper upper portion of the pre-existing ancient failure surface P-2. This movement (designated M-2 for purposes of this report) appears to have largely overridden the slide debris sitting in the 2006 Hazel slide source area above and below the BLS cliff. Evidence for this over-riding is the fact that none of the extensive alder brush covering the 2006 slide debris prior to the SR-530 Slide can be found at the appropriate locations of the deposit covering the valley floor post-2014. Therefore, it appears to have been ground up and incorporated into the slide deposit.

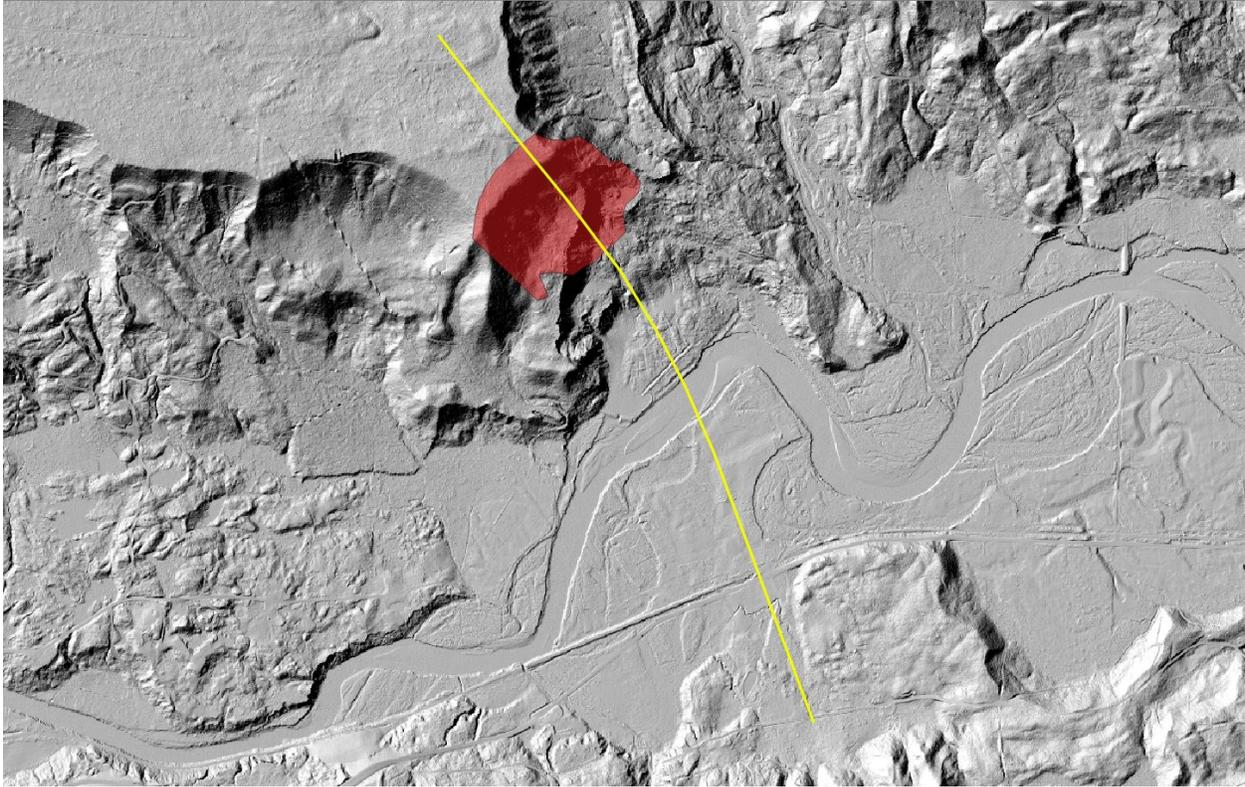
Approximate Extent of M-3 Movement

Movement of the M-2 mass instantaneously unloaded the toe of the Whitman Bench slope, resulting in rotational failure of the much larger M-3 mass. Given its comparatively large mass and elevation above the valley floor, this mass possessed significant potential energy, which, once moving, was converted to kinetic energy. Portions of this kinetic energy were imparted to the M-2 mass still moving on the slope below when it was struck from behind by the leading edge of the M-3 block. This ultimately resulted in propelling the combined M-2 mass and leading edge of the M-3 mass into the Steelhead Haven neighborhood, and flung the leading edge of the M-2 mass far beyond SR-530. It is also possible that the impact of the leading edge of M-3 on the backside of the moving M-2 block resulted in the acceleration of the M-2 mass when the leading portions of the M-2 block were already in view of John Reed, moving on the relatively flat portions of the valley floor in the vicinity of the river. This would be consistent with his report that the slide accelerated “when it hit the river.”

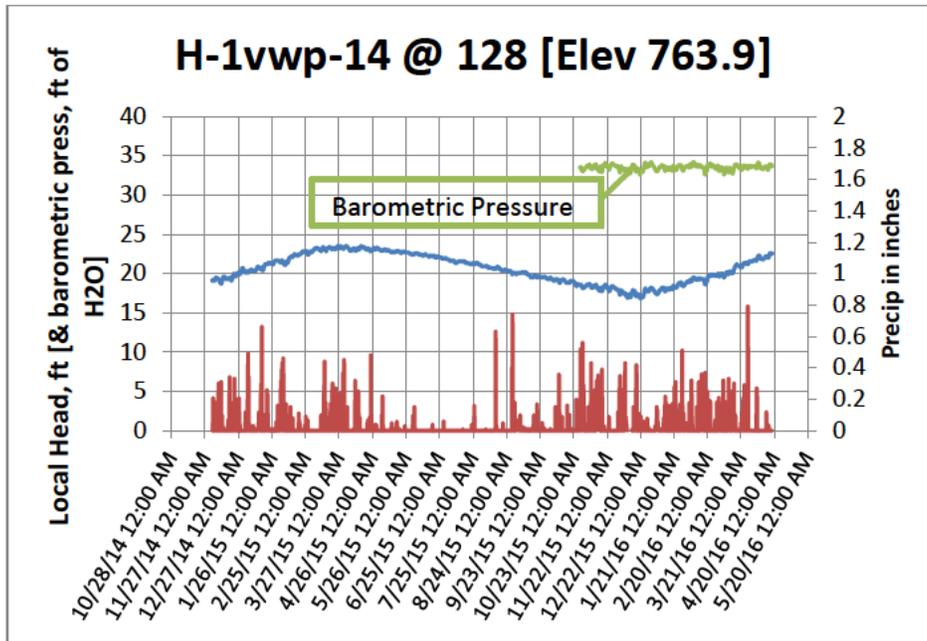
Figure I-7. Piezometric record from above the till in H-1vwp-14.

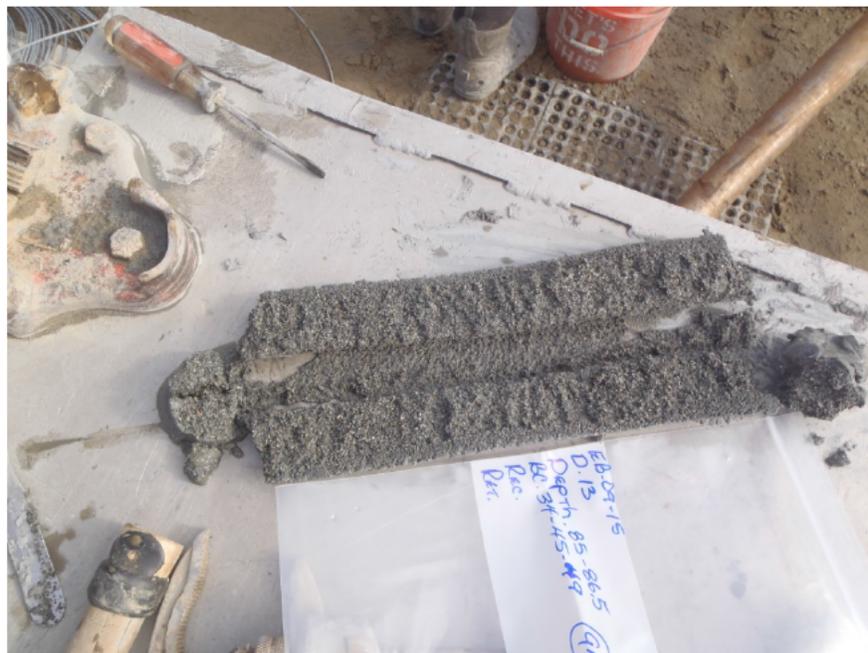
- The Bear Lake Sands which underlie the entire landslide area and beyond, from the toe of the surface of rupture through to at least the location of boring EB-02 on the Whitman Bench are either not saturated or not significantly pressurized at the base of the Glacial Lacustrine silts and clays the directly overlie the Bear Lake Sands.
 - Evidence of a lack of saturation can be inferred from the samples that were obtained in split spoon samplers from the Bear Lake Sands in Boring EB-09. The photo below shows such a sample. Saturated sand is unlikely to be retained in a sample tube, and if it is retained, will not retain its texture when tub is split open.

Figure I-8. Split spoon sample from the Bear Lake Sands.

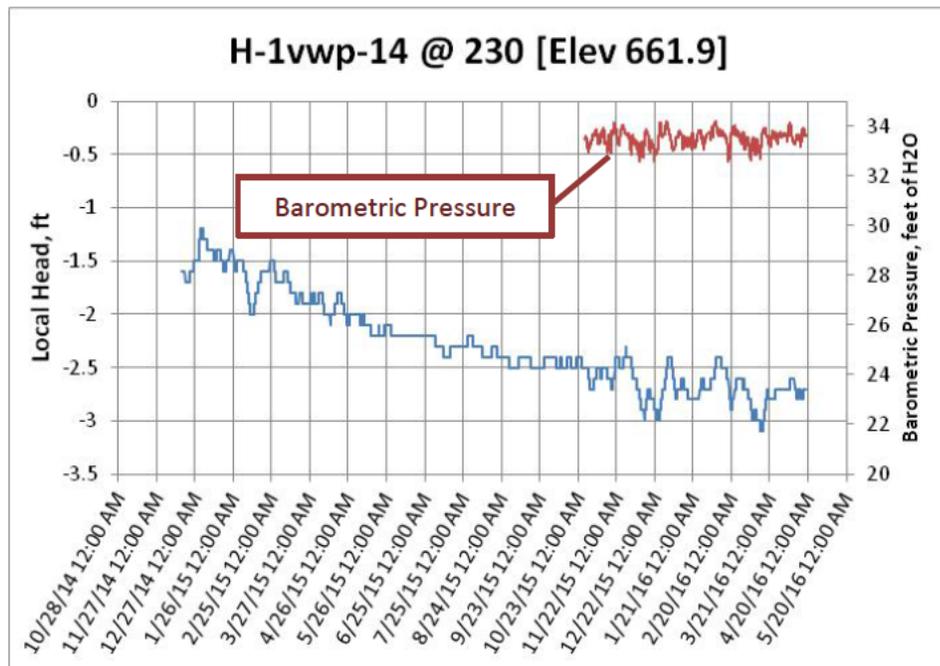
- Piezometer readings in H-1vwp-14 and H-2vwp-14 from below the glacial till down to the Bear Lake Sands indicate four modes of behavior.
 - First, the near zero piezometer reading at elevation 662 indicates that the till above is in fact an aquitard.

Figure I-9. Piezometer reading from advance outwash strata beneath the glacial till

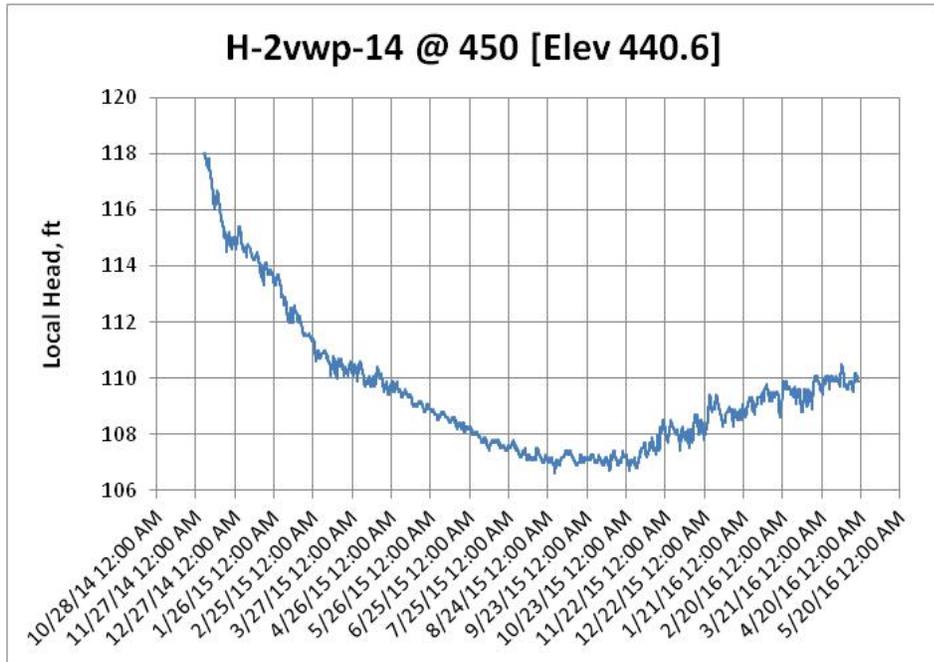
indicates that there was a significant period of adjustment of internal seepage patterns below the Whitman Bench following the SR 530 landslide.

Figure I-10. Adjustment of the piezometric level in one piezometer attributed to changes following the SR 530 landslide.

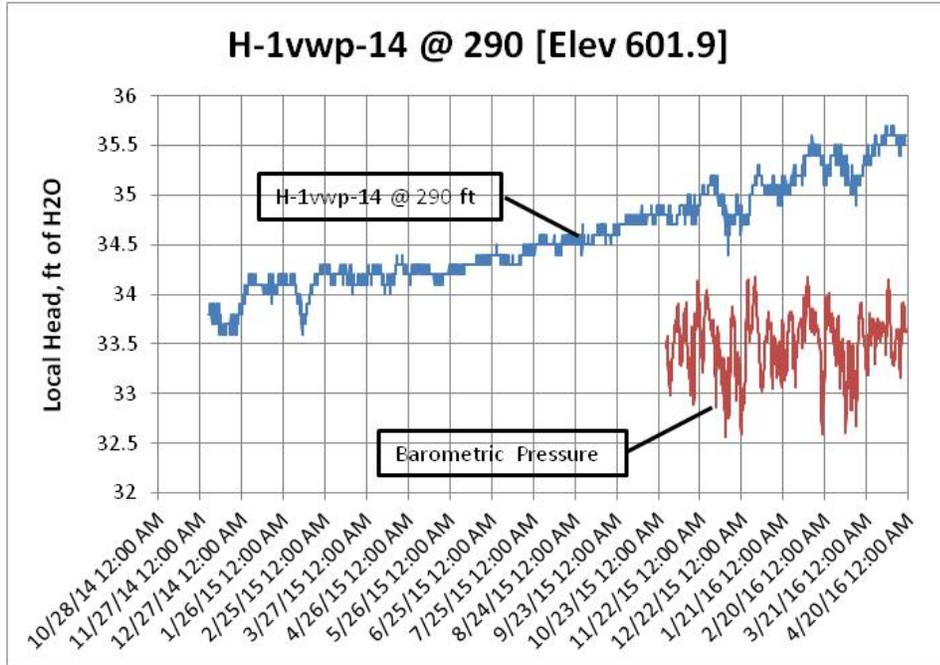
coincide with a locally much thinner and broken section of the silt/till aquitard layer.

Figure I-11. Piezometer reading indicate slight leakage through the silt/till aquitard.

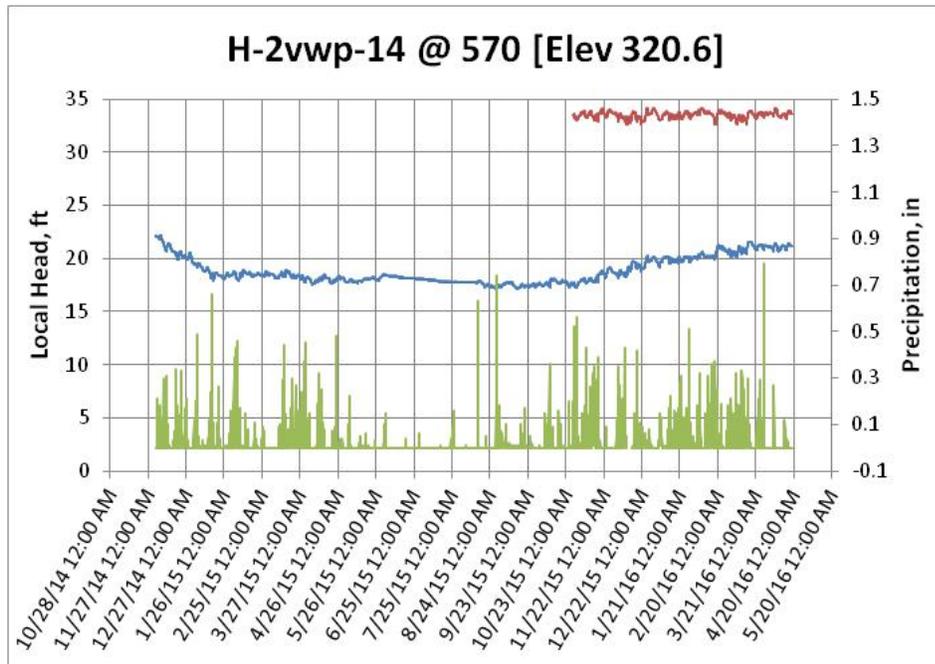
Figure I-12. Bear Lake Sands piezometer in H-2vwp-14 showing a seasonal response.

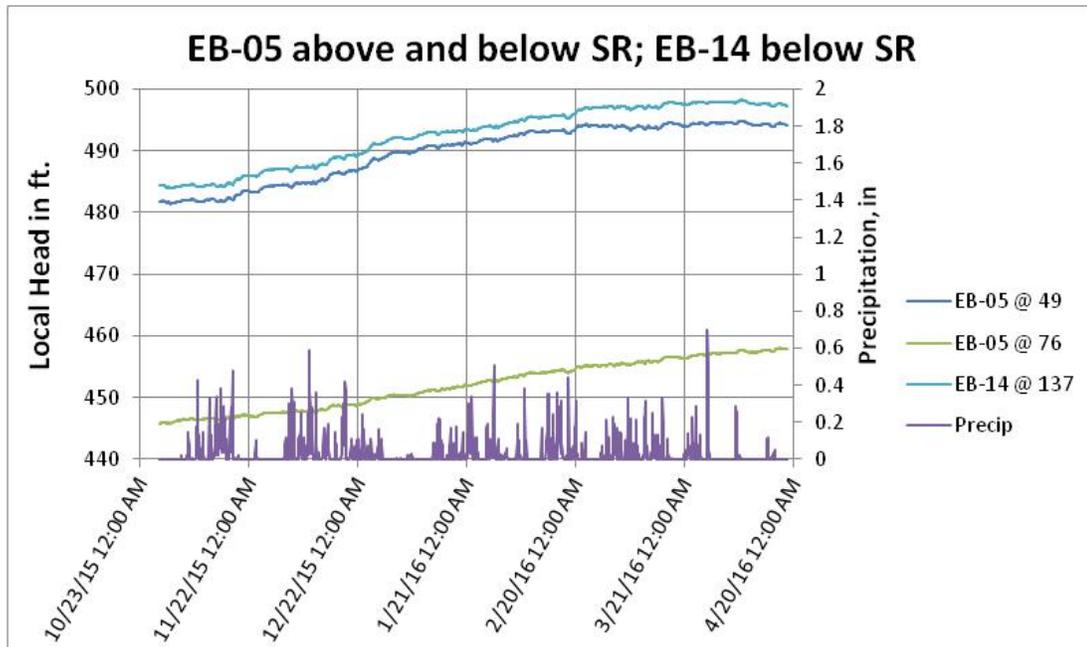
Figure I-14. Piezometers indicating connectivity between the slide debris and the lacustrine silt/clay below the surface of rupture.
