The Performance of Structures Subjected to Surface Fault Rupture during the Mw 6.0 South Napa Earthquake, California, USA

J. Cohen-Waeber¹, R. Lanzafame², J. Bray³, N. Sitar⁴

ABSTRACT

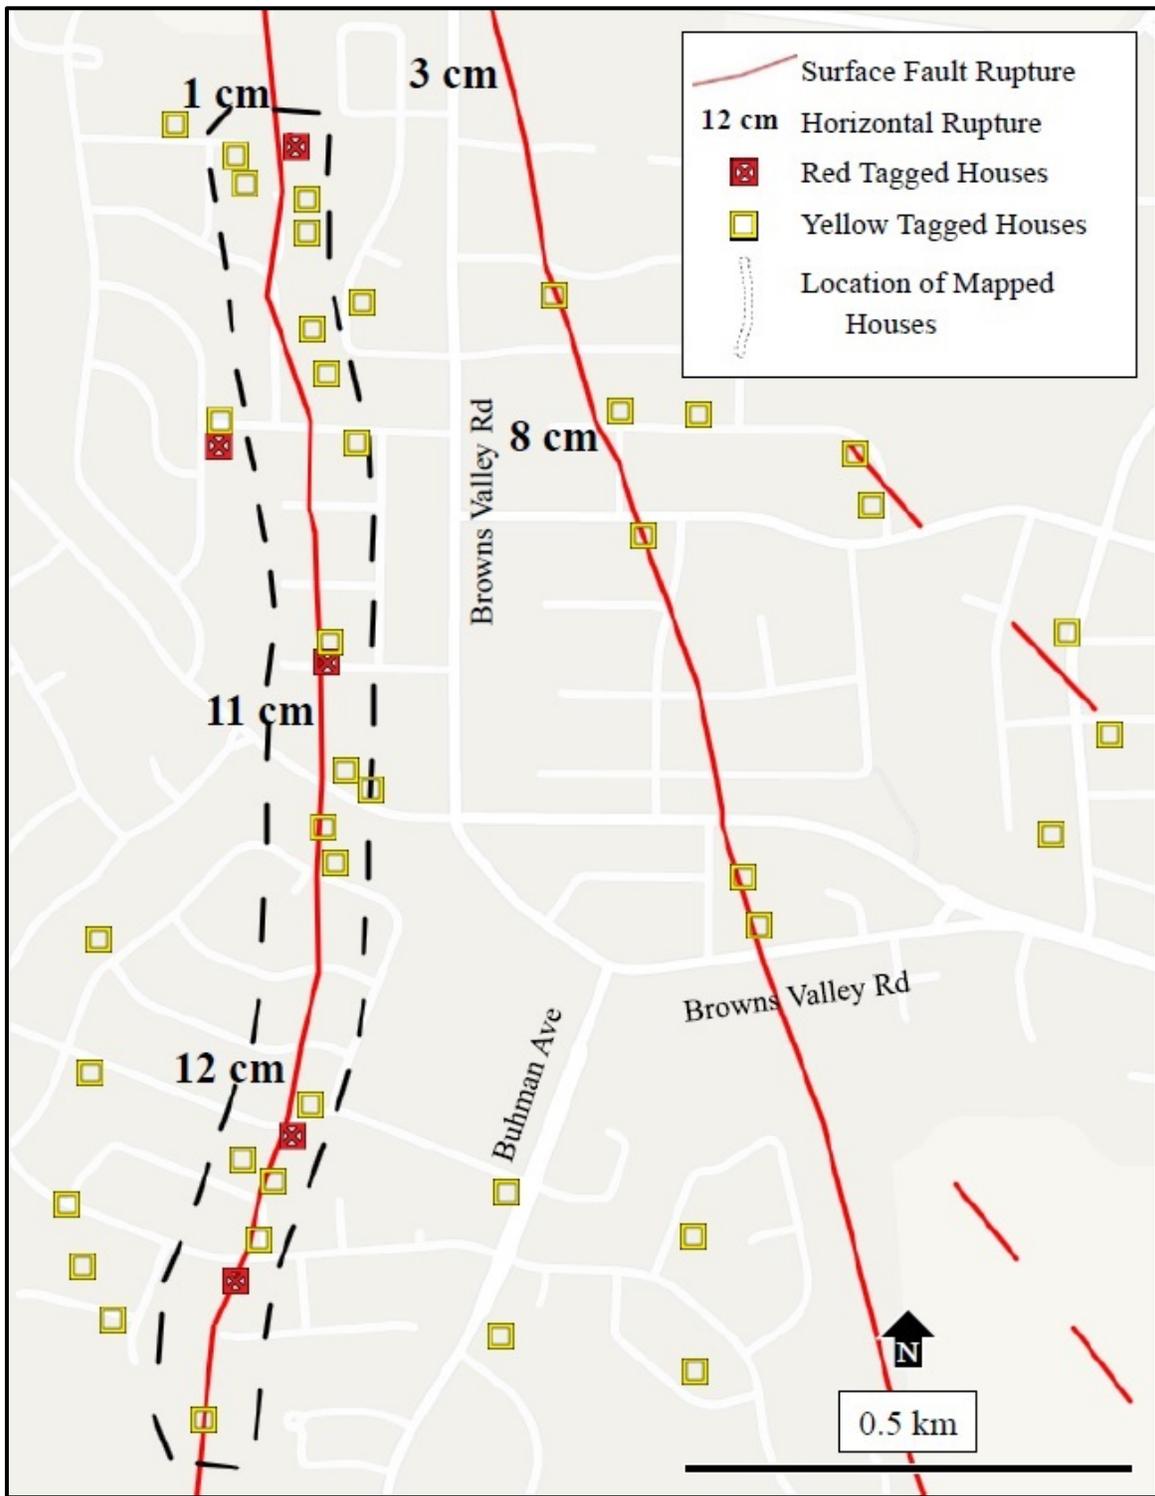
Structural damage due to shaking during the South Napa Earthquake was prevalent in the historic downtown Napa. However, principal damage to residential structures in the western Napa area of Browns Valley was due to surface fault rupture, along two coherent fault strands (Figure 2). Offset along the main (western) strand within Browns Valley was 10-20 cm (a maximum of 46 cm was measured 1-2 km to the south; Bray et al. 2014), and decreased progressively to the North (Hudnut et al. 2014). Smaller offsets of 2-8 cm were measured along the eastern strand (Hudnut et al. 2014). To ensure safe occupancy, California State regulation requires structures in areas affected by damaging earthquakes to be inspected by trained professionals, soon after the event. Based on the severity of their damage, structures suitable for only brief entry are assigned yellow tags and those not suitable for entry are assigned red tags. In the Browns Valley, most damaged and tagged structures were located on or near surface fault rupture, and red tagged structures were exclusively located along the main strand (Figure 2). The tagging system was used to guide the field mapping effort by the GEER teams.

Figure 2. Surface rupture trace of the South Napa Earthquake through Browns Valley, illustrating magnitudes of displacement and approximate damaged property locations. [Note: not all red and yellow tagged structures were visited by the GEER team]

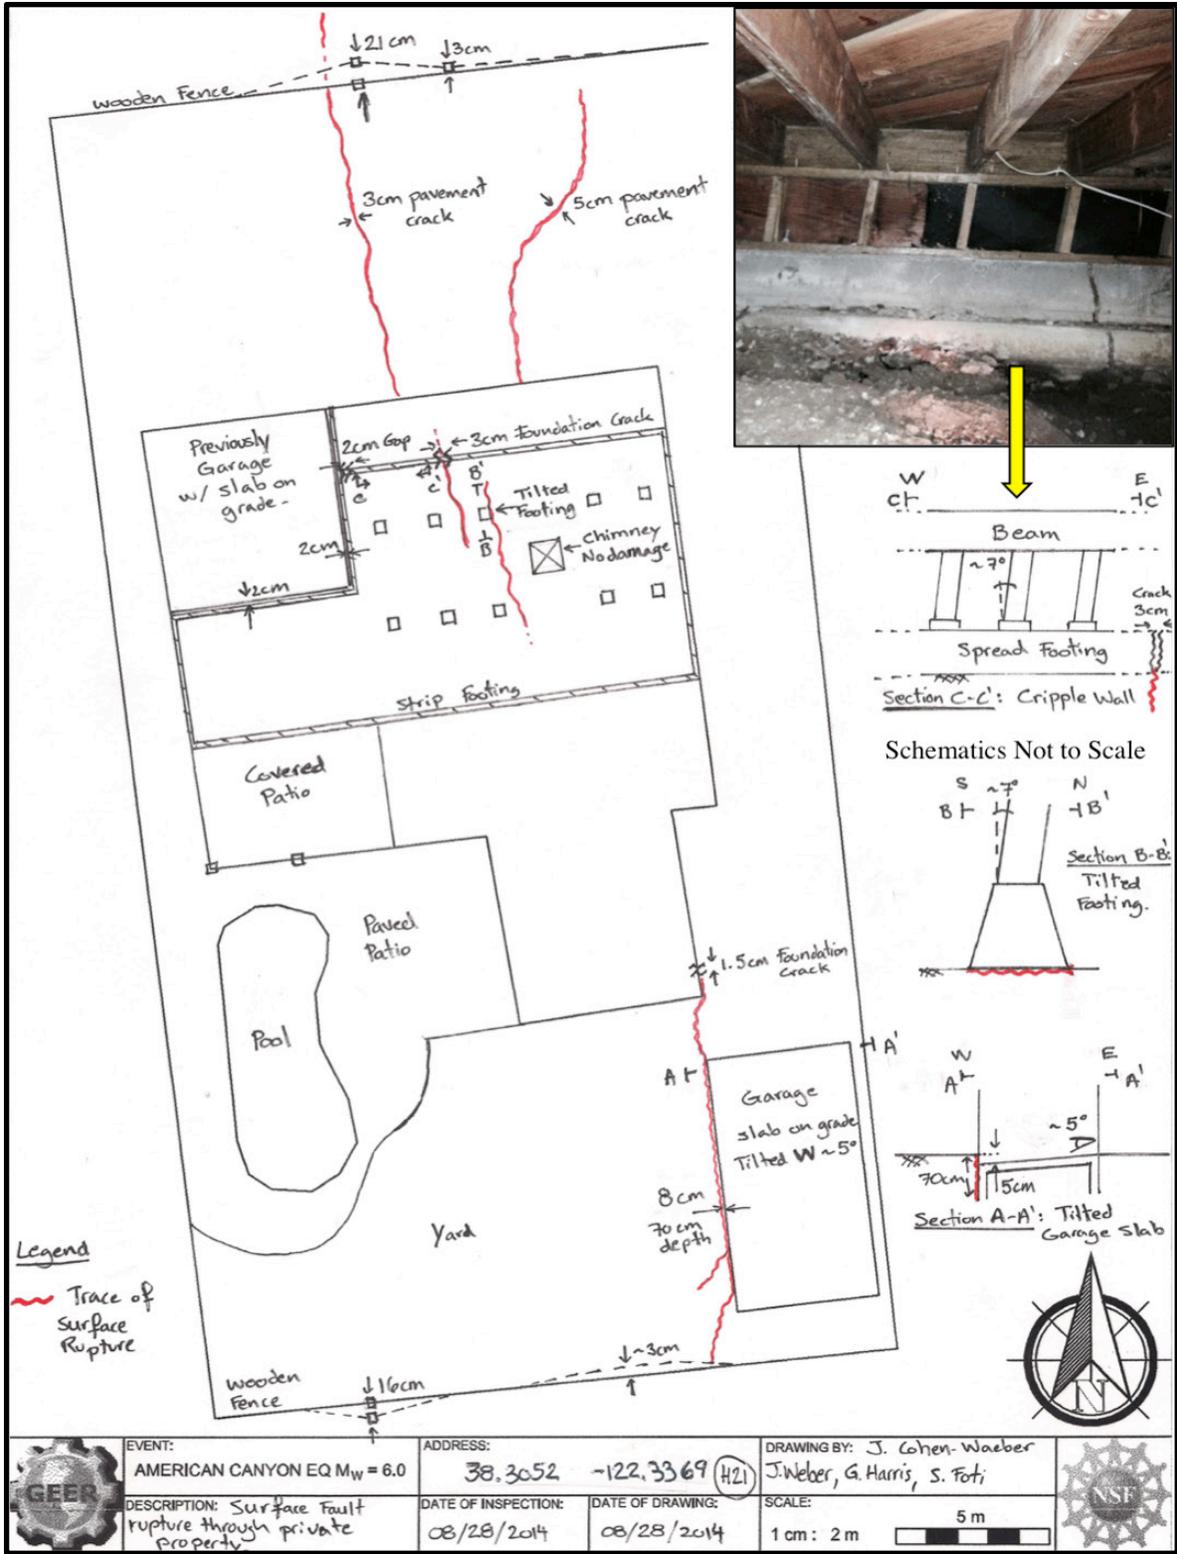
The structural damage associated with surface fault rupture in the Browns Valley area was mapped between August 25 and August 28 and detailed maps of damage to individual structures were produced (Bray et al. 2014). While not all tagged structures were mapped, damage to properties on or adjacent to the primary trace of the fault was mapped with a focus on tagged structures, and to the extent possible given time constraints and subject to property owners' permission. In total, of the approximately 60 residences along the main fault strand alignment within Browns Valley (outlined in Figure 2), exterior damage was mapped at 39 residences and 26 structures were mapped in detail. Though similar damage occurred along the secondary (eastern) strand, only one residence was mapped in detail, also due to time constraints, for a total of 27 structures mapped in detail (Bray et al. 2014). In each case, major damage was documented (including measurements and photographs) and drawn to scale, concentrating on structural damage and ignoring cosmetic damage, as illustrated in Figure 3.

Figure 3. Detailed damage map for a structure on strip footings affected by surface fault rupture in the Browns Valley area. Photo inset shows Type I and II damage.

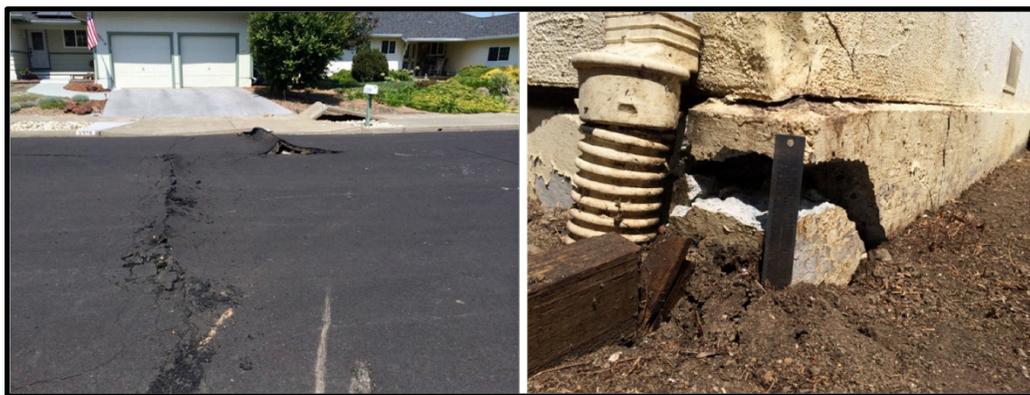
Type I: Cracking of reinforced concrete and concrete masonry components within structures ranged from cosmetic cracking of swimming pool patios to cracking of structure foundations (Figure 4). Damaged structures included: foundation elements (cracks up to 5 cm wide); non-foundation unreinforced and reinforced concrete slabs (cracks up to 8 cm wide); and curbs and sidewalks (i.e., buckling due to compression).

Type III: Cracking of paved and unpaved areas at the ground level (Figure 4) included tension and compression features in paved (i.e., asphalt) and unpaved surface, and was a clear indicator of fault trace location (for both main and eastern strands). These features ranged from thin fissures to deep open cracks or buckled asphalt and soil mounds. This damage mode was consistently mapped in a narrow alignment that is very consistent with surface fault rupture as mapped by Hudnut et al. (2014), and this type of damage away from the fault trace is negligible. Asphalt cracking reached depths of 50 cm and horizontal offsets up to 20 cm; buckling reached a maximum height of 24 cm. Rupture of unpaved surfaces reached maximums of 13 cm horizontal offset and 76 cm depth.

Figure 4. (Left) Type III damage in street; negligible damage to left structure, significant damage to right structure, including (Right) Type I foundation damage.
