## Ground Deformations in the Very Near Fault Region during the M6.0 South Napa Earthquake

N. Wagner<sup>1</sup>, J.D. Bray<sup>2</sup> and N. Sitar<sup>3</sup>

### ABSTRACT

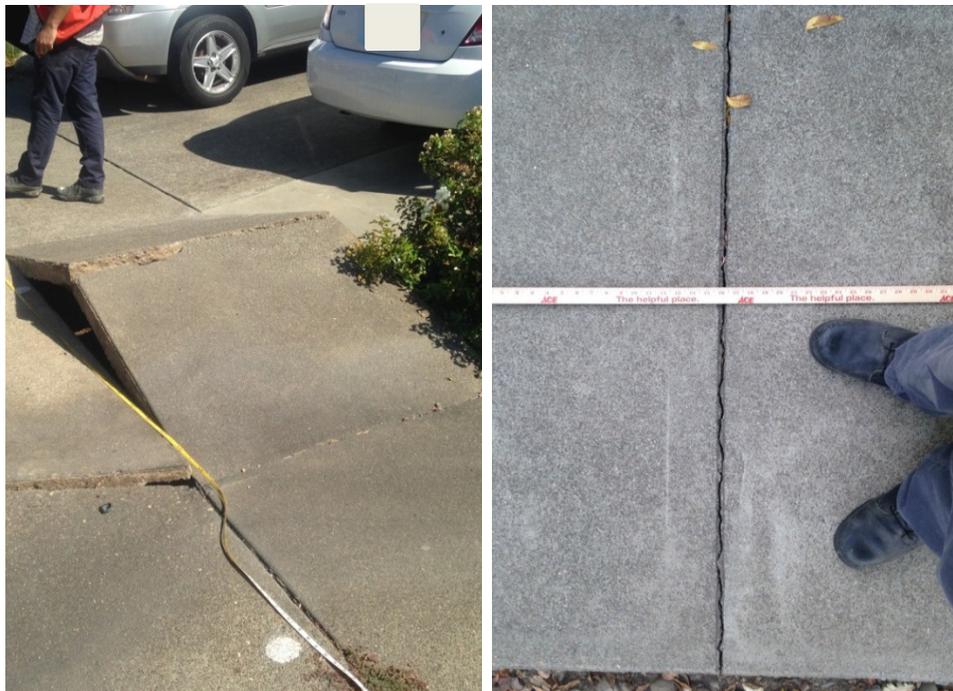
A typical buckled compression zone and extension crack is shown in Figure 2. These types of compression features were predominantly concentrated in concrete sidewalks and were quite

readily apparent while extension cracks were typically quite innocuous and required a careful inspection. It should be noted that frequently there was no evidence of similar deformation in the adjacent bituminous pavement in the street.

Figure 2: Typical buckled compression zone (left) and extension crack (right) [N 38.3037 W 122.3433; 8/26/2014 15:41 (left); N 38.3055 W 122.3455; 8/26/2014 18:34 (right)]; Bray et al. (2015).

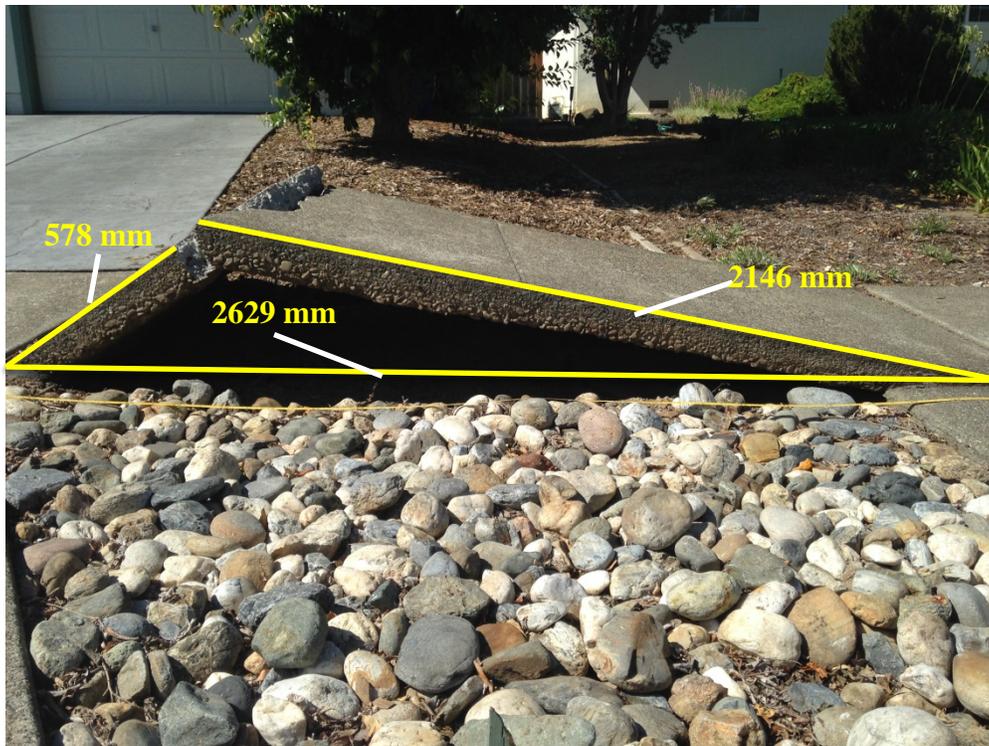
Deformation in the buckled compression zones was assessed by first measuring the lengths of the uplifted sidewalk section along the top surface on the same edge to obtain the original length of the section. Then, the distance between the new outer edges of the sidewalk was measured to obtain the new length of the section. The difference between the measurements was recorded as the compression in the zone. Measurements for a typical buckled section are shown in Figure 3.

Figure 3: Measuring a typical buckled compression zone in sidewalk pavement [N 38.3039 W 122.3430; 8/26/2014 15:24]; Bray et al. (2015).

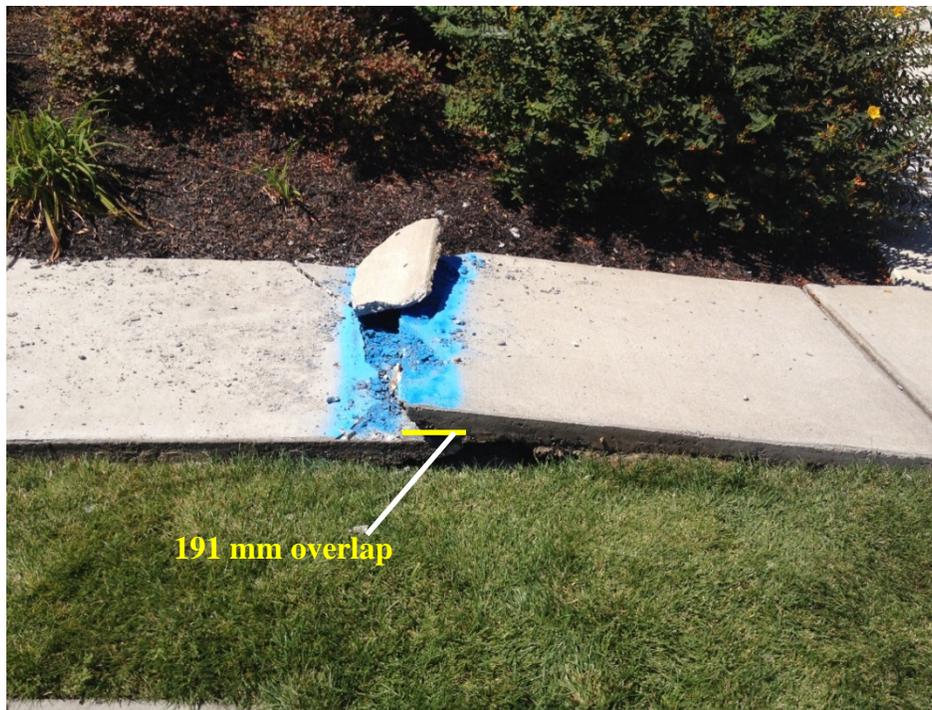
In some locations, compression in the sidewalk pavement manifested as an overlap instead of a buckled section. In such cases the overlap was measured and recorded as the compression in the zone. The measurement for an overlapping compression zone is shown in Figure 4. In cases where both gaps and overlaps were observed, the gaps were subtracted from the overlap measurement and this value was recorded as the compression in the zone. The measurement for an overlapping compression zone with a gap is shown in Figure 5.

Figure 4: Measuring an overlapped compression zone in sidewalk pavement [N 38.3065 W 122.3454; 8/28/2014 14:00]; Bray et al. (2015).

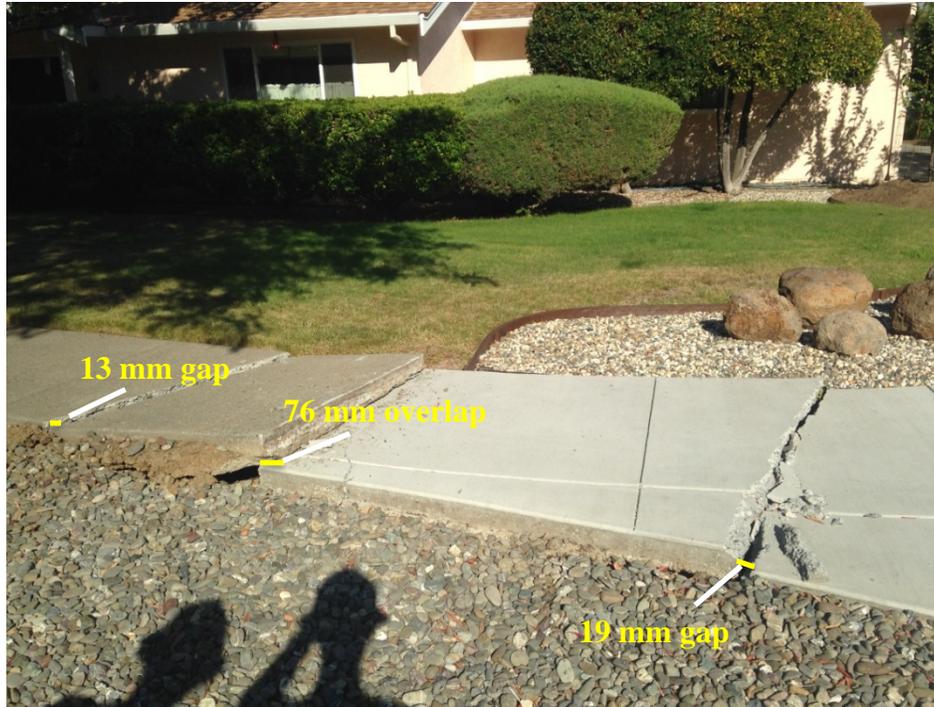
Figure 5: Measuring an overlapped compression zone with a gap in sidewalk pavement [N 38.3047 W 122.3459; 8/26/2014 16:52]; Bray et al. (2015).

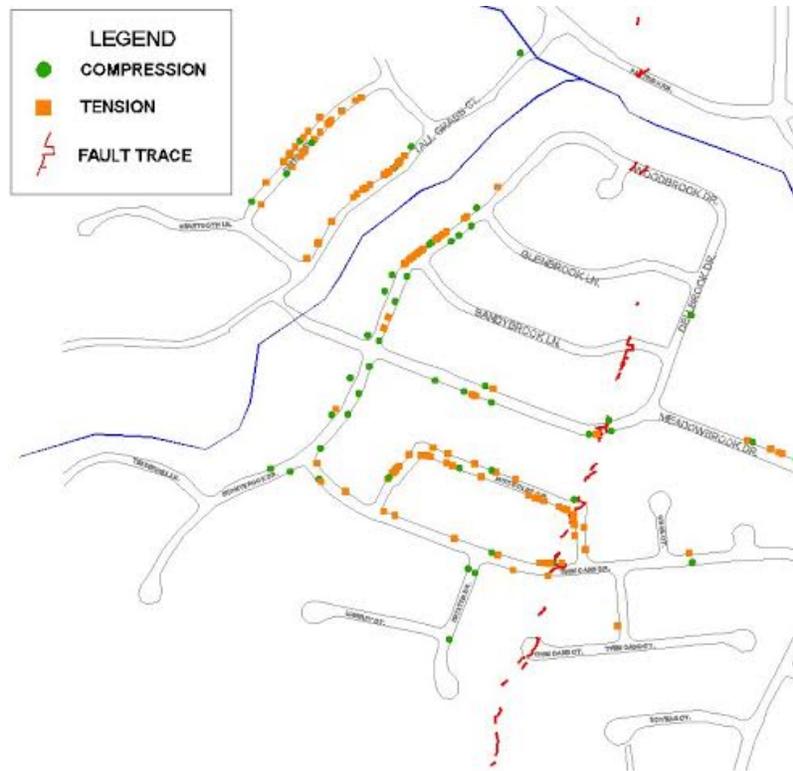
Ground strain was computed over each 25 meter segment by adding the measured extension cracks (positive) and compression zones (negative) to the measured segment length to obtain the original segment length. This became the “gage length” of the strain measurement. Then, the difference between the measured and the estimated original length was divided by the estimated original length to obtain the decimal strain, which was converted to a percent strain. Additionally, the average strain for each sidewalk section as a whole was computed in a similar manner by considering all measured extension cracks and compression zones added to the total length of the segments of a single sidewalk. The results of the average strain over each total sidewalk are shown in Table 1 for sidewalks parallel and perpendicular to the fault. A schematic showing the approximate location of each extension crack and compression zone is shown in Figure 6.

Figure 6: Observed and measured tension (orange squares) and compression (green circles) locations; Bray et al. (2015).

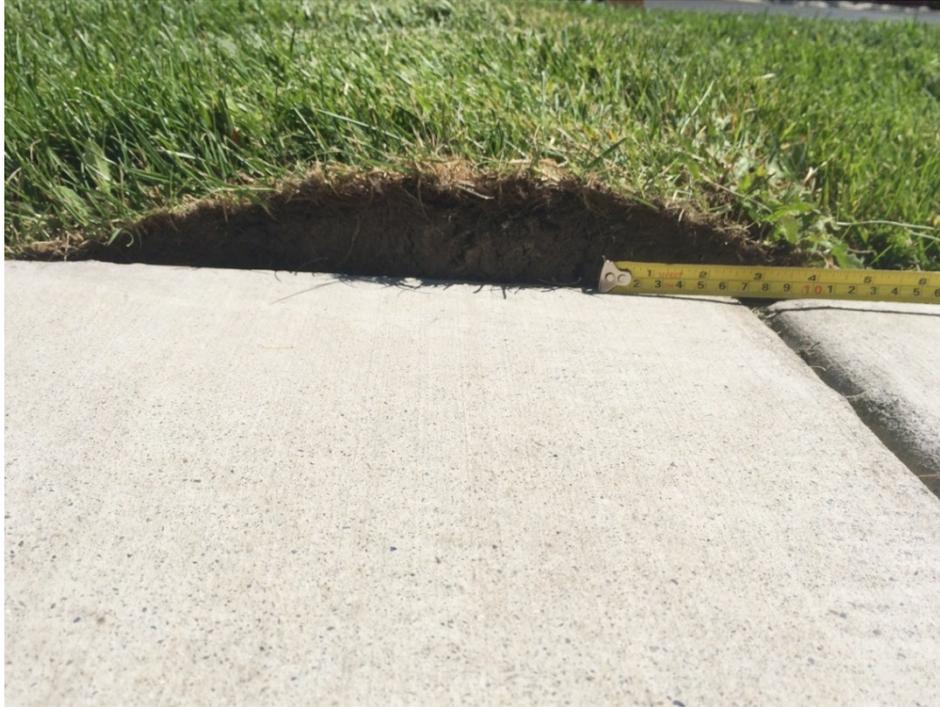
An interesting phenomenon were compression features in grass mats in the curb strips at various locations adjacent and parallel to the sidewalk pavement (Figure 7). Note the lack of apparent deformation in the adjacent concrete walk pavement while the grass mat buckled and actually shortened as a result of the buckling. This suggests that the concrete behaved elastically as the surface wave(s) traveled across this zone whereas the grass mat remained in its compressed state.

Figure 7: Compression feature in curb strip parallel to fault, across from creek [N 38.3065 W 122.3455; 8/28/2014 13:52]; Bray et al. (2015).

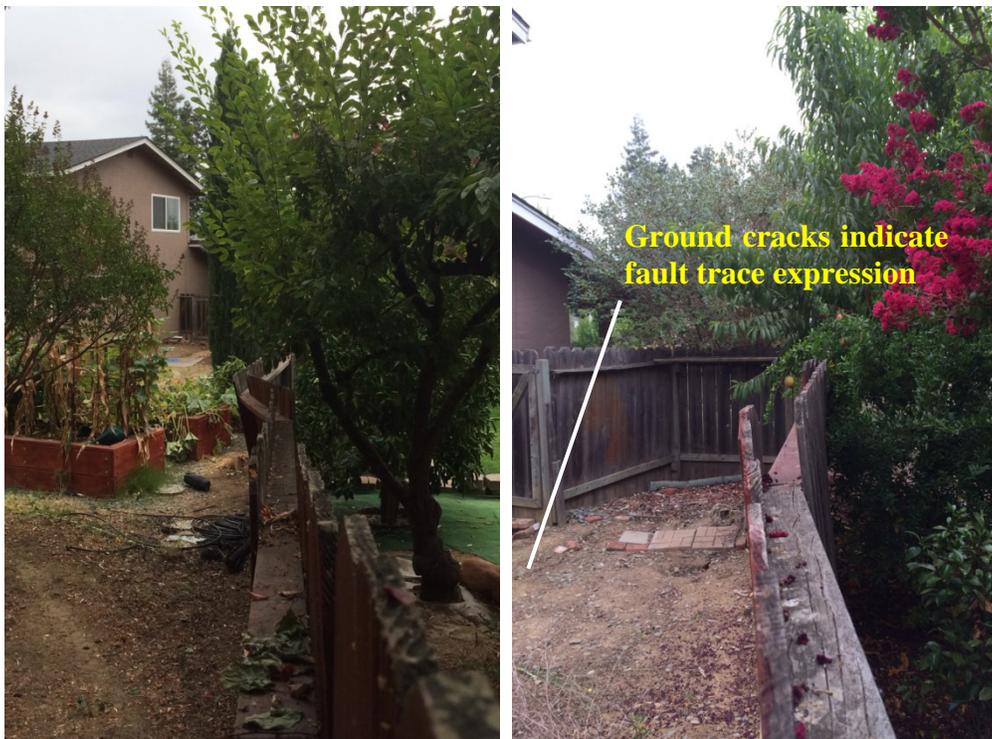
Permanent deformation was also observed on a section of a fence running parallel to and adjacent to the fault trace (Figure 8). To compute the strain, the horizontal boards at the top of the fence were measured in segments to obtain an estimate of the original length of the fence. Then, the ground along the base of the fence was measured to obtain an estimate of the new length of the fence. The average strain in the fence was the same order of magnitude as the average strain in the sidewalk pavement for roads crossing the fault trace.

Figure 8: Buckled section of fence for strain measurements [N 38.3015 W 122.3442; 8/25/2014 09:57]; Bray et al. (2015).
