SUPERIOR COURT OF WASHINGTON FOR KING COUNTY

EXPERT OPINION REPORT OF

DR. MARVIN R. PYLES, Ph.D., P.E.

JUNE 30, 2016

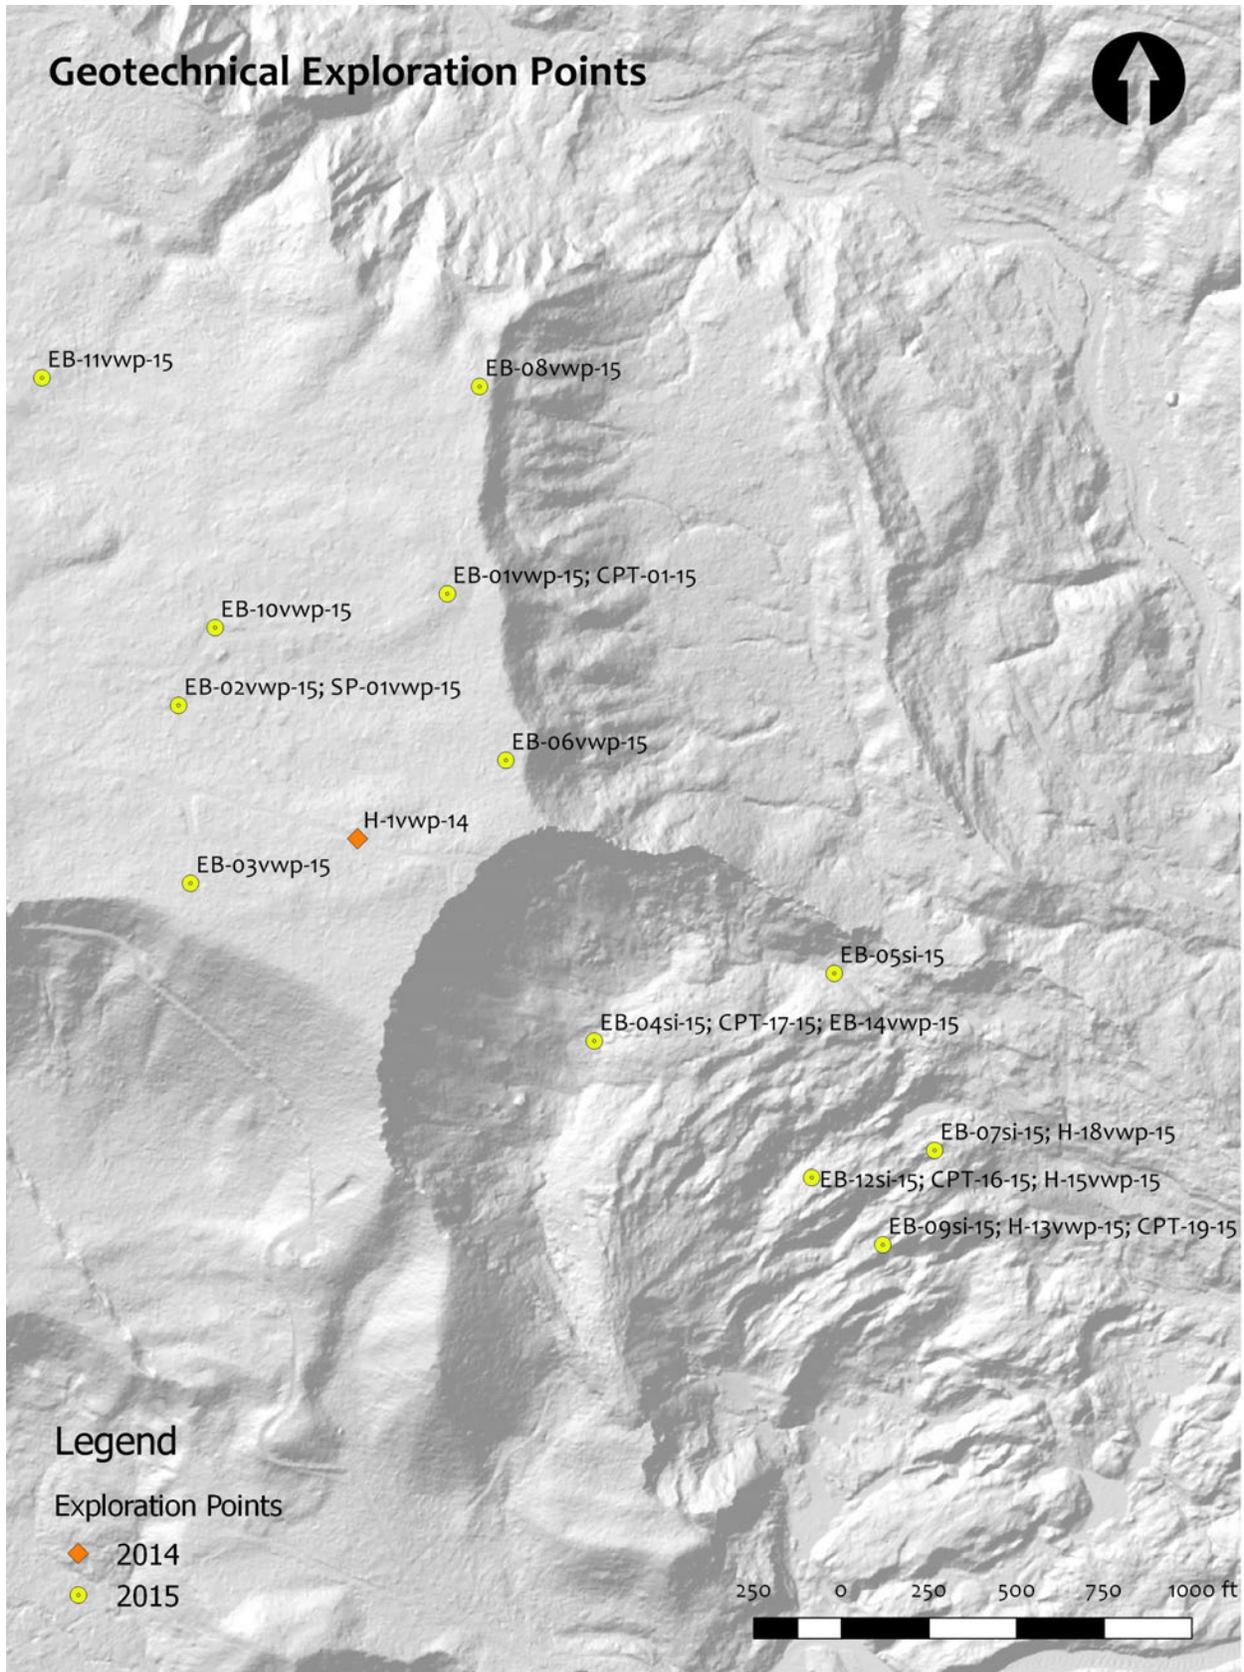
22
23 As-completed locations are shown in Figure 2 and summarized in Table 4. Note that Figure 2 also shows
24 the location of H-1vwp-14, which was a deep exploratory boring completed by WSDOT in 2014, prior to
25 initiation of this field exploration program.

Figure 2: Locations of completed exploratory borings and CPTs.

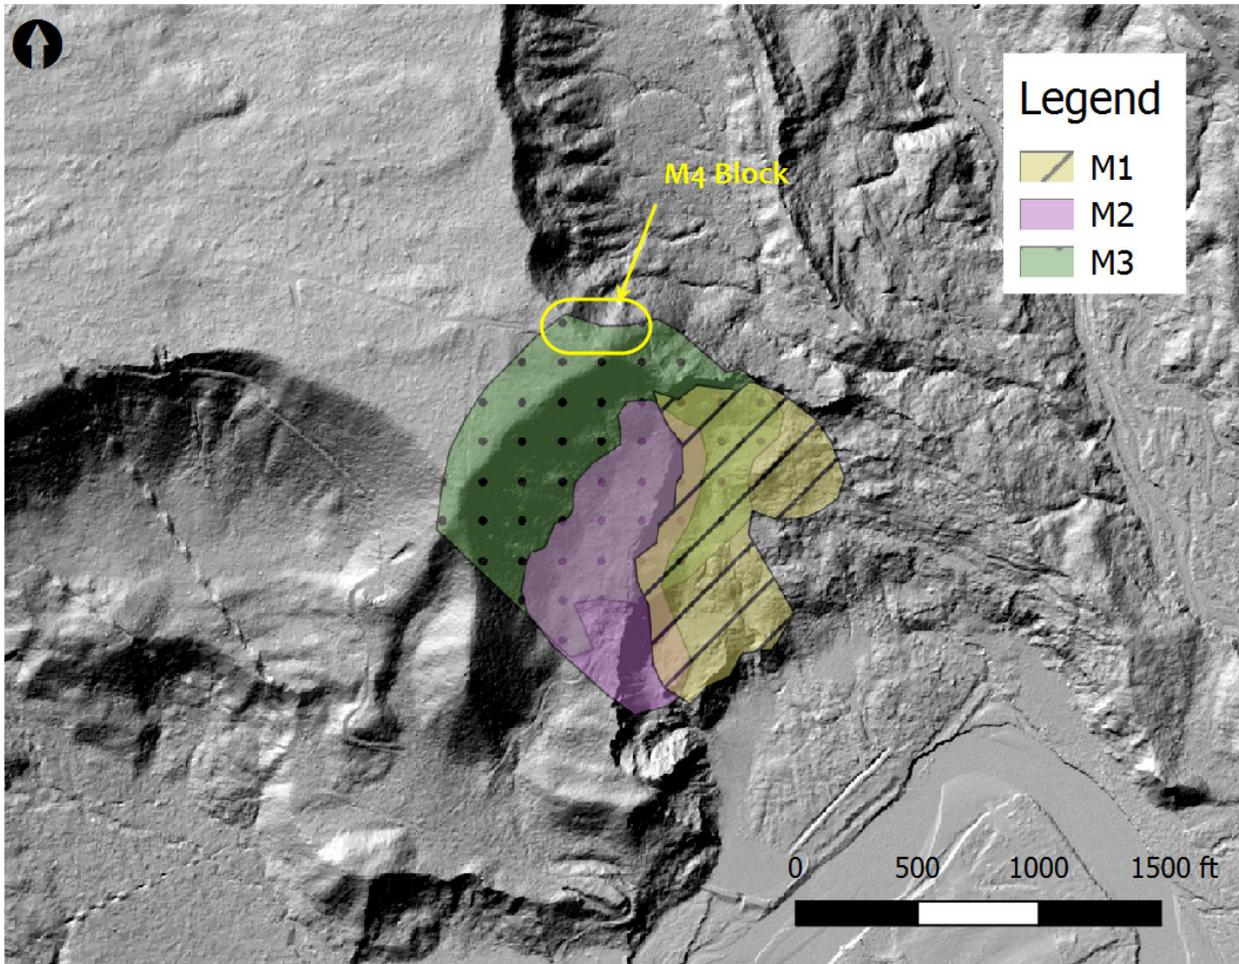
22 Based on the collected site-specific evidence, our expert team developed a working conceptual model of
23 the failure sequence for the SR 530 Landslide. This conceptual model has yet to be fully vetted, but all
24 of our analyses to date support the developed concept. We subdivided the failure area into four
25 movements: M1, M2, M3, and M4. M1 consists of the body of the Hazel Landslide, which is an
26 assemblage of past slide debris, glacio-lacustrine blocks, some disaggregated till blocks, and advance
27 outwash (primarily silt and fine-grained sand). M2 consists of the midslope bench, M3 comprises the
28 Whitman Bench segment, and M4 is the block of till that dropped from the northeast corner of the slide
29 limits. A plan view of the four movement areas is shown in Figure 6. Figure 7 shows a view of the M4

5 **Figure 6: Map of conceptual movement sequences M1, M2, M3, and M4.**

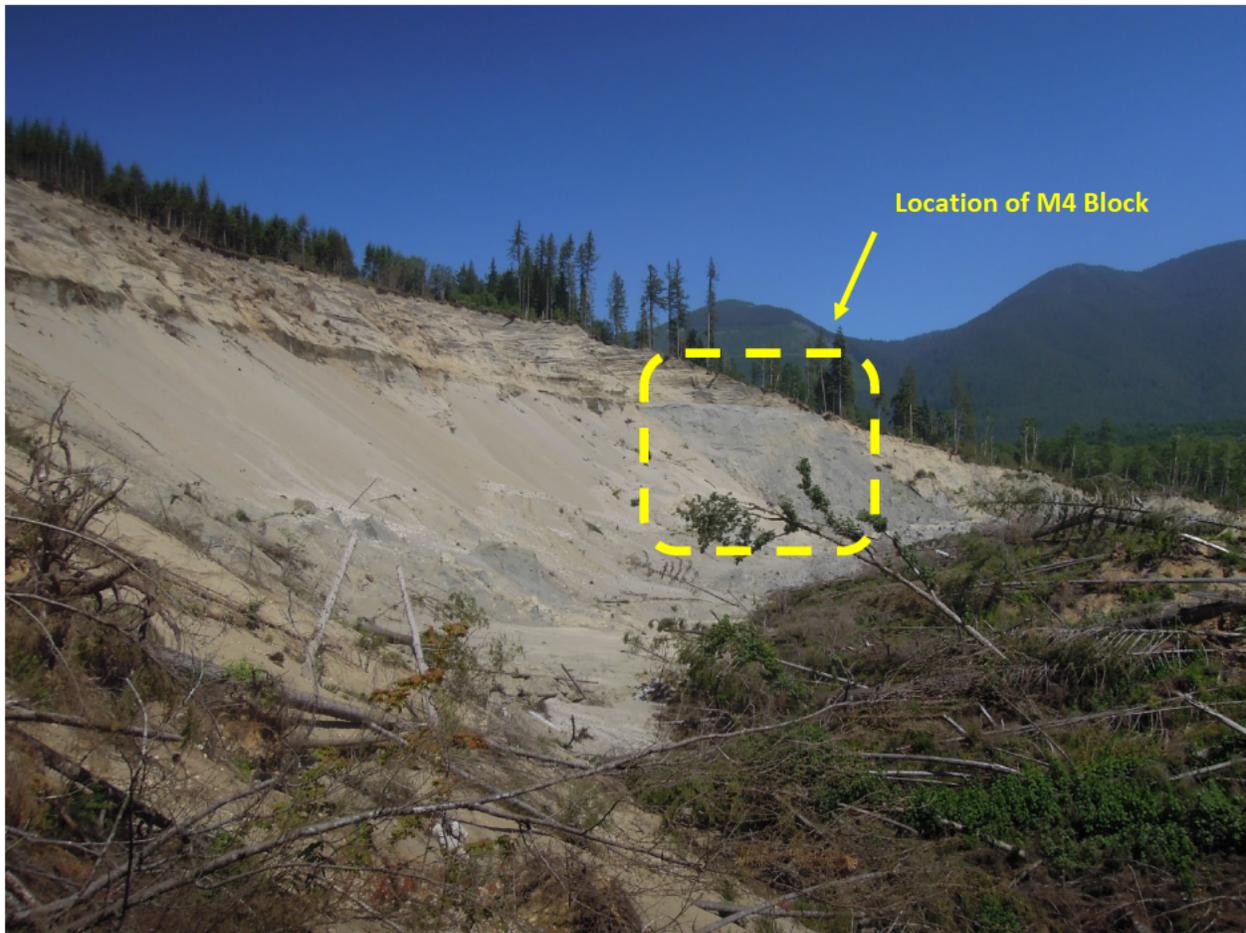
Figure 7: View towards M4 block, as seen from western margin of the head scarp graben.

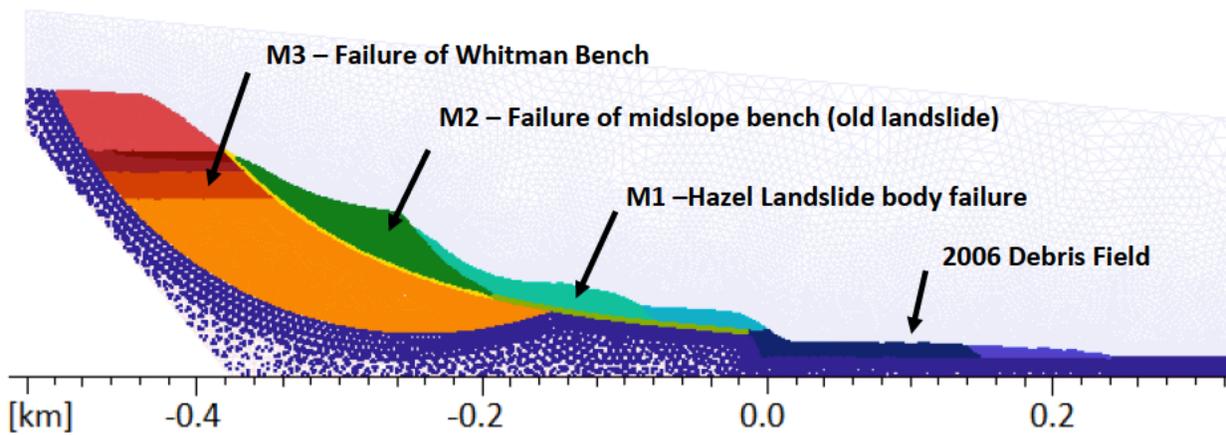
Figure 8: Overview of SR 530 Landslide movements sequences M1, M2, and M3. Note that M4 is not depicted.

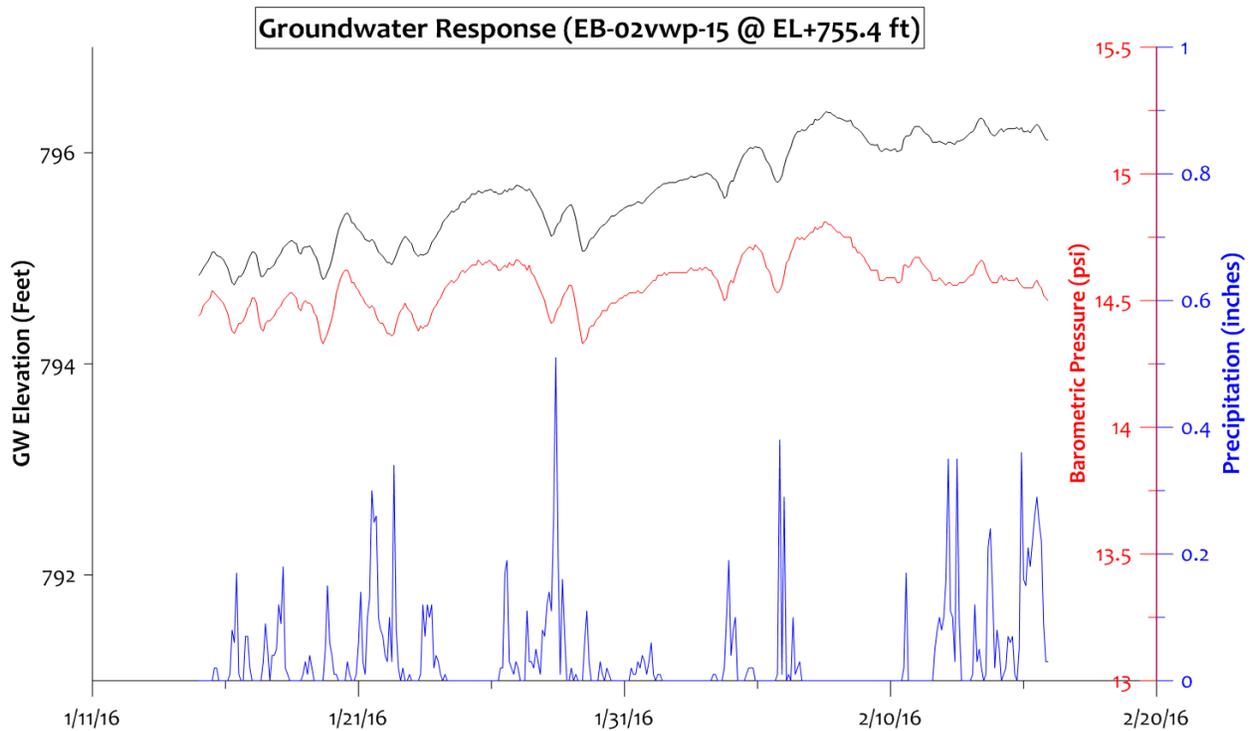
- 1 pressure variations were observed (Figure 9 and Figure 10). The data do not support any immediate
- 2 groundwater response due to infiltration.

6
7 **Figure 10: Immediate groundwater response to barometric pressure compared with no discernible immediate**
8 **response to precipitation events.**

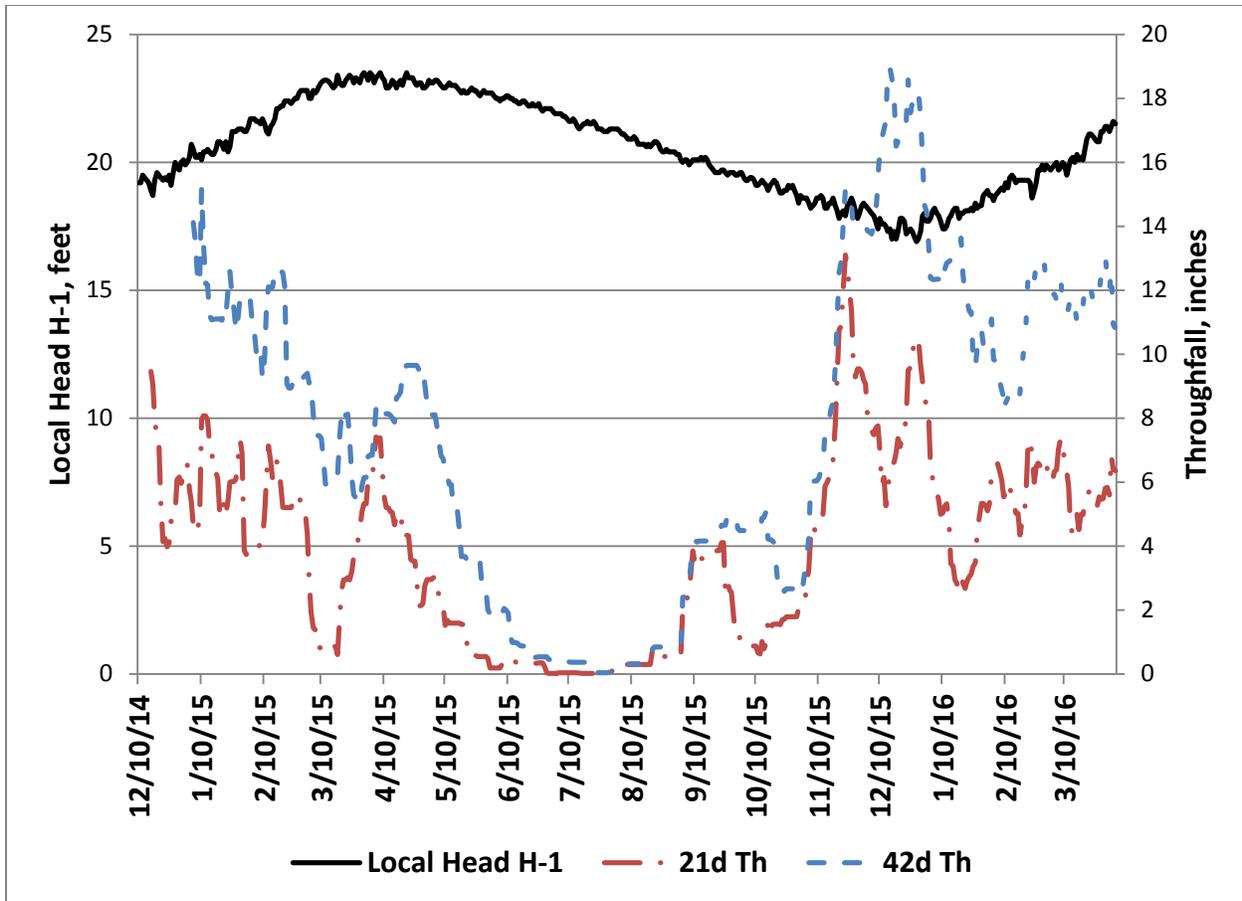
10
11 The perched water table on top of the glacial till does appear to respond to rainfall, however the
12 response is muted, lagged, and has a periodicity. The local elevation of the water table is at a minimum
13 in the late fall. It builds during the winter rainy season and reaches a maximum in the spring. The water
14 table drains throughout the spring and summer to again reach a minimum in the fall (Figure 11). The
15 time lag in the response shown in Figure 11 is apparent given the pattern of maximum 21 day and 42
16 day rainfall amounts which occur between late November and Early January. The groundwater peak is
17 subdued, but appears to occur in the late March through April time frame.

Figure 11: A graph of local head in feet at H-1 with the 21 day and 42 day throughfall on Whitman Bench.

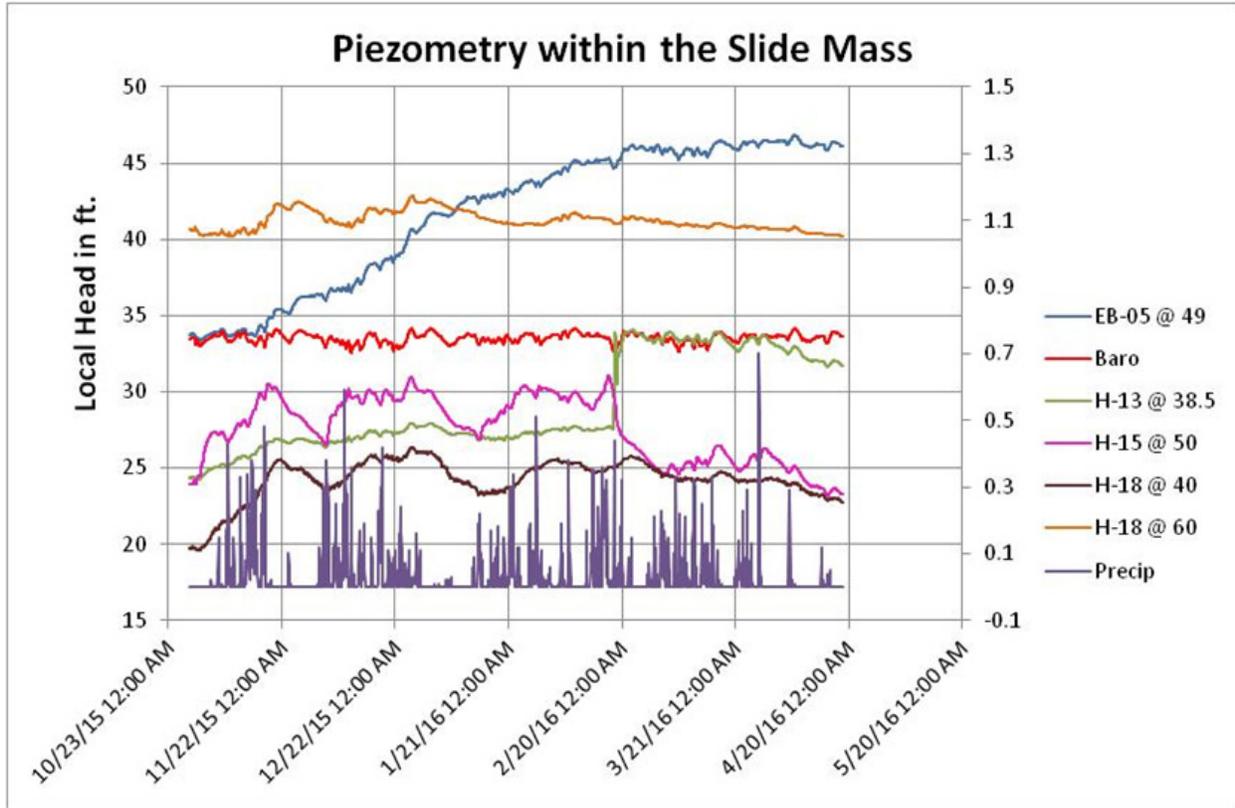
2 Based on our instrumentation (vibrating wire piezometers) over the last winter season (2015-2016), a
3 direct relationship was observed between precipitation and groundwater response in the SR 530
4 Landslide debris. Figure 13 shows precipitation and piezometer records for piezometers installed in the
5 slide debris for the period between October 2015 and April 2016.

8 **Figure 13: Piezometer response within the slide debris to precipitation during the 2015-2016 winter season.**

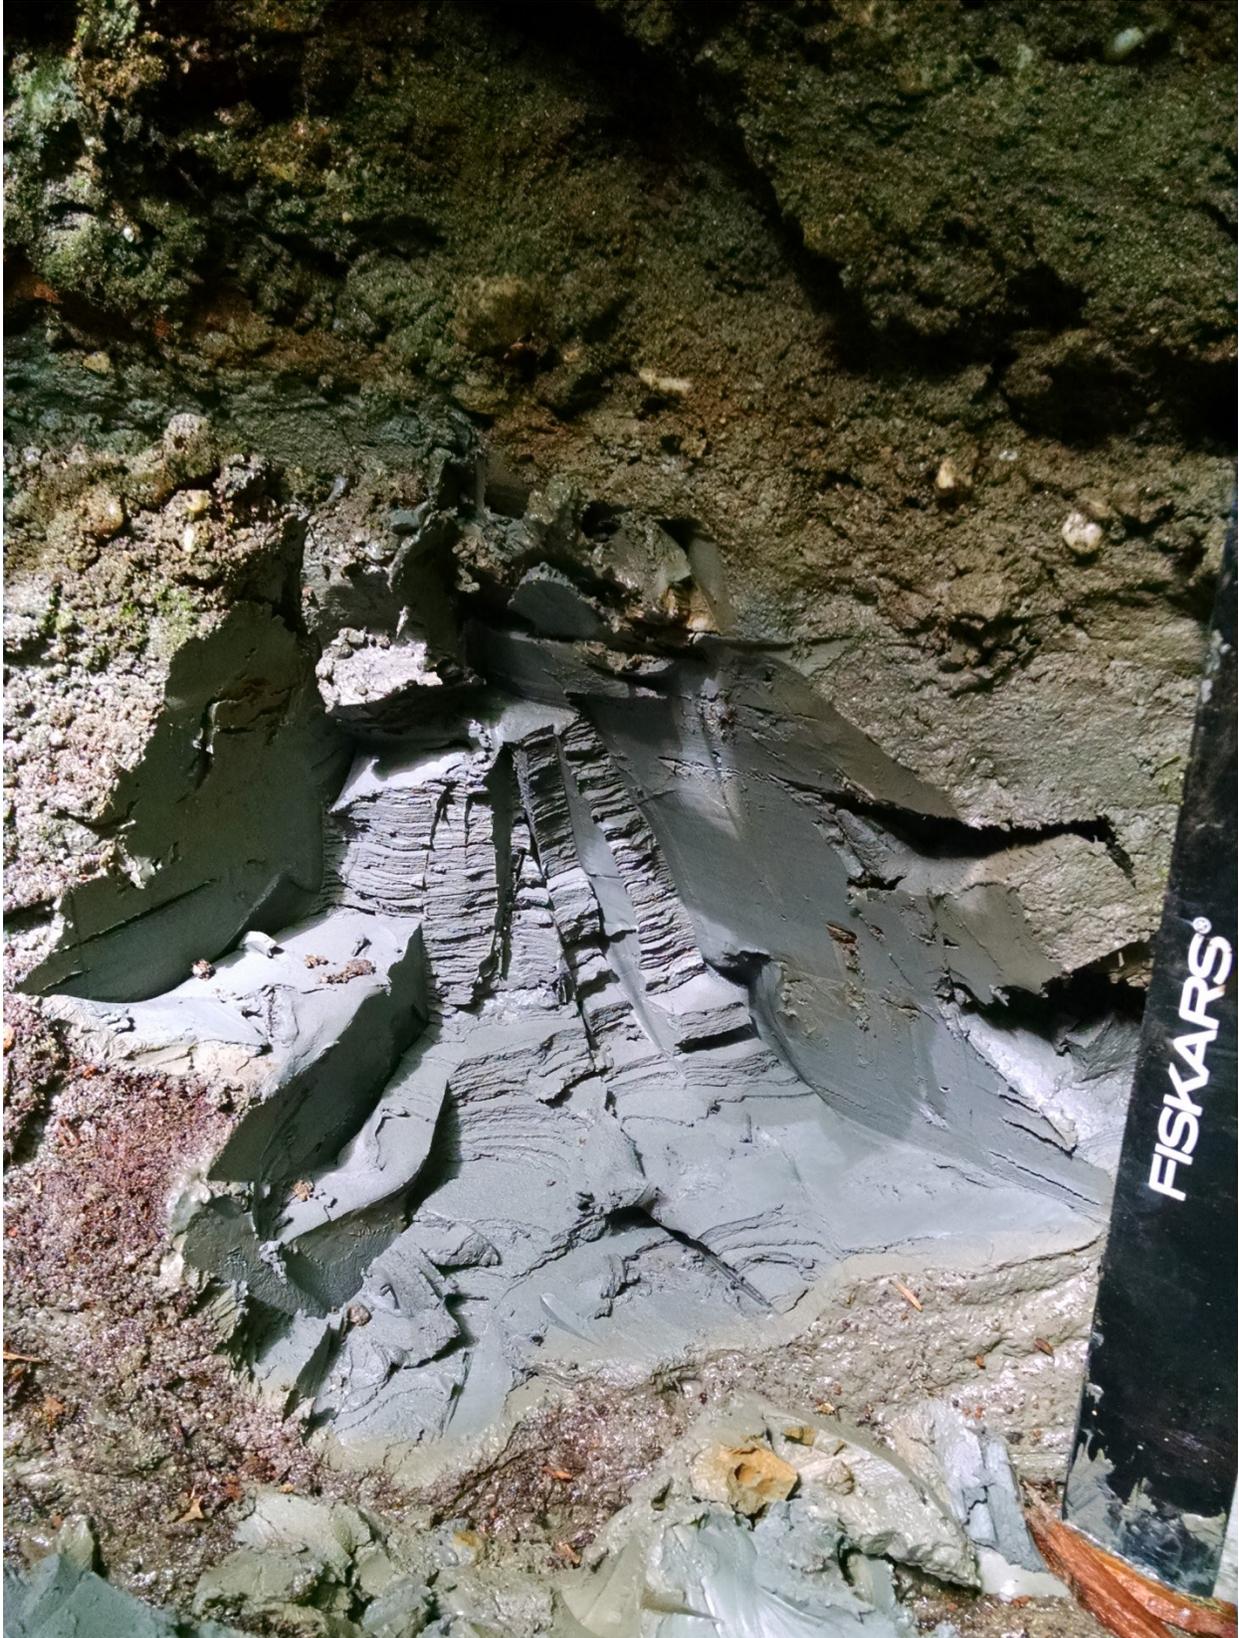
8 As noted earlier, water seeping into the body of the old Hazel Landslide, drains to the Stillaguamish
9 River as surface flow. This is a result of the presence of low permeability glacio-lacustrine and advance
10 silts and fine-grained sandy soils on the Hazel Landslide body.

Figure 14: Exposed very low permeability laminated glacio-lacustrine clay beneath a thin veneer of sand and gravel in Headache Creek, just above the left lateral escarpment of the SR 530 Landslide.

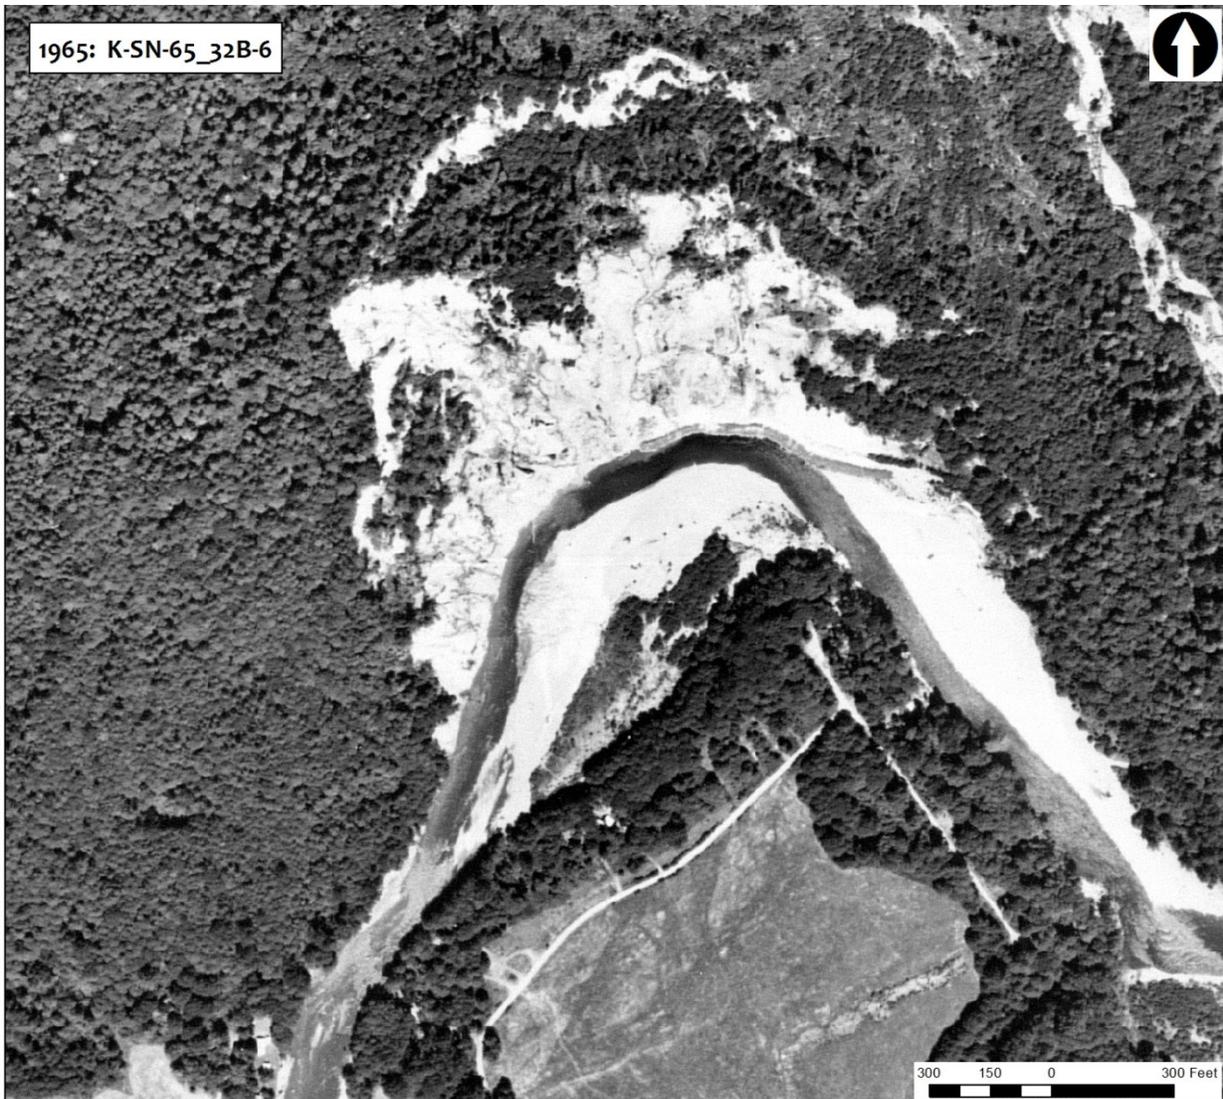
Figure 16: Aerial image from 1965 that shows 'turbid' water at the mouth of Slide Creek. Notice also that the river channel is 'pinched' at this location due to active deposition of sediment.

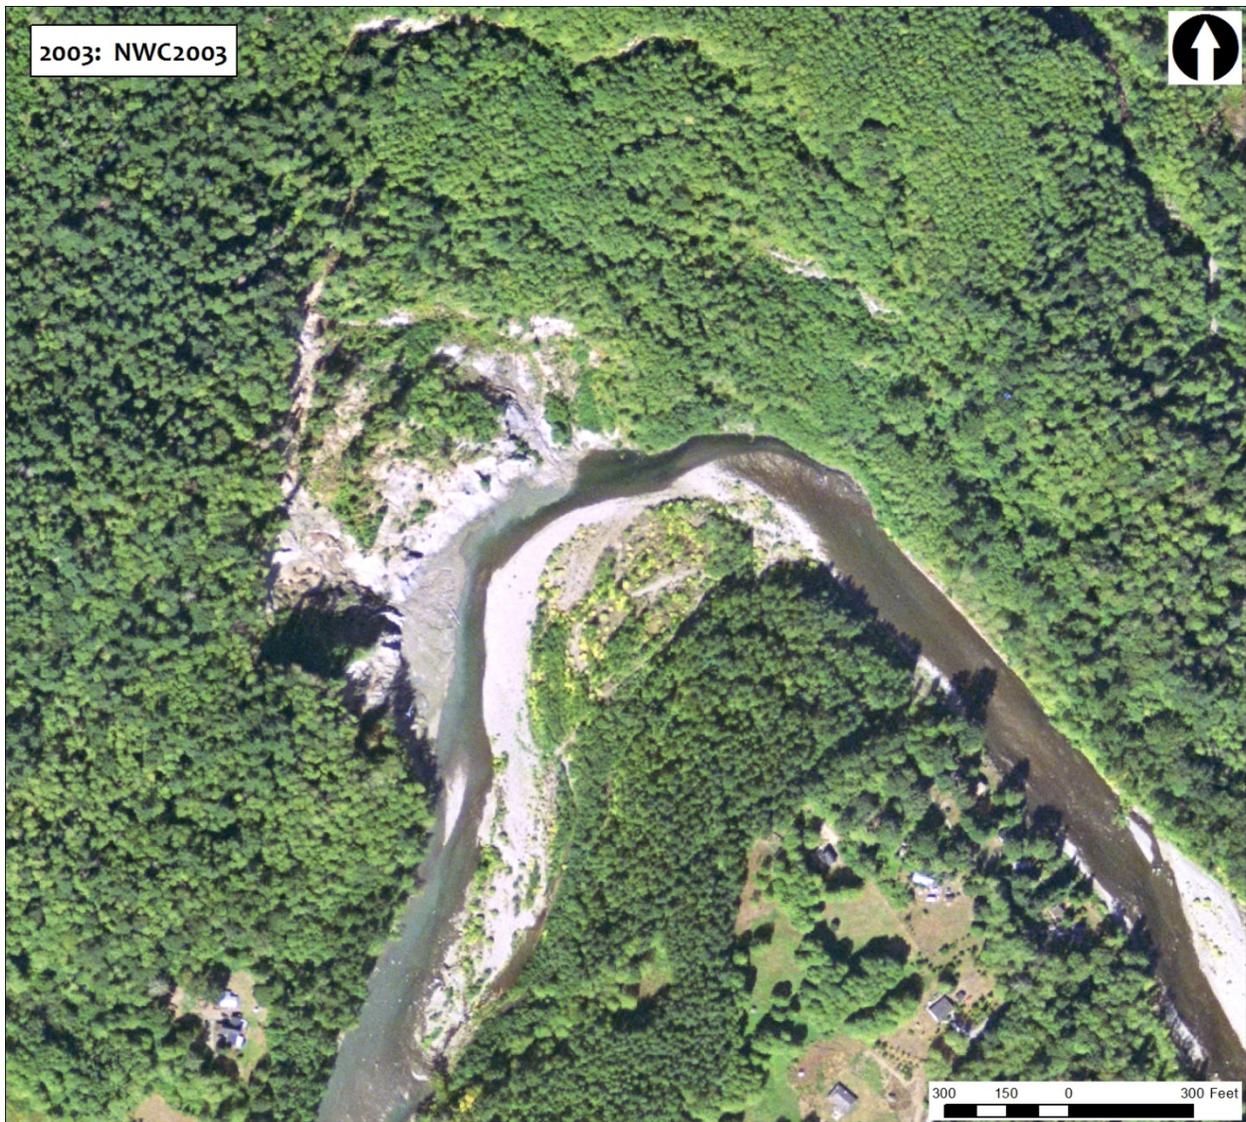
2 **Figure 17: Aerial photo from 2003 showing active deposition from Slide Creek.**

7
8 Previously presented photographs in Figure 17, Figure 18, and Figure 22 show the different
9 characteristics of the debris material below the western side of the Hazel Landslide and its eastern side.
10 This is a result of the differing characteristics of the material in the western and eastern parts of the
11 Hazel Landslide source area discussed previously. The materials in the western side of the 2006 debris
12 field and in the area in the vicinity of the sedimentation pond are largely alluvial deposits derived from
13 erosion of the materials in the western portion of the slide area. The clayey and silty materials in the
14 eastern side of the 2006 debris field are largely mudflow deposits derived from the eastern part of the
15 source area.

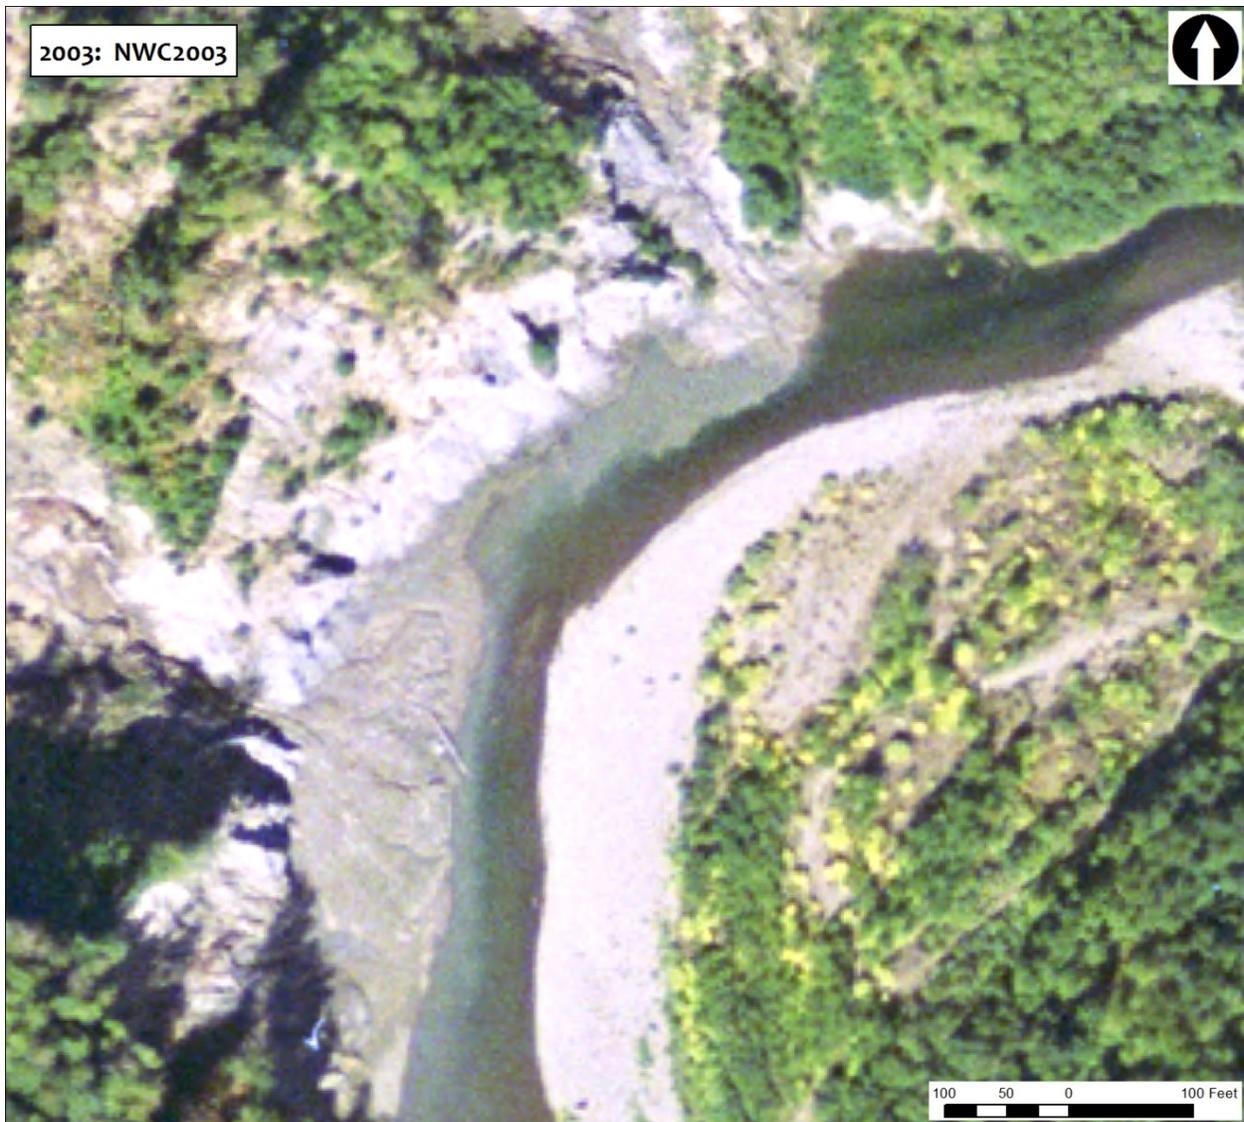
Figure 18: Close-up view of the 2003 aerial image, showing recent deposits from Slide Creek.

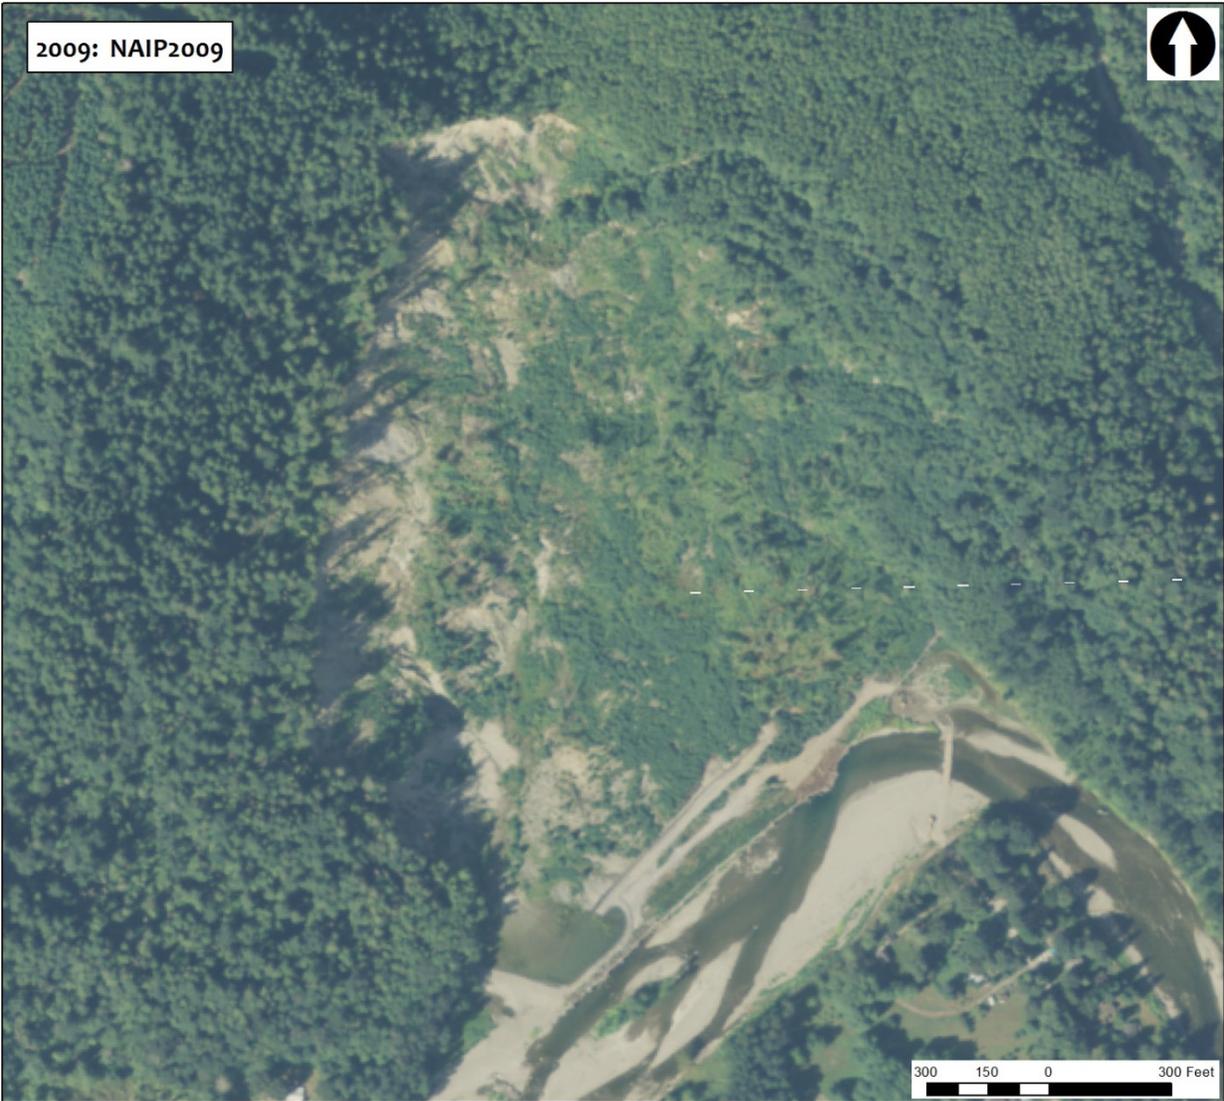
2 **Figure 19: 2009 aerial image showing active sediment deposition from Slide Creek, into the sedimentation pond.**

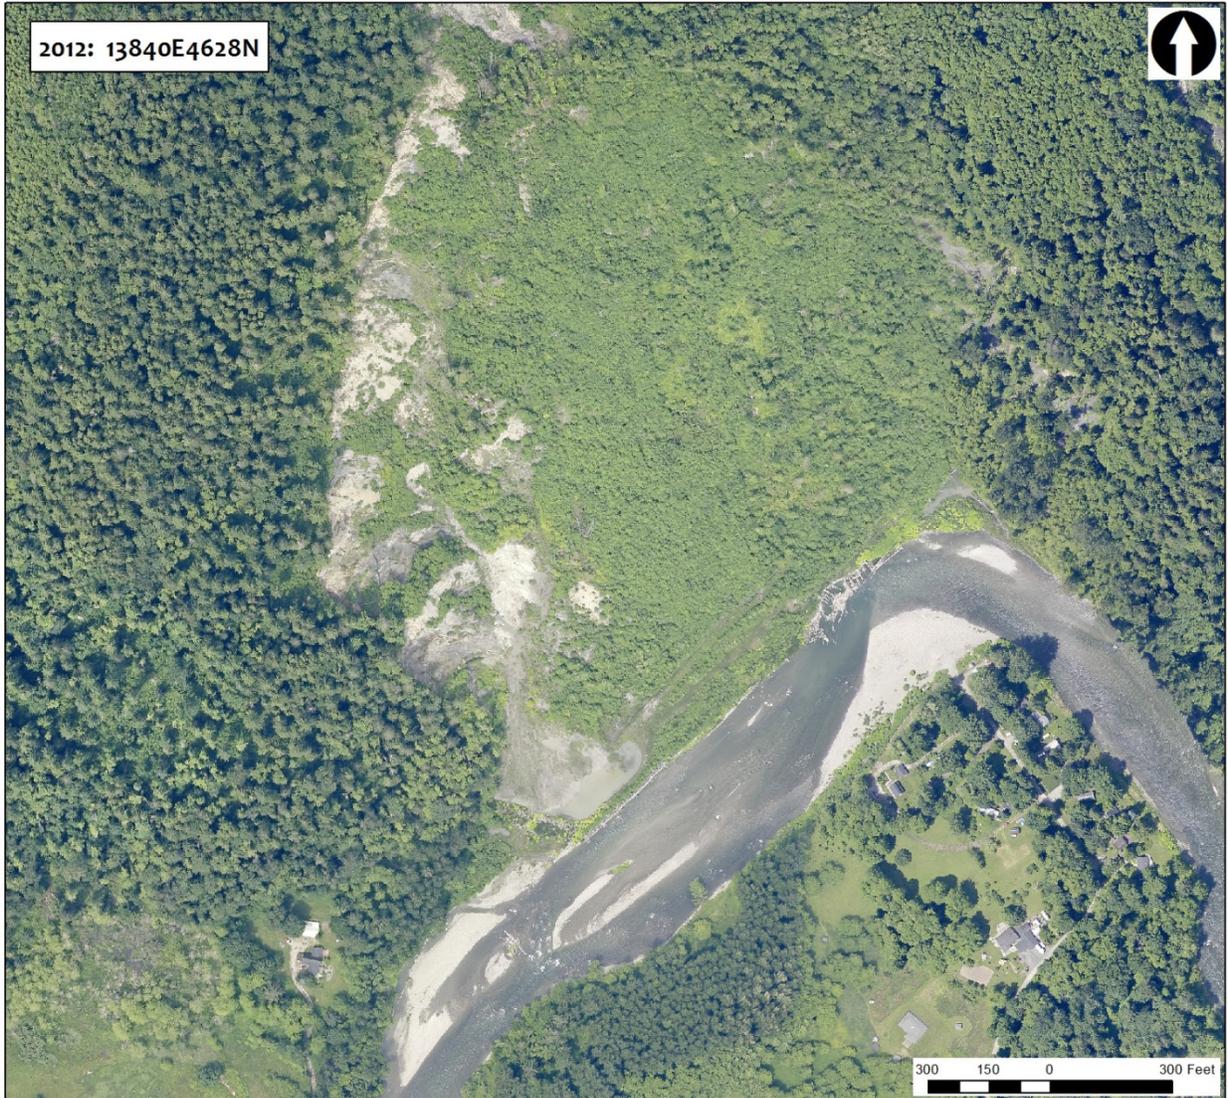
2 ***Figure 21: 2012 aerial image showing continued active deposition in the sedimentation pond.***

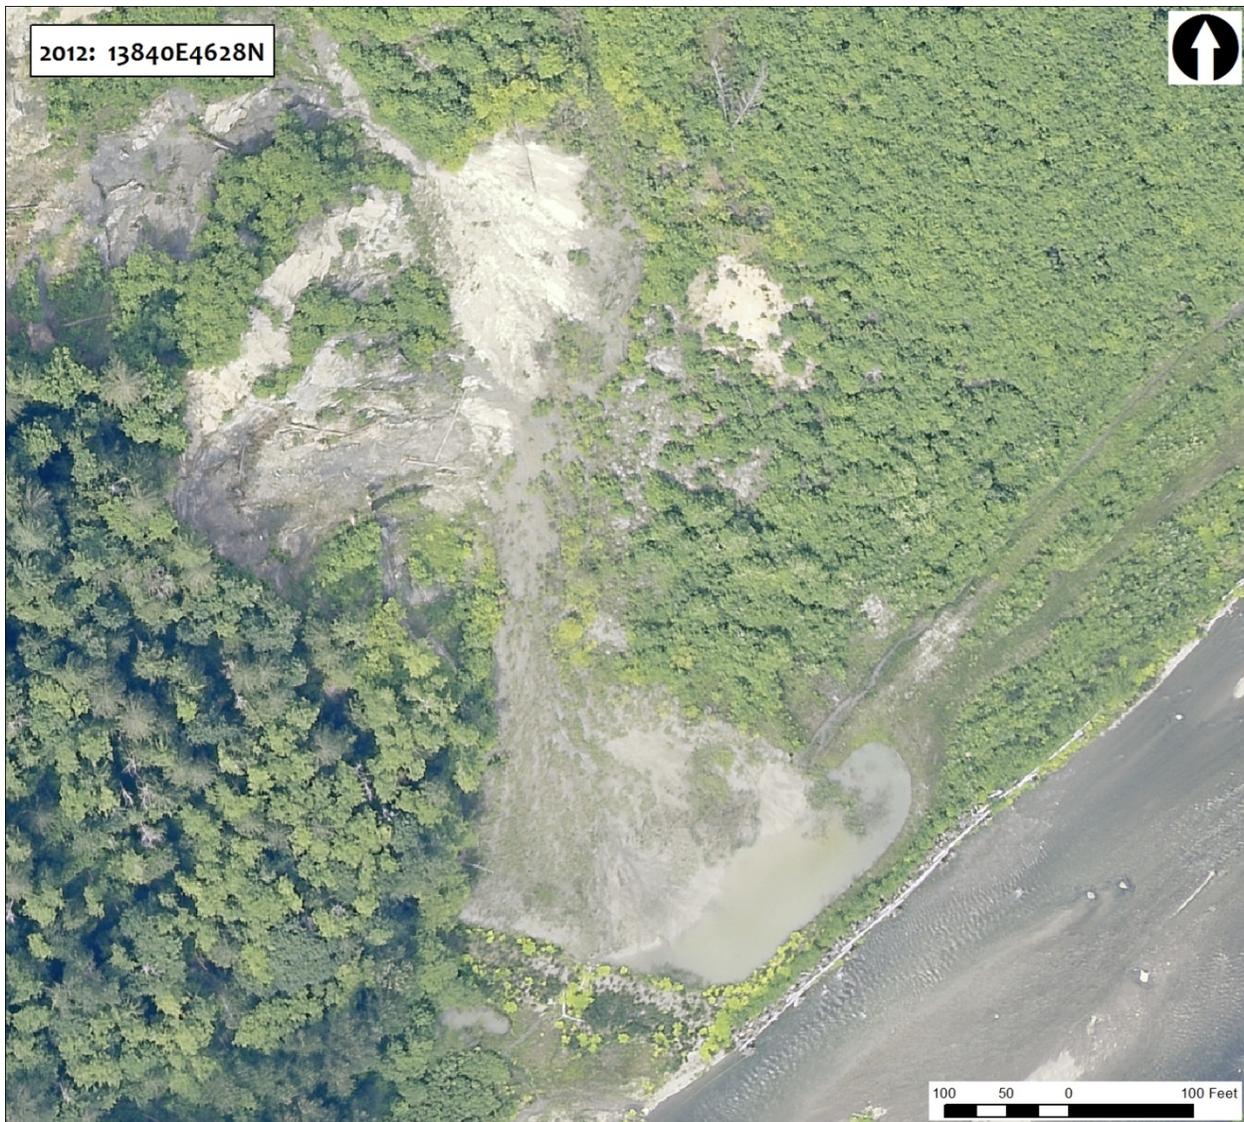
Figure 22: Close-up of the 2012 aerial image showing recent sediment deposition from Slide Creek into the sedimentation pond.

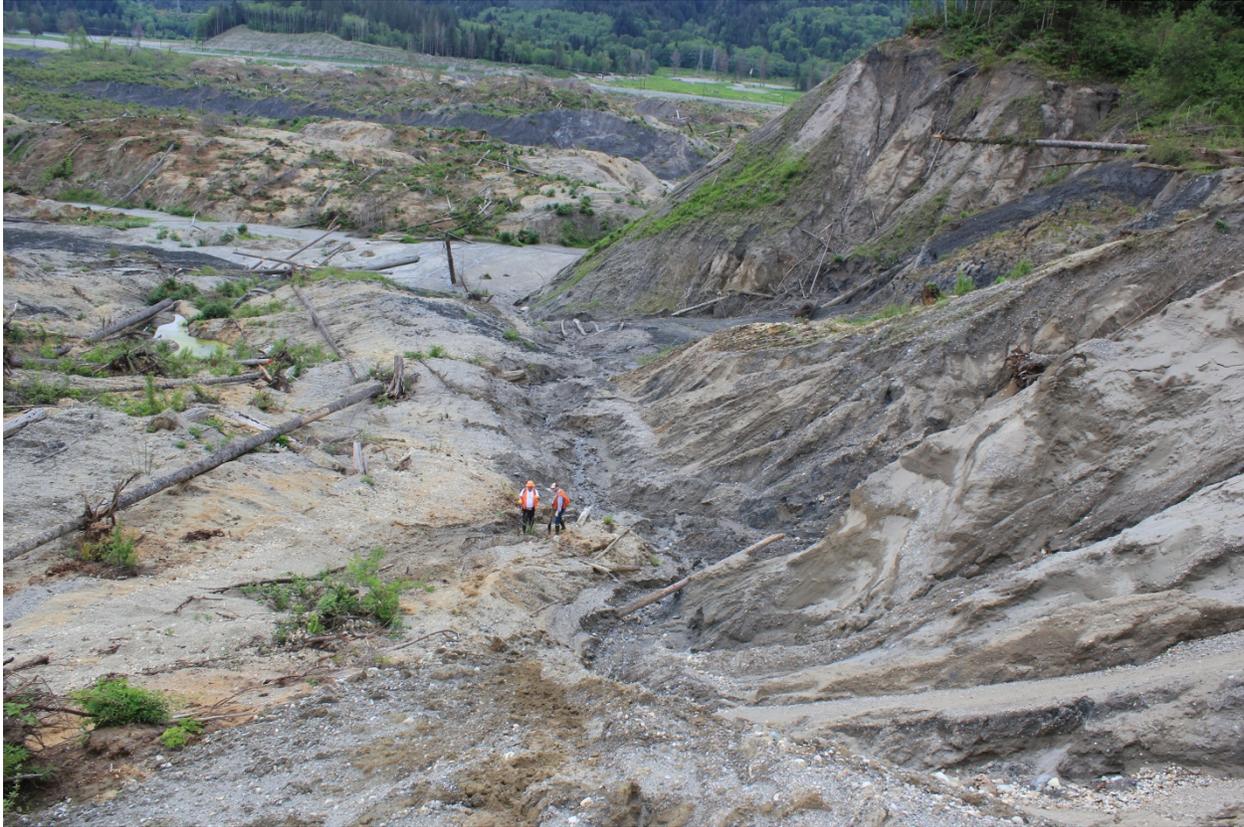
1
2 **Figure 23: Continued deposition of material eroded by Slide Creek, following the 2014 SR 530 Landslide (photo**
3 **taken in April 2016).**

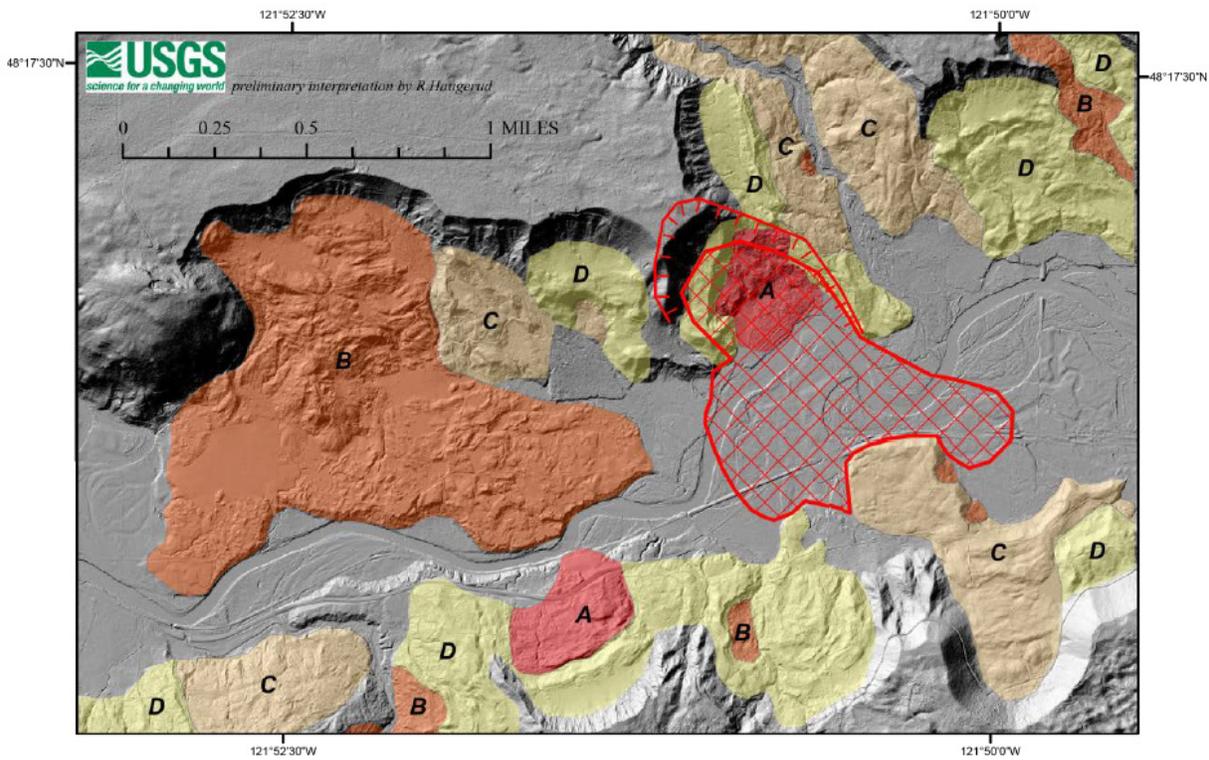
1 a Whitman Bench elevation may cross the valley floor. Recent studies by others ((9), (10), (11)) have
2 identified historic and pre-historic runout events in the North Fork of the Stillaguamish Valley (Figure 24,
3 Figure 25, and Figure 26). Landslides that involve materials similar to the SR 530 Landslide include the
4 Rowan slide, which has been mapped to extend across the valley floor. There is no evidence that a
5 debris field was in place below this long runout landslide at the time it occurred. Certainly, there were
6 no crib walls or sedimentation ponds present at the time of this pre-historic slide.

9 **Figure 24: Landslide deposits as mapped by Haugerud of USGS (9) published after the 2014 SR 530 Landslide.**

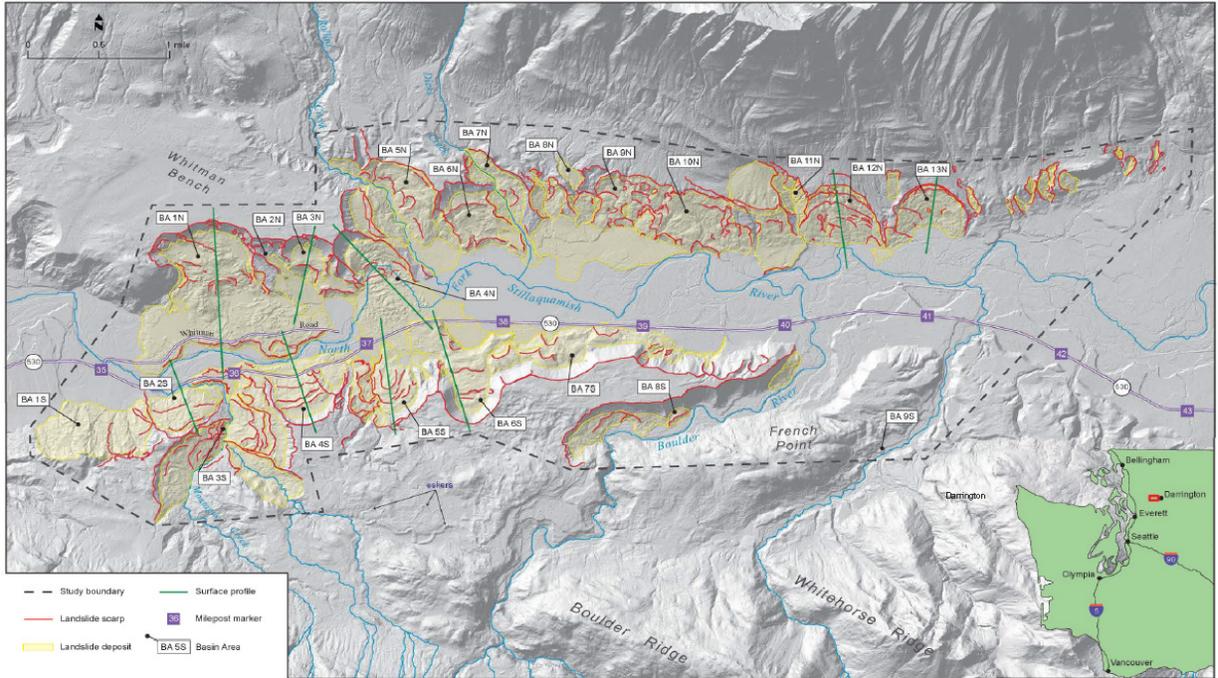
1
2 **Figure 25: Landslides as mapped by Gerstel and Badger (10) published after the 2014 SR 530 Landslide.**
