SUPERIOR COURT OF WASHINGTON FOR KING COUNTY

EXPERT OPINION REPORT OF

DR. MARVIN R. PYLES, Ph.D., P.E.

JUNE 30, 2016

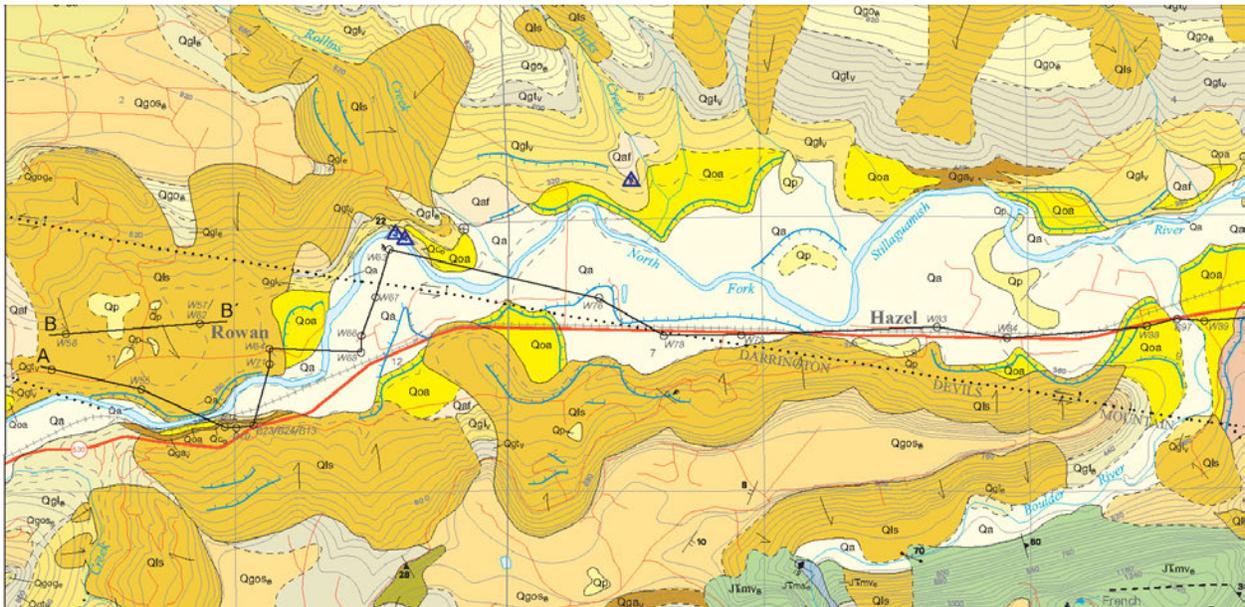
3
4 **Figure 26: Quaternary age landslides (Qls) as mapped by Dragovich et al (11), released in 2003.**

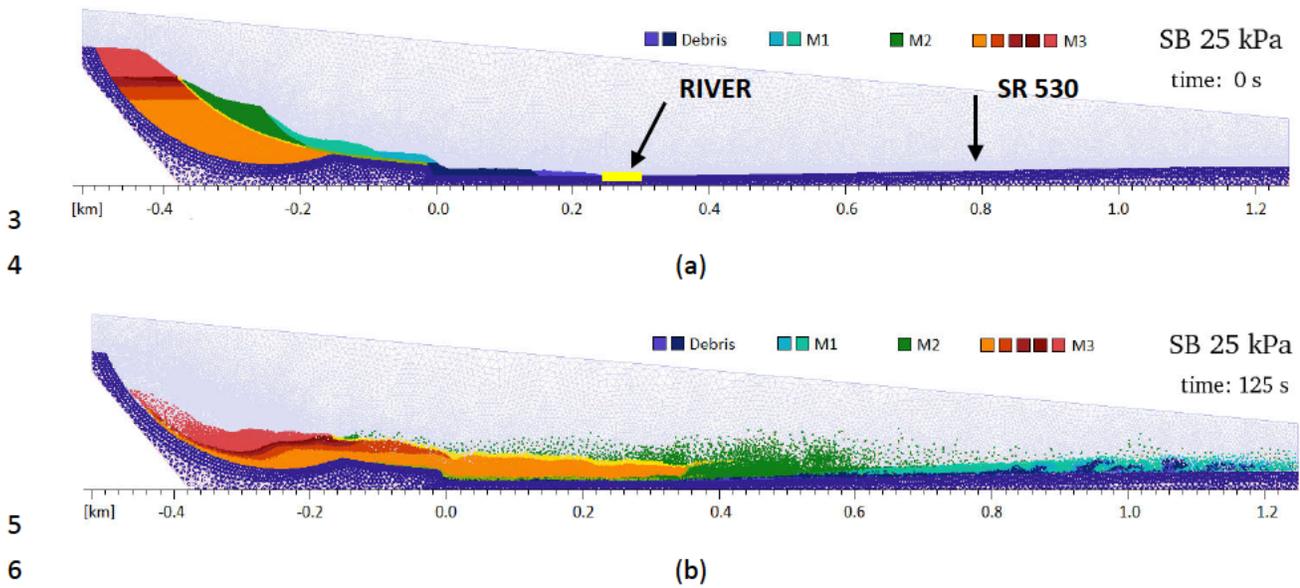
17 debris field below the toe of the landslide was similar to the simulated runout behavior of the actual SR
 18 530 Landslide case (compare Figure 30 with Figure 29). In both analyses, the SR-530 Landslide debris
 19 runout distances were essentially the same. In both cases, the debris ran out across the valley floor.
 20 Therefore, the calibrated SR-530 Landslide MPM runout analyses fully support the opinion that the

7 **Figure 29: (a) Initial landslide geometry, and (b) final landslide geometry for the SR 530 Landslide runout for the**
8 **calibrated MPM baseline model case (see Appendix K).**

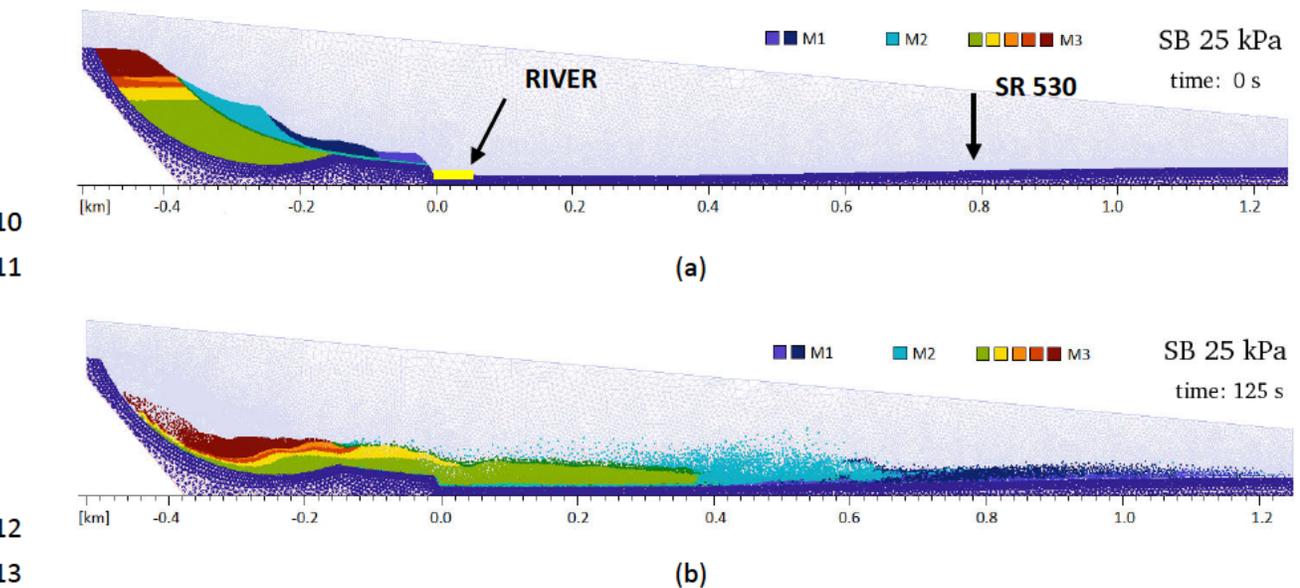
14 **Figure 30: (a) Initial landslide geometry, and (b) final landslide geometry for a hypothetical case wherein the**
15 **2006 debris field does not exist at the time of the SR 530 Landslide (see Appendix K).**

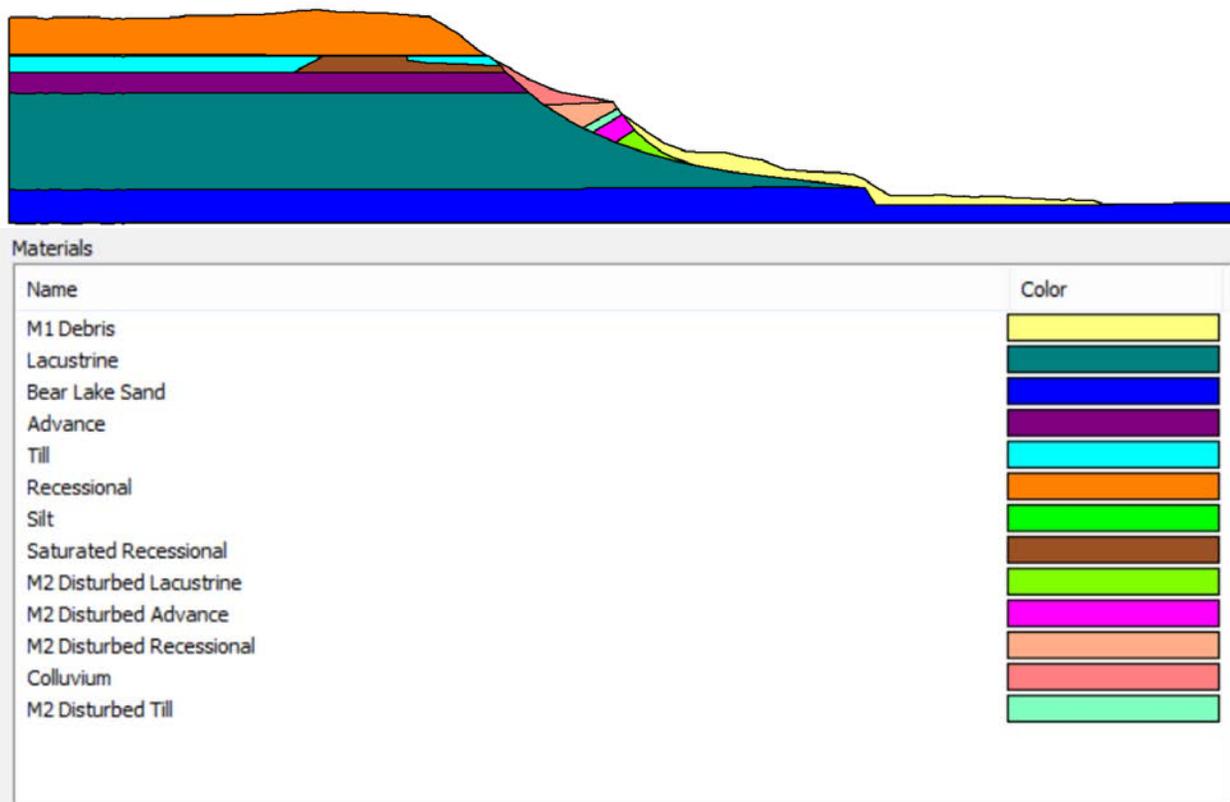
The generalized stratigraphy of the Whitman Bench and the Hazel slide before the March 22, 2014 SR-530 landslide is shown in Figure E-1. The generalized stratigraphy is based on the geologic studies and fieldwork performed as part of this study. After describing the geometry of the soil stratigraphy in this section, the results of the field and laboratory testing program are used to develop preliminary estimates of the engineering properties of key soil units, which are shown in Table E-1. These estimates of engineering soil properties are revised slightly based on the slope stability calibration analyses discussed in Appendix J.

Figure E-1: Generalized stratigraphy of Whitman Bench and the Hazel slide before the 2014 SR-530 landslide.

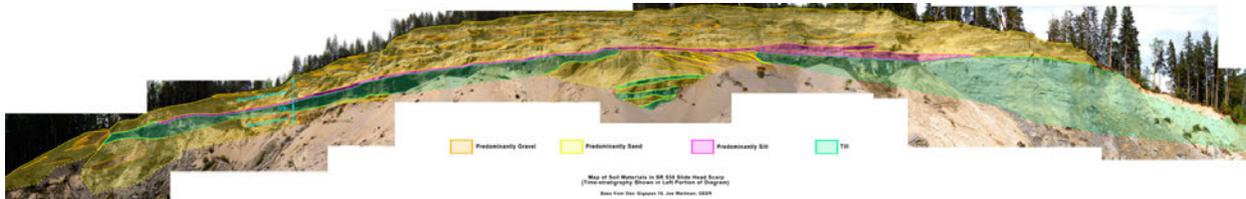
Figure 1: Mapping of geologic units exposed in the main scarp of the SR 530 Landslide.

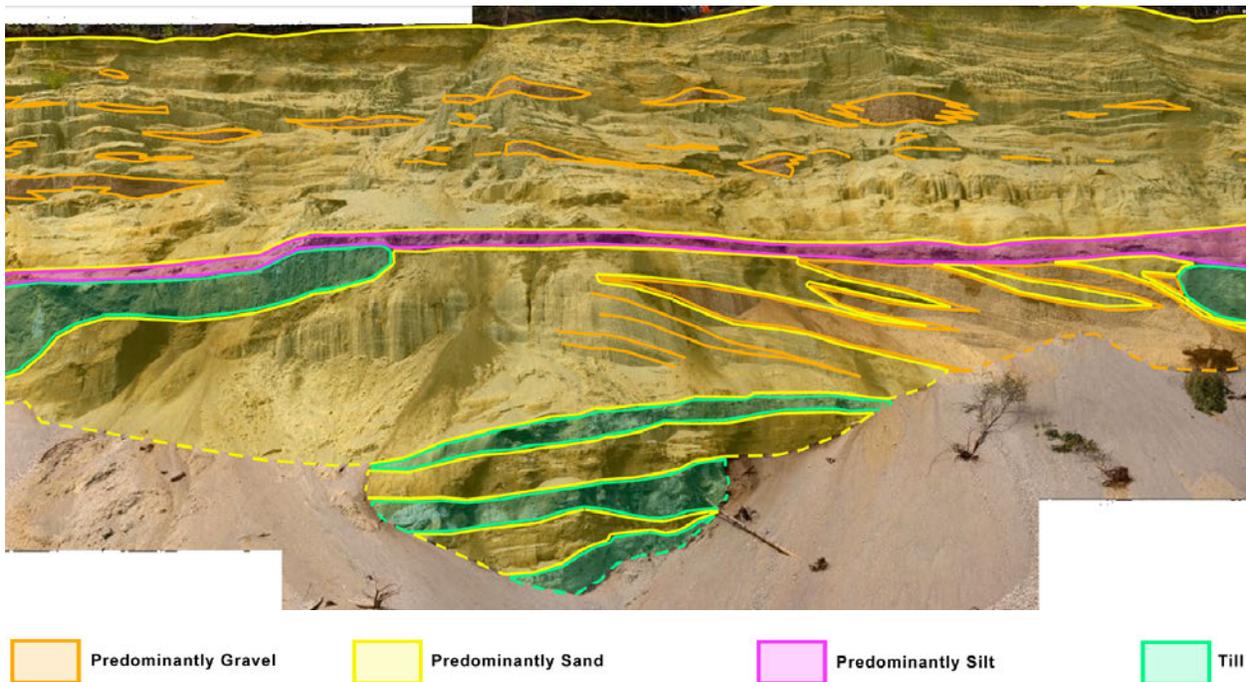
Figure 2: Close-up view of the central portion of the SR 530 Landslide main scarp, showing the stratigraphic complexity.

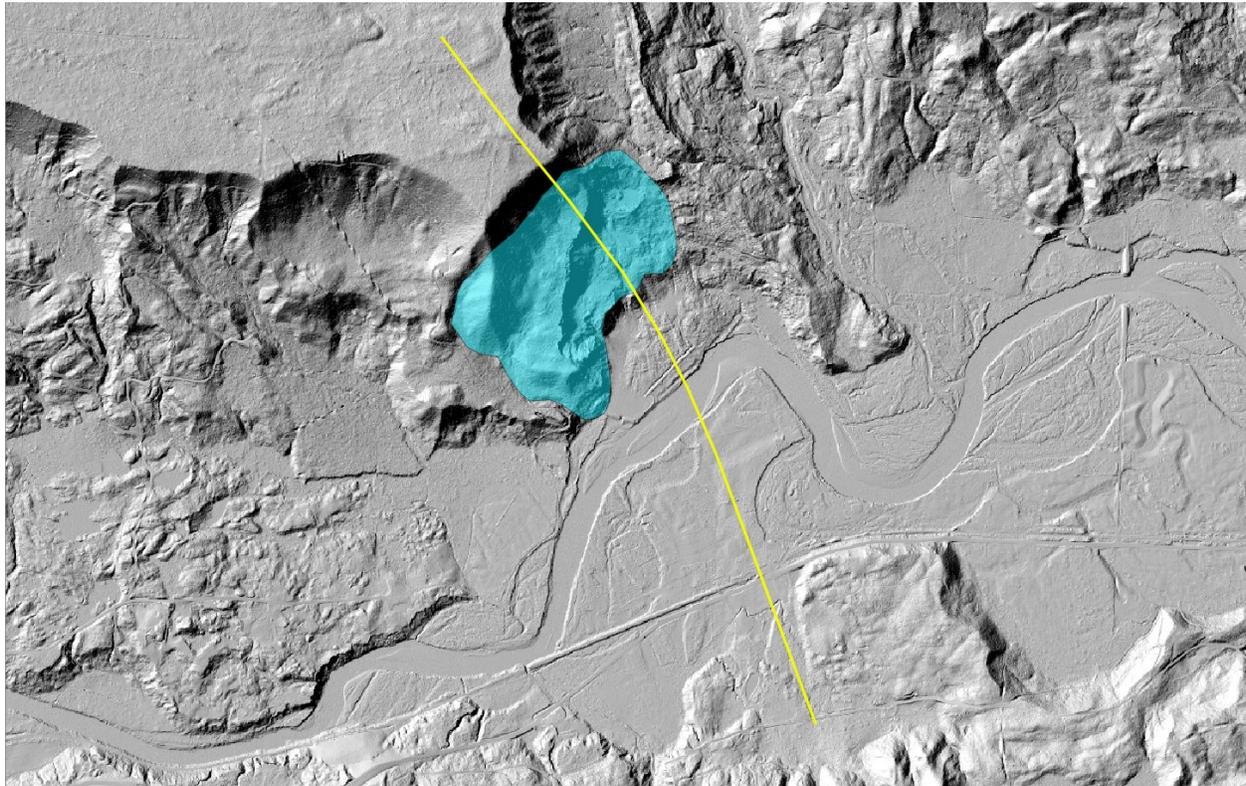
Approximate Extent of Ancient P-2 Failure Surface

This discrepancy can be explained by invoking a pre-historic two-stage failure involving the same slide material. The first failure, involving the upper half of the bench deposit would have occurred toward the southeast, roughly in the fall line direction of the former SE slope of the Whitman Bench. This failure would have been in response to melting of the ice buttressing the slope on that side. The failure surface on which this movement occurred is labeled P-2 on Sections 6 through 12. It is also likely that the slide debris at least partially rode up onto the adjacent, melting glacier. The back-rotation of the top of the block(s) resulting from the movement on the P-2 surface would have been to the northwest.

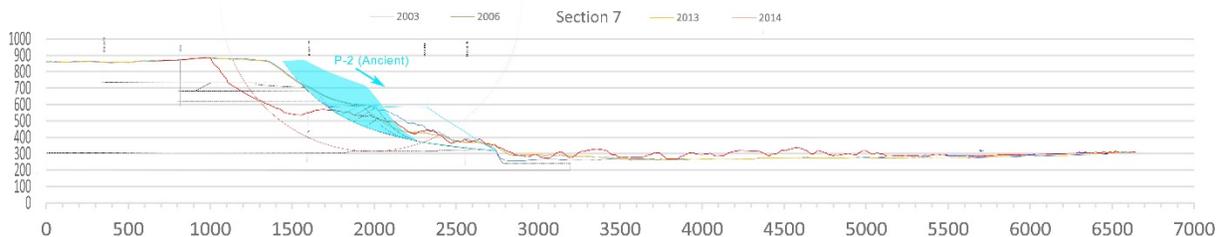
Mid-slope Bench Block Restored to its Inferred Pre-Kame-Terrace-Collapse Position

A kame terrace collapse of portions of the upper edge of Whitman Bench also provides a plausible explanation for the origin of the former mid-slope bench, large portions of which were involved in the SR-530 Landslide in 2014. The deposits underlying this bench had been previously identified as ancient landslide blocks (Thorsen, 1988). Photos taken by Bob Tart and others of the post-2006 slide scarp indicate that these slide blocks were significantly back-rotated, along failure surfaces with steep apparent southwest dips separating individual blocks. However, the contacts of the soil units within the blocks are dipping in a northerly direction, rather than to the northeast, as would be expected from back-rotation only along the steeply southwest-dipping failures.

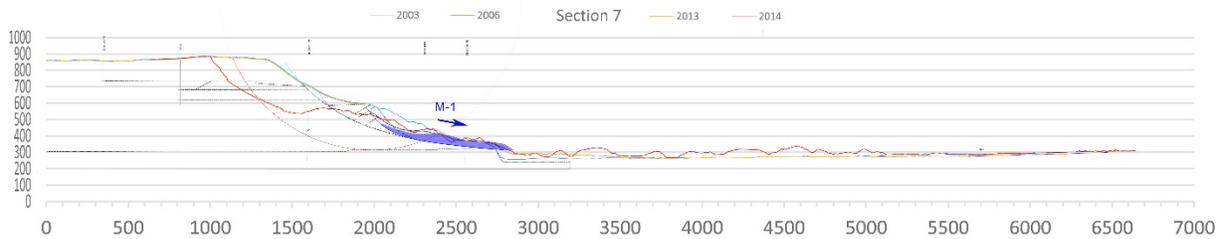
M-1 Movement on Lower Ancient P-2 Surface.

The second scenario only involves erosion of material from the toe of the SE facing Hazel scarp by Slide Creek. Significant deposition of alluvial material can be documented in the LiDAR between 2006 and 2013, both in the sedimentation pond and along the lower part of the course of Slide Creek, just upslope from there. This near-constant erosion may, in itself, have ultimately resulted in removal of sufficient lateral support at the toe of the mid-slope bench to initiate failure of a large portion of the remaining mid-slope bench blocks, along surface P-2.

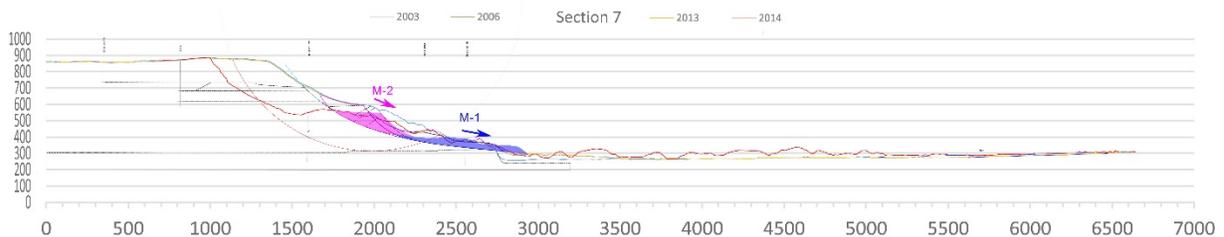
Approximate Extent of M-2 Movement, Involving the Central Portion of the Former Mid-slope Bench

Initiation of M-2 Movement After Unloading of the Toe by M-1

The initiation of rapid failure of the SR-530 Slide by acceleration of the former central portions of the mid-slope bench block is also consistent with the fact that an area of significant extent exists within the middle to lower portions of the later, larger M-3 slide mass, now forming the new mid-slope bench block and debris field north of the river, that has little or no forest floor cover or trees. The bare spot would have been produced by sliding on the M-2 surface in areas where this surface was sufficient steep to preclude deposition of the tail end of the sliding M-2 mass. Once the M-2 mass had slid sufficiently far to have reached the lower-sloping portions of the M-2 surface (identical, or nearly so to the P-2 surface), the sliding mass left a comet-trail-like veneer of Recessional Outwash over the lower part of the M-2 scarp, which was underlain by Till, Advance Outwash, and Fine-grained Glaciolacustrine material.

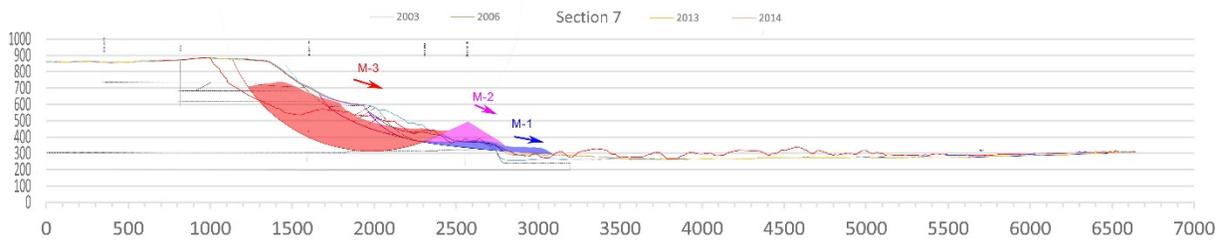
Movement of the M-2 mass instantaneously unloaded the toe of the Whitman Bench slope, resulting in rotational failure of the much larger M-3 mass. Given its comparatively large mass and elevation above the valley floor, this mass possessed significant potential energy, which, once moving, was converted to kinetic energy. Portions of this kinetic energy were imparted to the M-2 mass still moving on the slope below when it was struck from behind by the leading edge of the M-3 block. This ultimately resulted in propelling the combined M-2 mass and leading edge of the M-3 mass into the Steelhead Haven neighborhood, and flung the leading edge of the M-2 mass far beyond SR-530. It is also possible that the impact of the leading edge of M-3 on the backside of the moving M-2 block resulted in the acceleration of the M-2 mass when the leading portions of the M-2 block were already in view of John Reed, moving on the relatively flat portions of the valley floor in the vicinity of the river. This would be consistent with his report that the slide accelerated “when it hit the river.”

Approximate Extent of M-3 Movement

M-3 Movement Shortly After Initiation Along Section 7 (Yellow Line on Map).

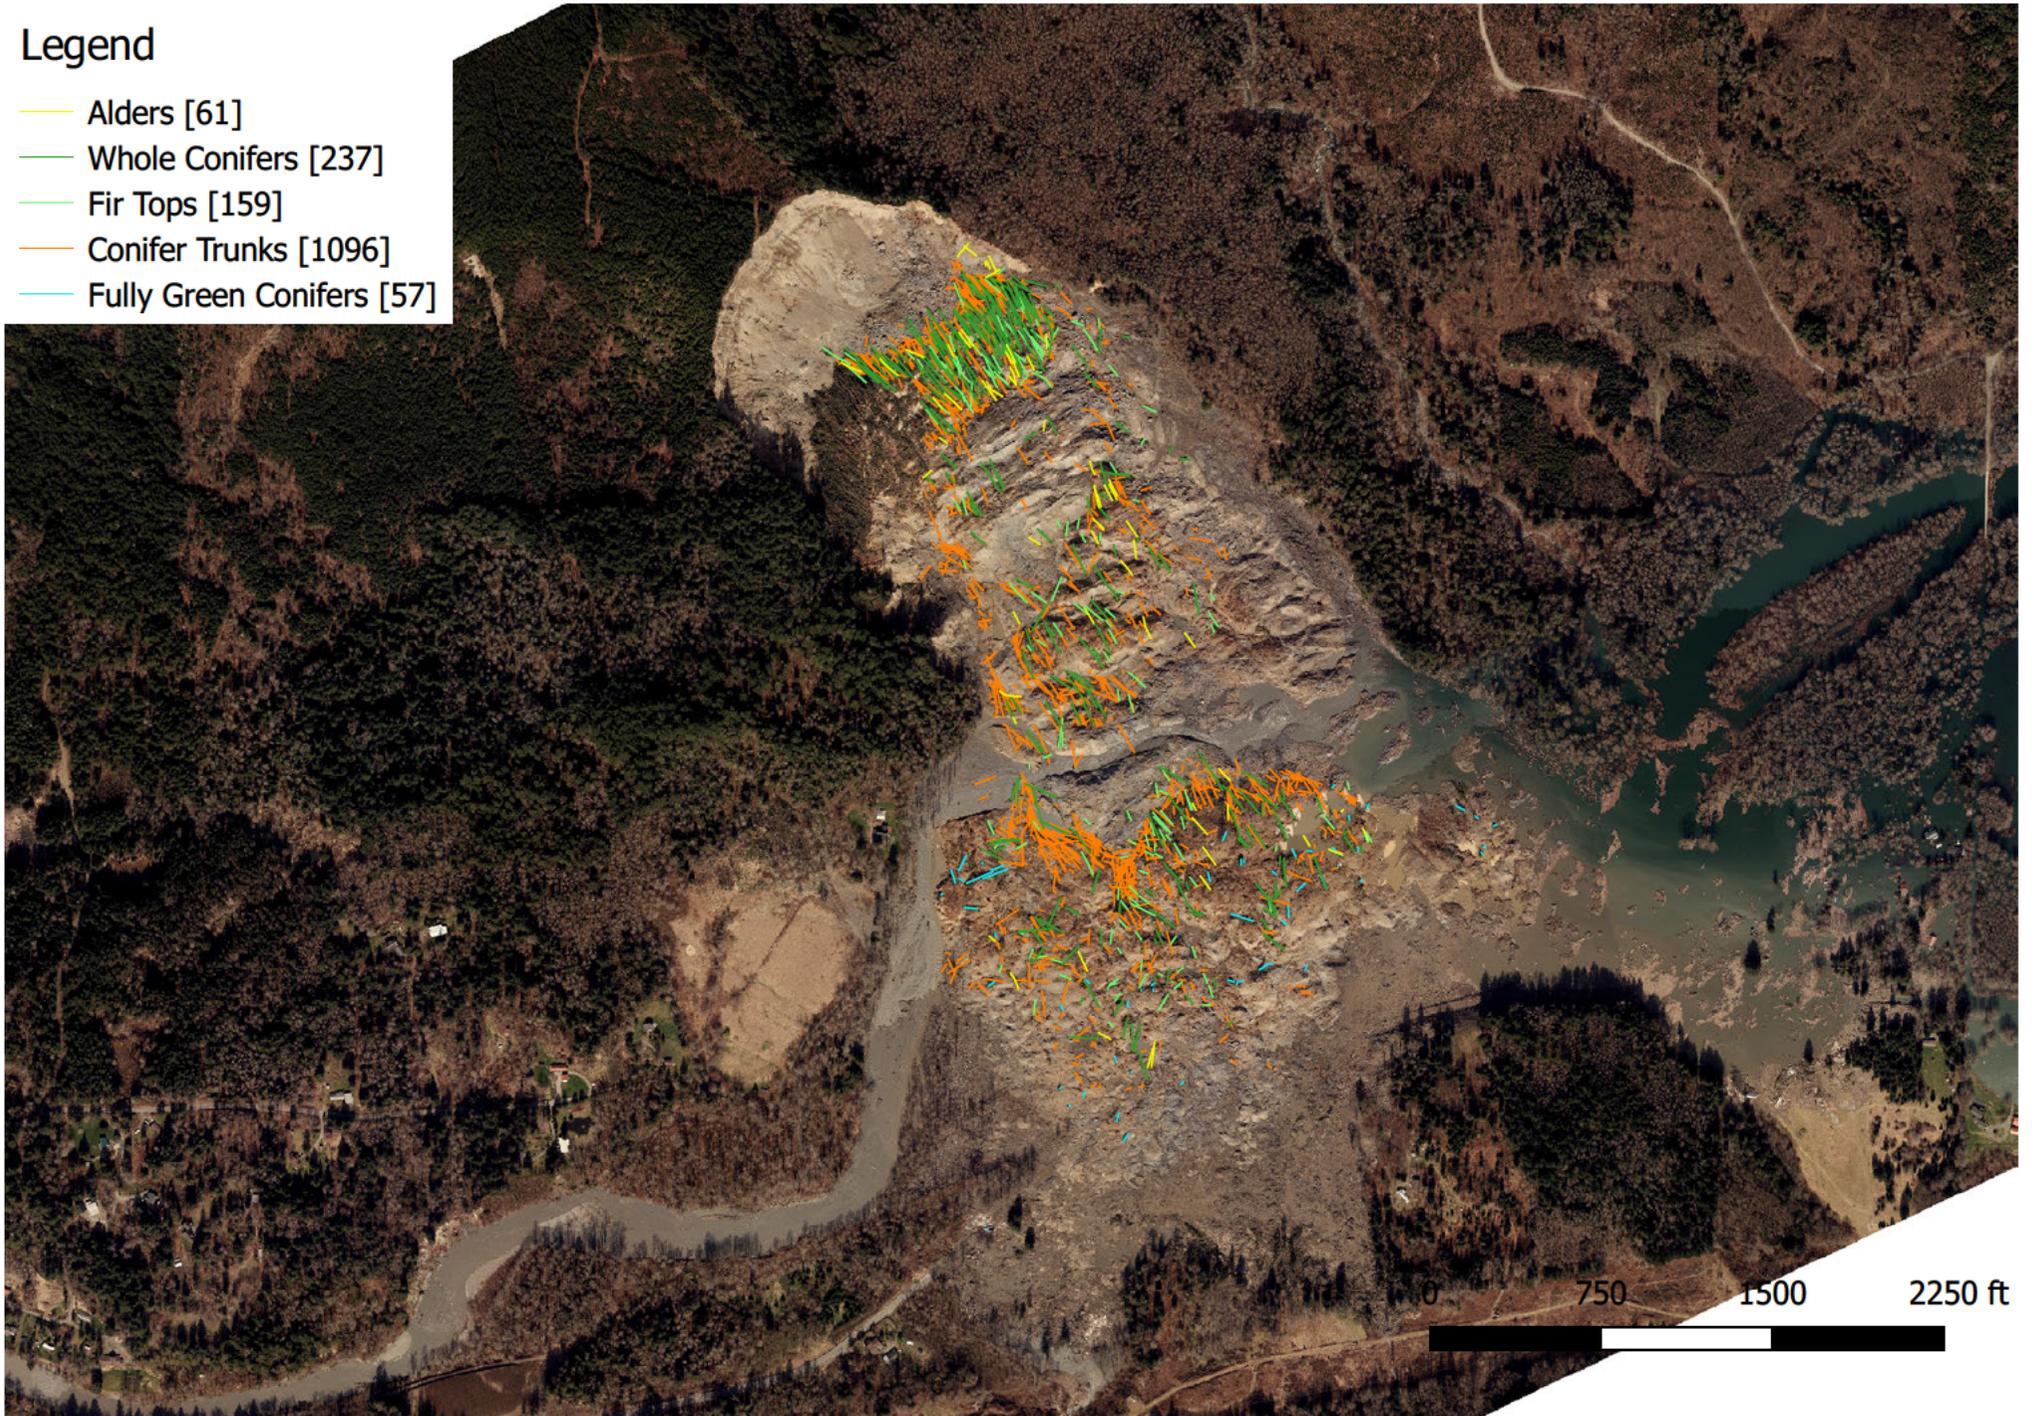
1. All 57 identified fully limbed green conifers found in the slope movement deposit are located in a wide band along the outer edge of the extremely extended forest floor on the material now located south of the river. Whereas according to Tart photo IMG_0315 there are a few such trees (possibly 15 to 20) in two groups on failure blocks at the base of the former mid-slope bench, the overall number of such trees in the deposit requires that the trees along the outer upper edge of the former mid-slope have been moved to the area south of the river, with the shortest transport distance around 1,230 feet and the longest approximately 3,360 feet to the south side of the highway in the western portion of the run-out.

2. The number of mature conifers or significant conifer segments identified on the SR 530 Landslide deposits south of the post-failure river alignment is 693. This consists of 75 whole mature conifers, 497 large trunk/root-ball combinations, 64 fir tops without root-balls and 57 fully limbed green trees. Because significant numbers of mature conifers were not located within the confines of the Hazel Landslide movement of 2006, the large number of mature fir trees deposited requires that the deposits on the Steelhead Haven community consist to a large degree of the top of the former mid-slope bench and a portion of the side slope of Whitman Bench above the former mid-slope bench.

3. Large numbers of broken conifer trunks are concentrated in concentric bands around the grey deposit located partially on the treed slope movement blocks immediately south of the river. This infers that the grey material likely “rode up” on the treed blocks a significant distance (up to 350 feet or more), sweeping trees up and ahead of it. In turn, this implies some velocity differential between the two soil masses, with the grey material moving significantly faster than the treed blocks.

4. The number of large alder trunk segments found in the area south of the river (15) corresponds relatively well with the number of mature alder trees mapped on the former mid-slope bench on pre-SR 530 Landslide aerial photos (13). This is another indication that the entire portion of the former mid-slope bench which was involved in the SR 530 Landslide came to rest on the

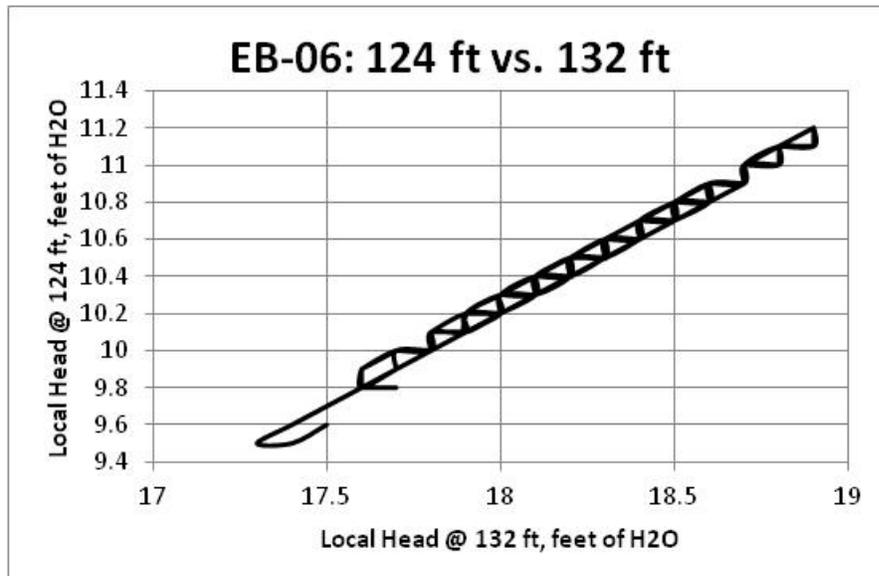
Figure I-1. Piezometer readings from boring EB-06 at 124 ft versus 132 ft from 21 December 2015 through 22 February 2016. The departures from a perfect linear relationship are the result of the reading resolution employed in the data logger connected to the piezometers. Note that a change in local head of 1.0 ft at 132 ft corresponds to exactly the same 1.0 ft change at 124 ft. Further, the difference in head between the two piezometers is very close to the 8 foot difference in the elevation of the piezometer tips, indicating identical, and in this case hydrostatic readings.

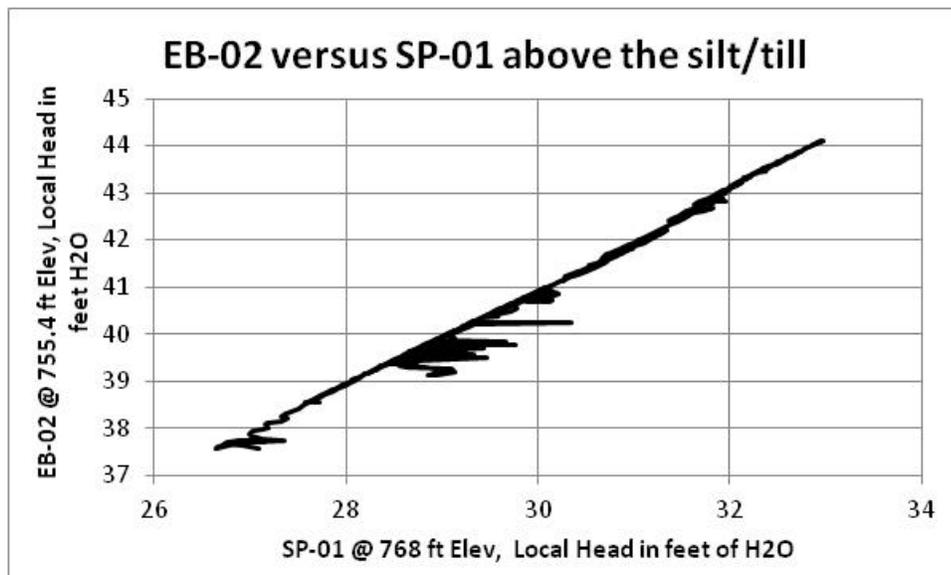
Figure I-2. Borings EB-02 and SP-01 are within feet of each other, hence they should produce corresponding readings. The linear relationship indicates that head changes between the two

piezometers are nearly identical, and the difference in the local head [11 feet] nearly matches the elevation difference between the two piezometers [768 ft – 755.4 ft = 12.6 ft]. The departures from the linear relationship appear to occur only with the piezometer in SP-01, which can be expected with an open standpipe piezometer. Obtaining a seal on an open standpipe piezometer is difficult and is often imperfect.

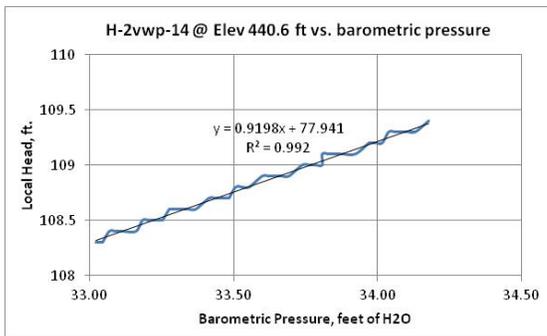
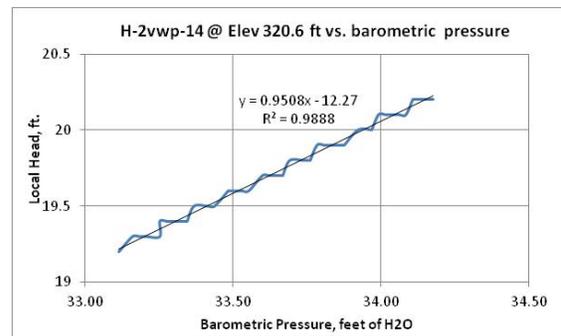
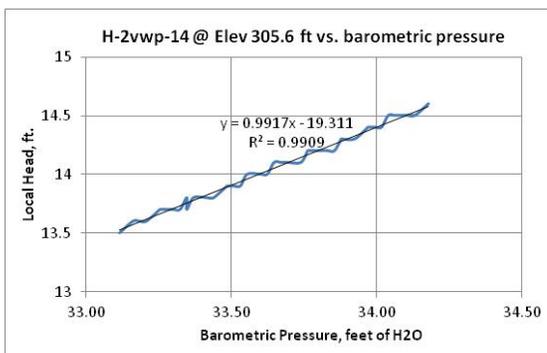
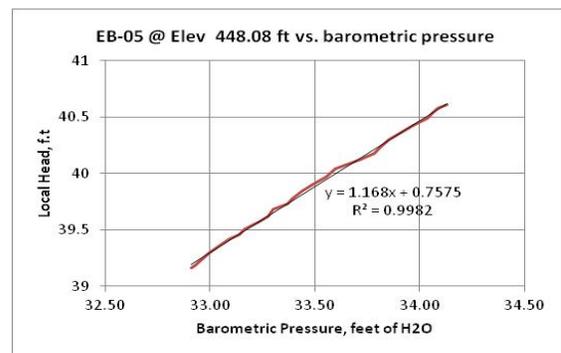
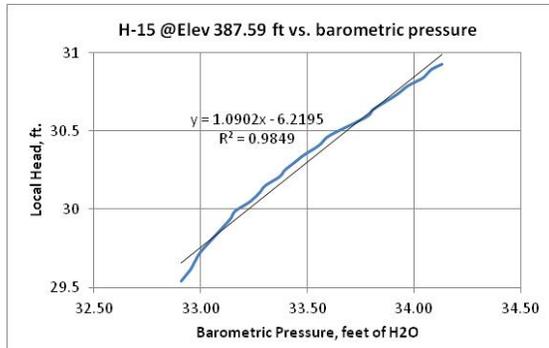
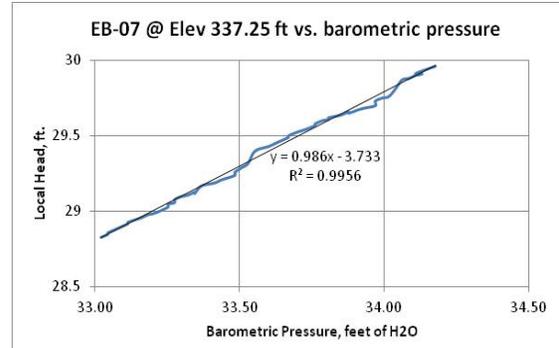
Figure I-3. Selected piezometer records that show a positive response to barometric pressure, indicating that they are operating correctly. Nearly one to one relationships with barometric pressure in these cases also indicate that there was little actual change in piezometric pressure occurring during the few days represented in each plot. A simultaneous change in actual pressure would result in other than a one to one slope of the line – numerous cases like this exist.

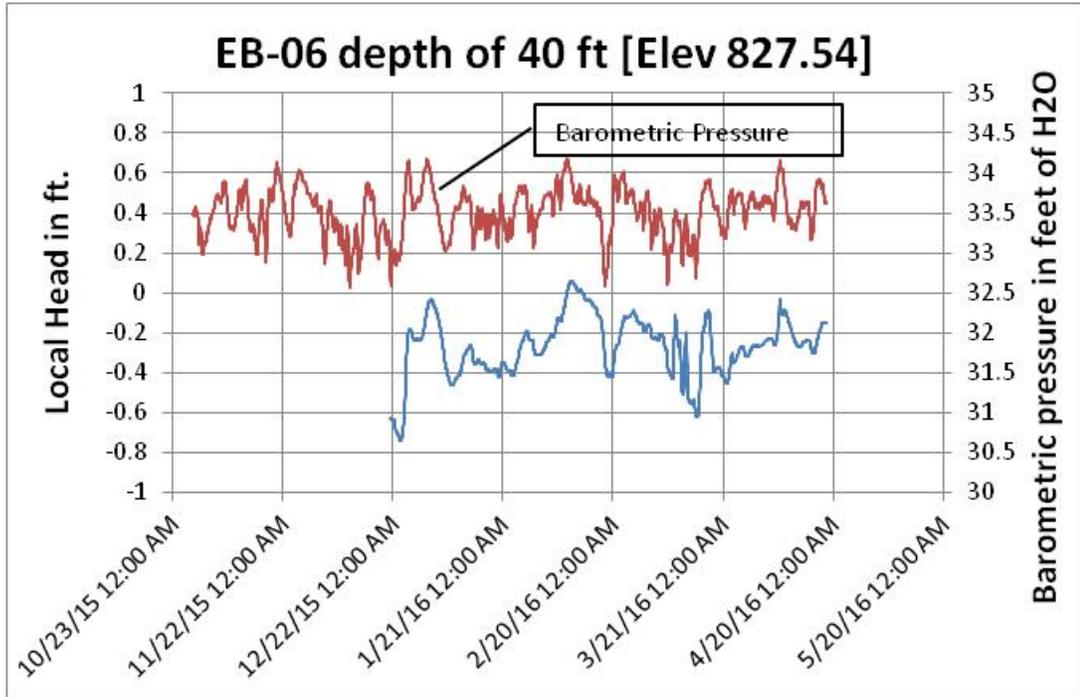
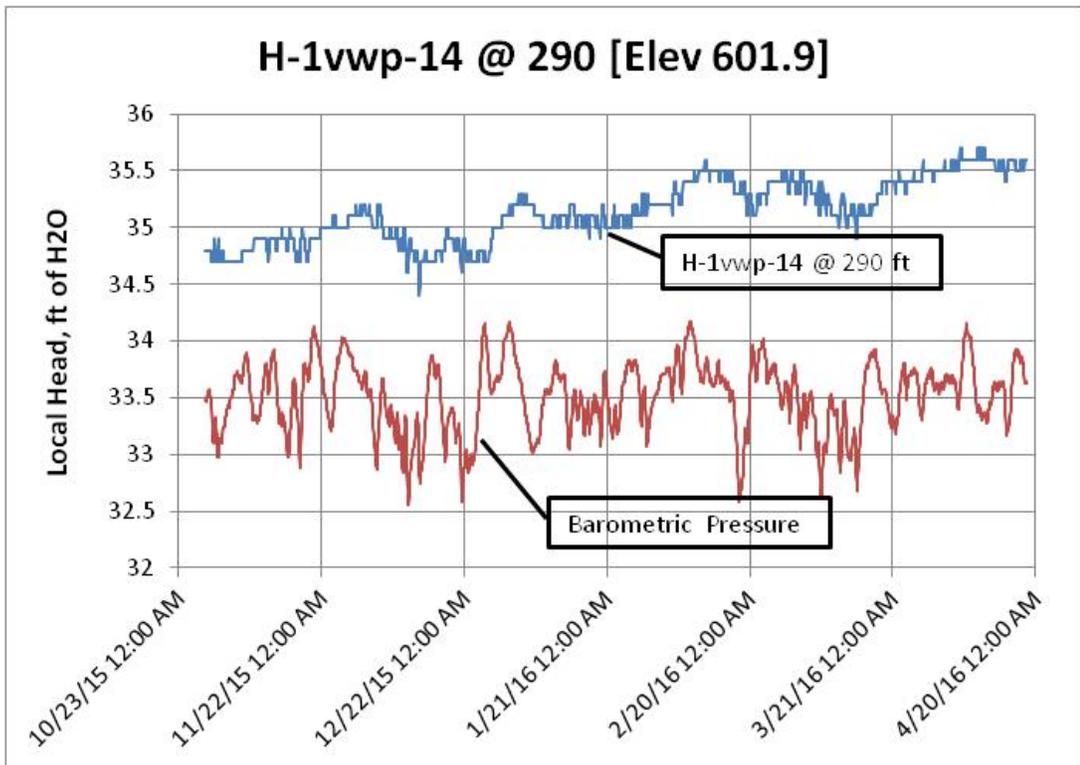
Figure I-4. Examples of piezometers where the pattern of change in piezometric reading indicates a delayed and subdued response to changes in barometric pressure.

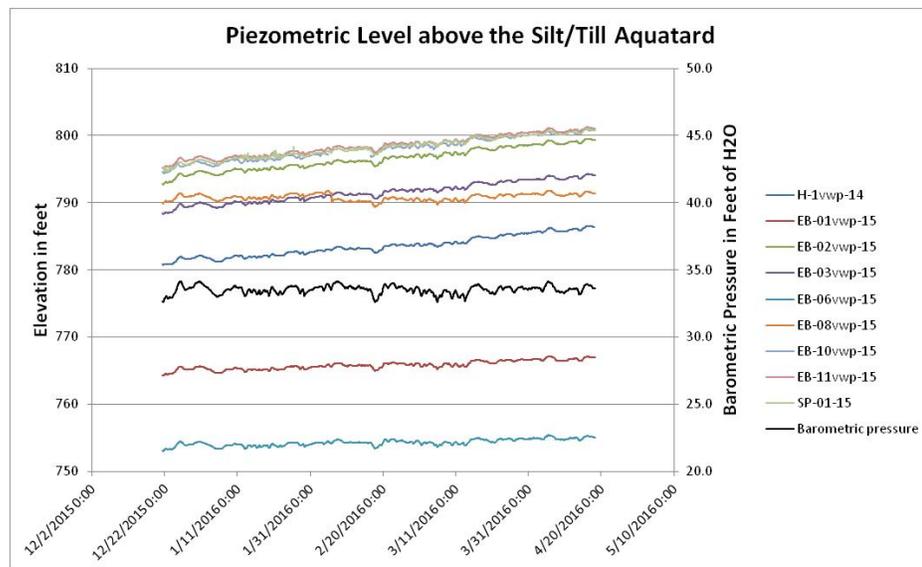
Figure I-5. Piezometric levels in the piezometers above the till interface beneath Whitman Bench.

- Two distinct groups of piezometric level traces plotted against time can be seen in the above figure. The piezometers in EB-01, EB-06, and EB-08, all have slopes with respect to time that are less than half of the slopes of the other piezometers above the till. These three piezometers are near the Headache Creek escarpment. A lesser slope with respect to time indicates that seasonal changes in groundwater level are less effected near the Headache Creek escarpment than at some distance away from the escarpment. This observation is consistent with lateral groundwater flow toward headache creek – in effect, the escarpment face is a boundary condition to the groundwater flow regime with little change in groundwater level as seasonal increases and decreases in seepage occur.

- It should be noted, that the piezometric level in EB-03 which is near the escarpment to the south into the Stillaquamish valley has a similar response with time to the piezometers further from the two escarpments, indicating that there is not a seepage boundary condition in that direction – in other words, significant seepage does not occur in a southerly direction.

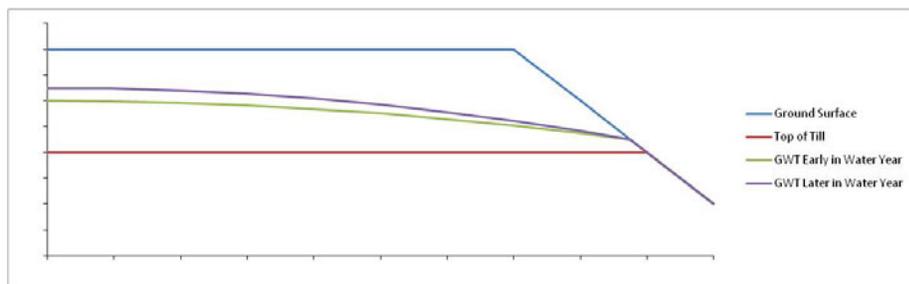
- A schematic diagram of the piezometric surface from the vicinity of EB-02 and EB-10 toward EB-01 and the Headache Escarpment is shown below. As can be seen in this schematic, the change in piezometric level near the point of drainage at the right of the section from early winter to later in the water year is less than the change at the left edge of the section – this is exactly the behavior exhibited in the piezometers.

I-6. This schematic illustrates the groundwater profile in a West to East direction with drainage of the recessional outwash deposits above the till draining toward the Headache Creek escarpment.

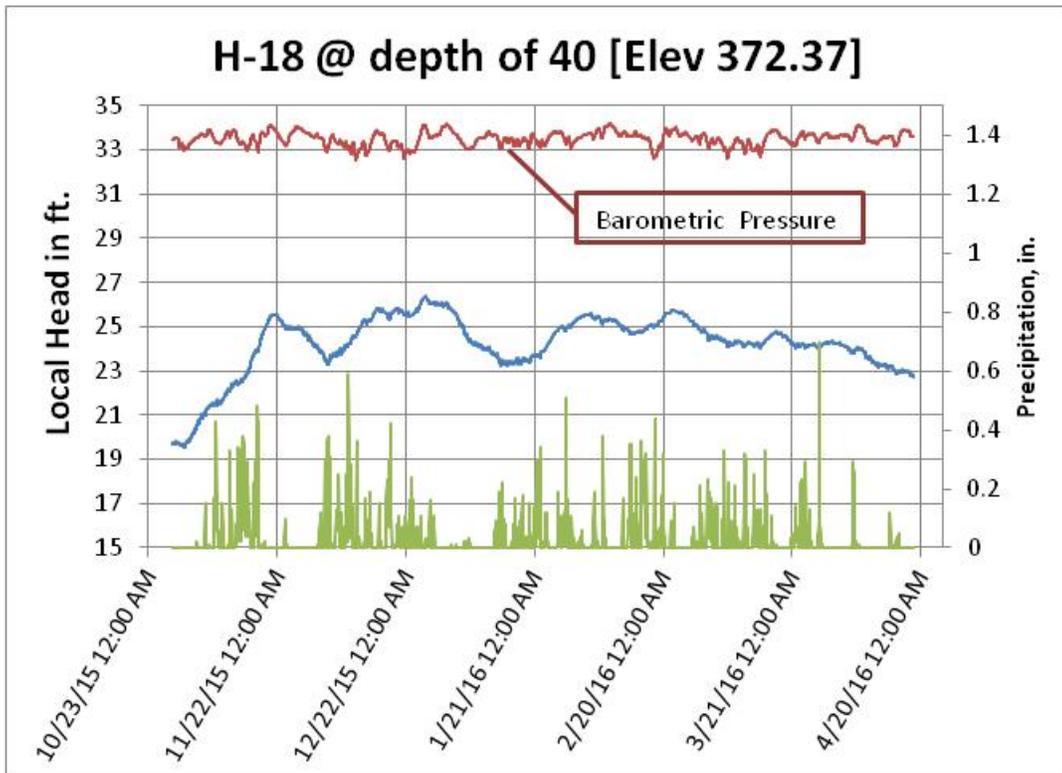
- Piezometers located within the SR530 slide mass demonstrate varied behavior that appears to be a function of the local connectivity of the piezometer tip to stratigraphy including the basal surface of rupture. Piezometers located in the slide debris above the surface of rupture, and some distance from the SR 530 landslide scarp exhibit relatively quick response to precipitation, whereas piezometers in the “free field” installed in bore holes on the Whitman Bench, exhibit only an annual cycle of response to wet season precipitation with a time delay of months.
 - Quick response to wet season precipitation is illustrated in the figure below.

- Figure I-13. Piezometer response to precipitation within the slide debris.
- The piezometer in EB-05 that is within the slide debris reacts differently than the other piezometers in the slide debris. This piezometer record is shown in the figure below for comparison with the piezometer in EB-05 that is below the surface of rupture and a similar piezometer in EB-14 that is below the surface of rupture. There is only the most subtle signature of precipitation in the piezometer records – a slight increase or decrease in the rate of general increase in the readings. The fact that both piezometers in EB-05 are responding similarly to the piezometer in EB-14 just below the surface of rupture indicates connectivity between the slide debris and the lacustrine silt/clay strata below the surface of rupture at the location of EB-05.

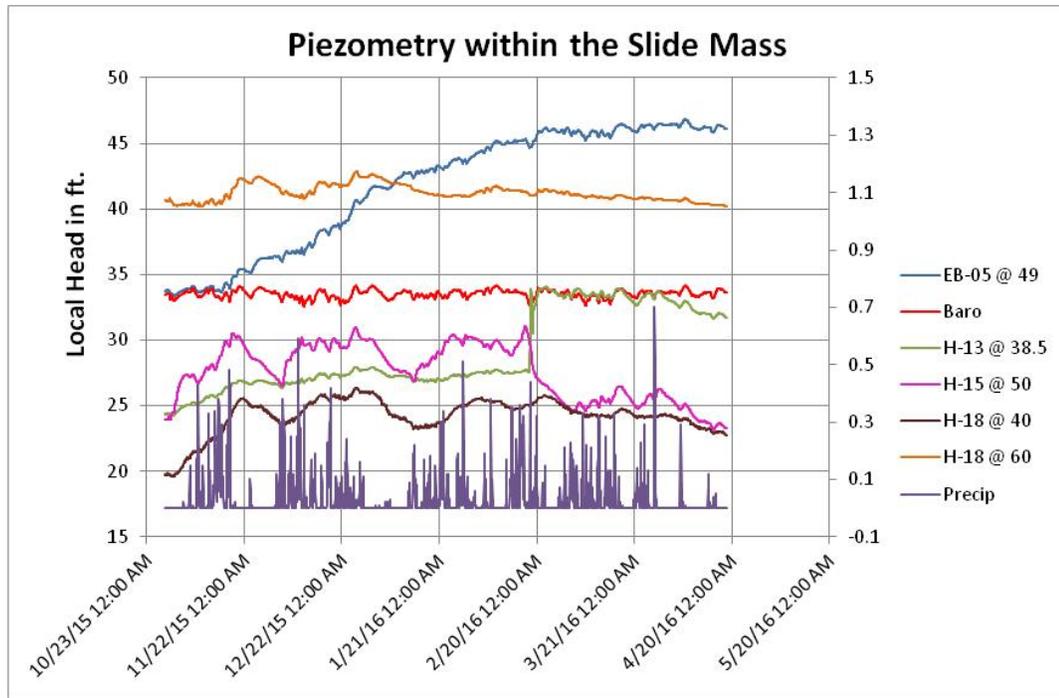
- With the exception of the piezometer in EB-05 that is located within the slide mass, the piezometers in the slide mass all show a decline in piezometric levels through the late winter and early spring at a time when the general response in the other piezometers – those in the recessional outwash above the till, and those below the till – appears to be an increase in piezometric level. This common behavior in the piezometers within the slide mass is illustrated in the figure below

Figure I-15. Response of piezometers in the slide debris.

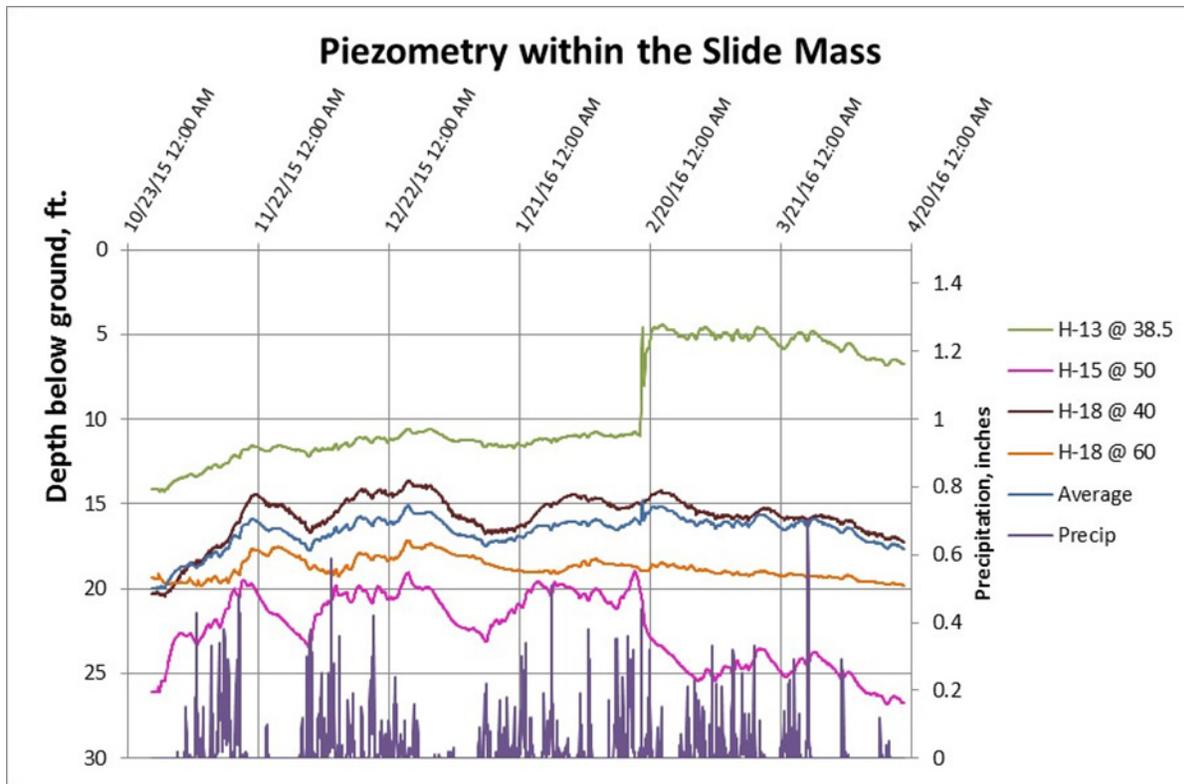
- If we infer that the previously failed portions of the SR 530 slide mass [the prehistoric failures and the Hazel slide in 2006] had groundwater behavior prior to the slide that is similar to that which we now see in the failed portions of the SR 530 slide mass after the slide, we can state that the piezometric levels within the slide mass from the north edge of the midslope bench south to the toe of the initial slide mass on the Bear Lake Sands respond to direct rainfall, while piezometric levels deep below the Whitman Bench do not.
- The net result of this response is that a near ground surface piezometric surface should be expected in the mid-slope bench and in the Hazel slide debris. This observation is illustrated in Figure I-16 below.

Figure I-16. Depth below ground of the Groundwater Table in the slide debris.

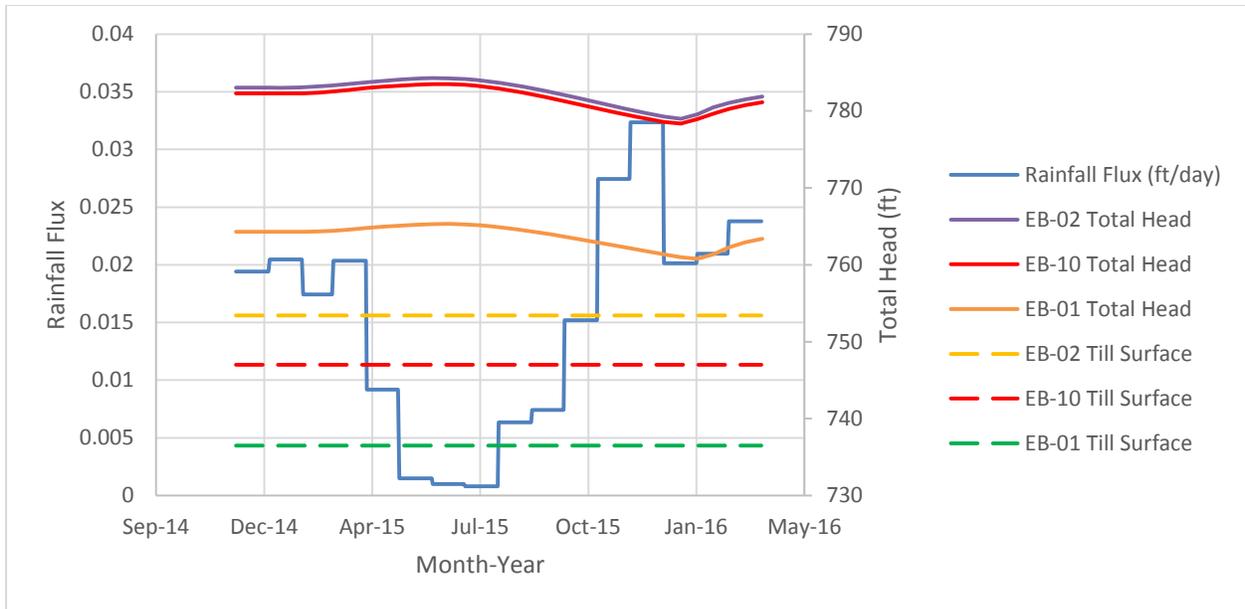
Figure I-22 shows the seasonal fluctuations in the recessional sand ground water table calculated with SeepW for a horizontal conductivity of 10 ft/day and a conductivity ratio of 1:1. Results indicate a seasonal fluctuation amplitude of about 5 feet and about a 5-month delay in the response of the groundwater table.

Figure I-22: Seasonal fluctuations in recession sand calculated by SeepW.
