SUPERIOR COURT OF WASHINGTON FOR KING COUNTY

EXPERT OPINION REPORT OF

DR. MARVIN R. PYLES, Ph.D., P.E.

JUNE 30, 2016

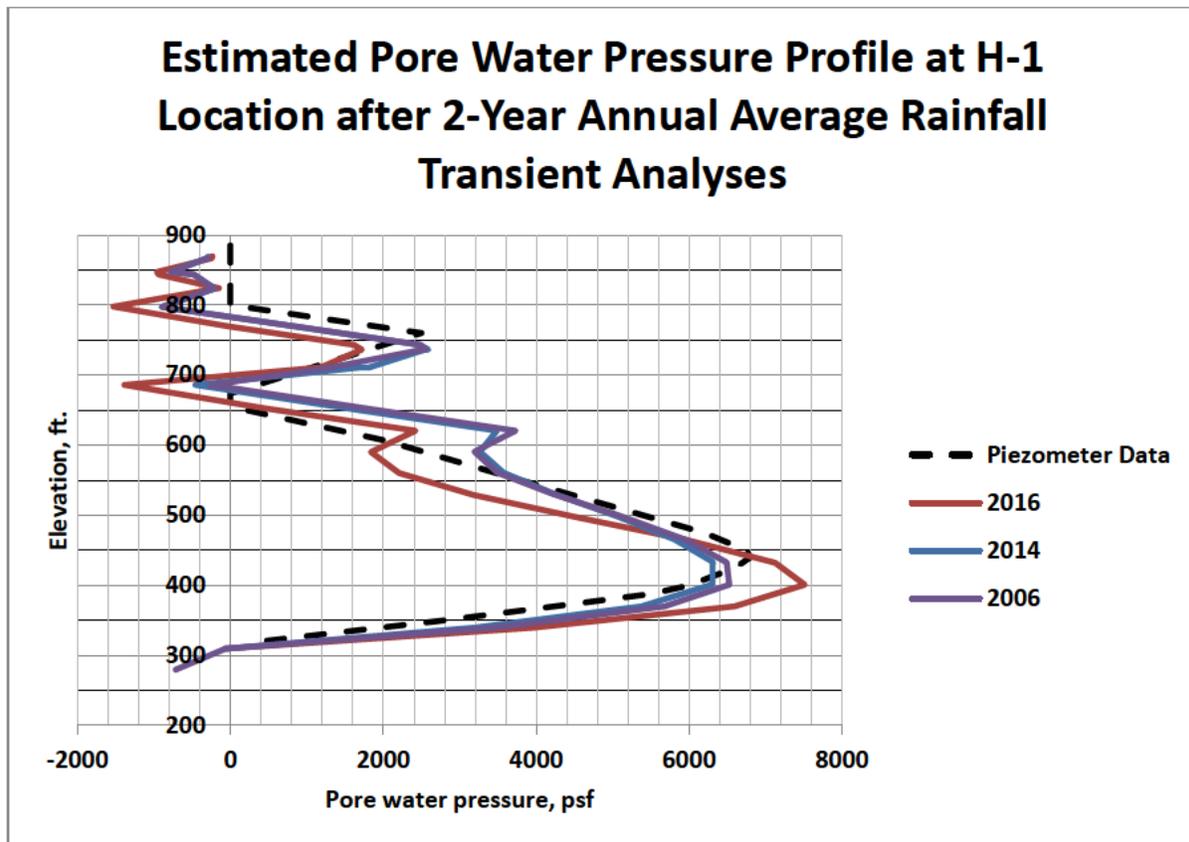
The pore pressure results for the 2006, 2014, and 2016 geometries are shown in Figure I-23. Results for 2006 and 2014 geometries are nearly equivalent since the material bordering the southeast end of the undisturbed materials is the same. Results for the 2016 geometries are different from the 2006 and 2014 geometries because the advance outwash and till have a free seepage face instead of being bounded by disturbed recessional sand and colluvium. The calculated pore pressures are reasonably close to the measured piezometer data. The SeepW results succeed in capturing the confined nature of the lacustrine aquifer by showing local minimum pore pressures near the bottom of the till layer and near the top of the lacustrine layer. The spike in pore water pressure at about elevation 625 feet for the transient analyses is a result of the boundary between the advance outwash sand and the lacustrine silt/clay. The lacustrine soil acts as an aquitard in relation to the more conductive advance outwash sands.

Figure I-23: Porewater pressures at the location of H-1 as measured in the field and as calculated using SeepW.

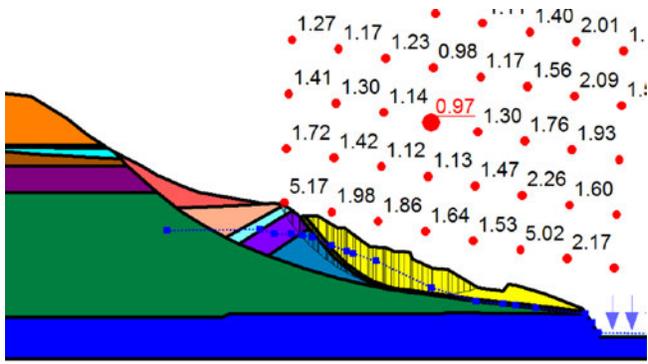
Figures J.1-5a-c show the surfaces of rupture for the groundwater level 30 feet below the estimated high water level. The circular surface of rupture in Figure J.1-5a includes a small amount of M2 material and has a marginally stable factor of safety close to 1. The non-circular surfaces of rupture shown in Figures J.1-5b-c have higher factors of safety than the circular surface of rupture, so the circular surface of rupture involving mostly M1 material is most likely to represent the initial failure geometry. The factor of safety of the circular surface of rupture drops to 0.9 if the groundwater level is raised to 20 feet below the estimated high groundwater level, as shown in Figure J.1-6a. The optimized non-circular surface of rupture is also low, but still above 0.9, and the fully specified surface of rupture actually remains above 1. This further suggests that a circular surface of rupture involving mostly M1 material and only a small amount of M2 material would fail when the water level is raised from 30 feet below the estimated high water level to 20 feet below the estimated high water level.

Figure J.1-5a: Critical circular surface of rupture using pre-failure strengths with the groundwater level located 30 feet below its estimated high level.

0.98

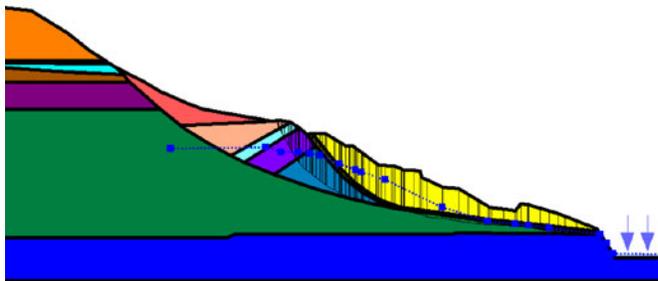
Figure J.1-5b: Optimized non-circular surface of rupture using pre-failure strengths with the groundwater level located 30 feet below its estimated high level.

1.09

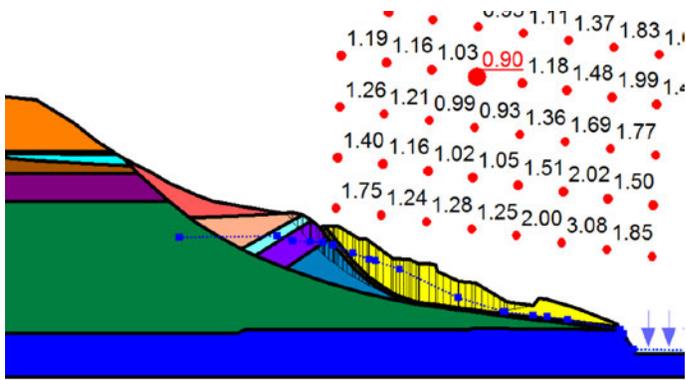
Figure J.1-6a: Critical circular surface of rupture using pre-failure strengths with the groundwater level located 20 feet below its estimated high level.

0.92

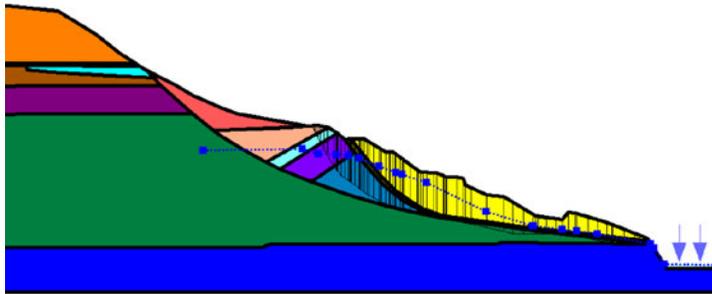
Figure J.1-6b: Optimized non-circular surface of rupture using pre-failure strengths with the groundwater level located 20 feet below its estimated high level.

1.01

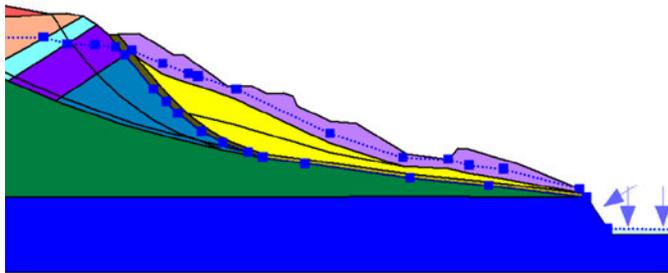
Figure J.1-7b: Shallow ponding schematic with no pore water pressures along M1 interfaces. The ponded region is shown in purple.

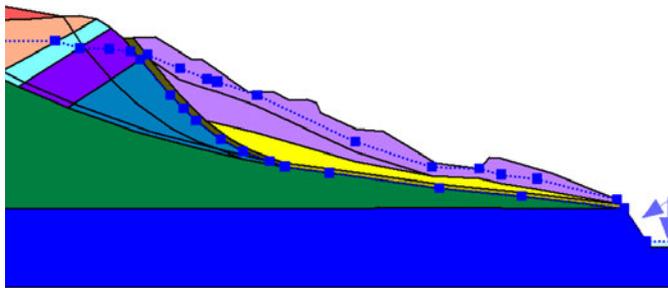
Figure J.1-7c: Medium ponding schematic with no pore water pressures along M1 interfaces. The ponded region is shown in purple.

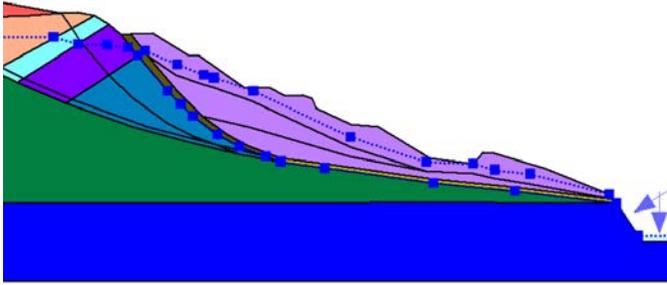
Figure J.1-7d: Deep ponding schematic with no pore water pressures along M1 interfaces. The ponded region is shown in purple.

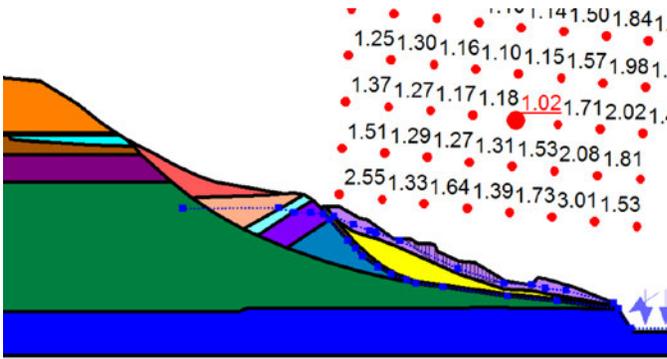
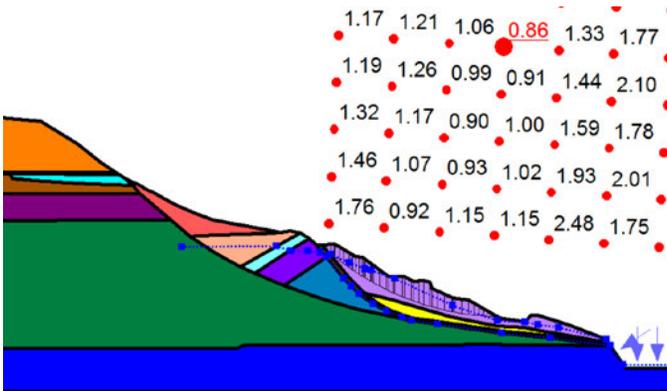
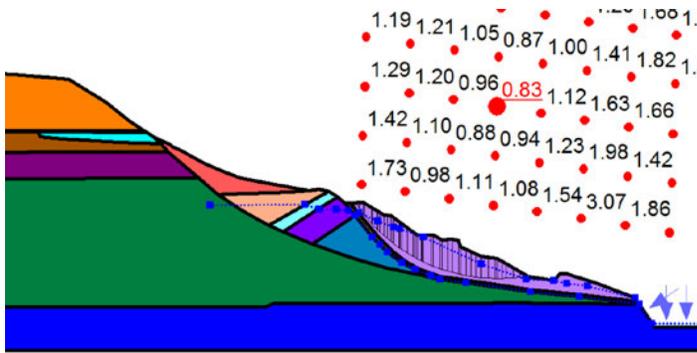
Figures J.1-8a-c present the results of a subset of the analyses with shallow, medium, and deep ponding within the M1 debris that does not create any pore pressures along the M1 interfaces. If there is shallow ponding within the M1 debris and no pore water pressures along the M1 interfaces, the M1 debris is more stable with a factor of safety above 1. For medium ponding with no pore pressures along the M1 interfaces, a shallow circular surface of rupture through the ponded region is most critical with a factor of safety slightly below 0.9. The factor of safety for the deep ponded region is below 0.9 for the circular surface of rupture. The shallow ponding case is considered to be most reasonable for the pre-failure case, because it provides a calculated factor of safety that is above 1, so it is marginally stable which is consistent with the pre-failure

Figure J.1-8a: Circular surface of rupture for shallow ponding with no pore water pressures developed along the M1 interfaces.

Figure J.1-8b: Circular surface of rupture for medium ponding with no pore water pressures developed along the M1 interfaces.

Figure J.1-8c: Circular surface of rupture for deep ponding with no pore water pressures developed along the M1 interfaces.

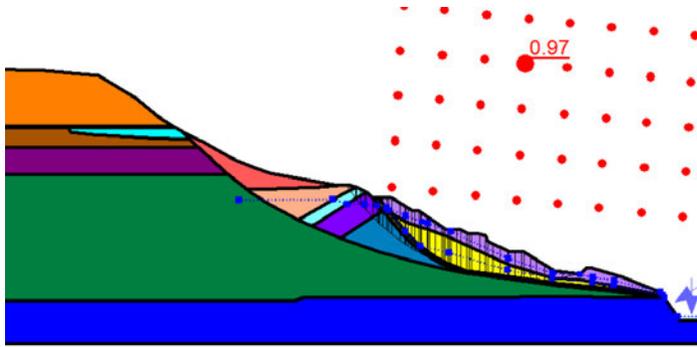
Some pore water pressures were likely present along the interfaces of the M1 debris. Analyses were also performed with different estimates of the water levels that were applied to the M1 interfaces along with a perched water level within the M1 body. When no pore water pressures were developed along the M1 interface for the shallow ponding case, the factor of safety was above 1 for circular and non-circular surfaces of rupture. When pore water pressures were developed from a groundwater level directly below the ponded region, the factor of safety drops dramatically to about 0.85. This is due to the fact that the shallow ponding case considered has high pore pressures, because the groundwater level that creates the M1 interface pore pressures in these cases is approximately 15 feet below the high groundwater level. In the analyses that do not consider ponding (Table J.1-2), the calculated factors of safety were below 0.9 for circular surfaces of rupture when the groundwater level was less than 20 feet below the estimated high water level. The Hazel landslide is marginally stable if shallow ponding is present within the M1 debris level and pore pressures along the M1 interface are developed from a groundwater level no higher than the bottom of the medium ponded region as shown in Figure J.1-8d. The results of this set of analyses are summarized in Table J.1-4.

Figure J.1-8d: Circular surface of rupture for shallow ponding with M1 interface pore water pressures developed from the medium ponding case.

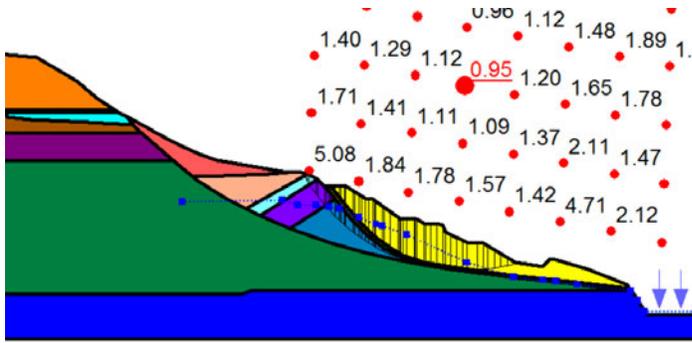
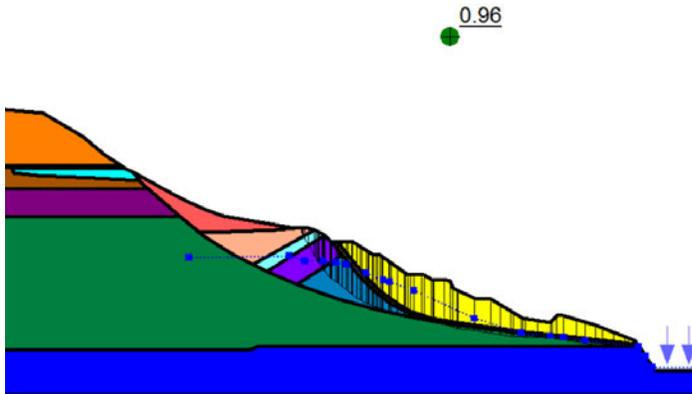
The engineering soil properties listed in Table J.1-1 for the failure scenario are used in the Stage 1 – 2006 Hazel landslide analyses. When the groundwater level is 30 feet below its estimated high level, the calculated factors of safety indicate marginal stability with $0.95 \leq FS \leq 1.04$ (Figures J.1-9a-b). When the groundwater level is raised to 20 feet below the estimated high water level, the calculated FS falls below 0.9 (Figures J.1-9c-d). When the pre-failure strengths were used, all factors of safety remained above or equal to 0.9 when the water level was 20 feet below the estimated high water level. The factors of safety for these analyses are summarized in Table J.1-5.

Figure J.1-9a: Critical circular surface of rupture using at-failure strength parameters with the groundwater level located 30 feet below its estimated high level.

Figure J.1-9b: Optimized non-circular surface of rupture using at-failure strength parameters with the groundwater level located 30 feet below its estimated high level.

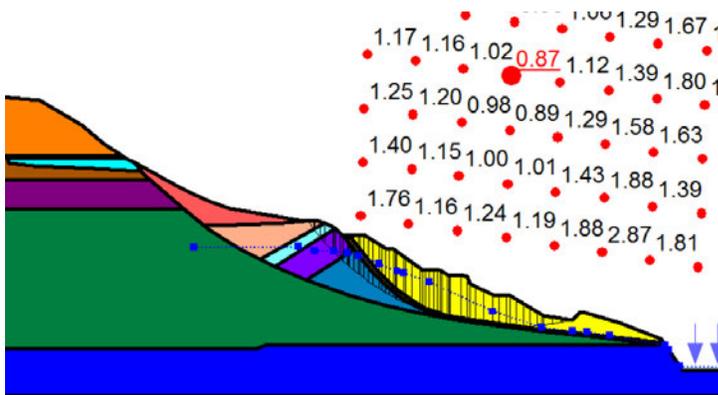
Figure J.1-9c: Critical circular surface of rupture using at-failure strength parameters with the groundwater level located 20 feet below its estimated high level.

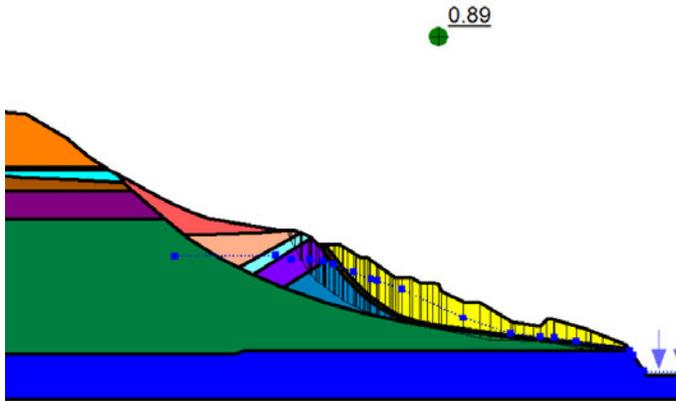
Figure J.1-9d: Optimized non-circular surface of rupture using at-failure strength parameters with the groundwater level located 20 feet below its estimated high level.

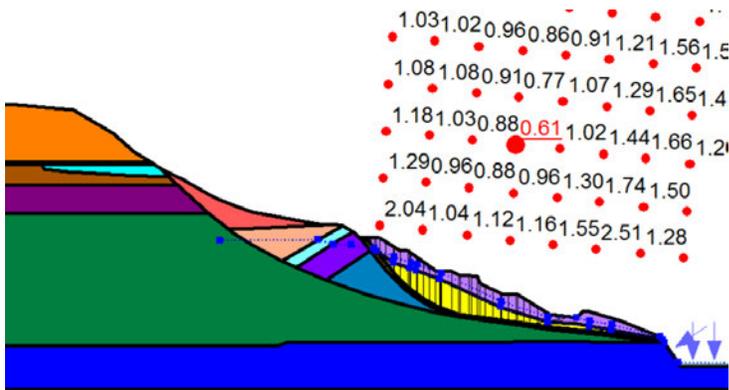
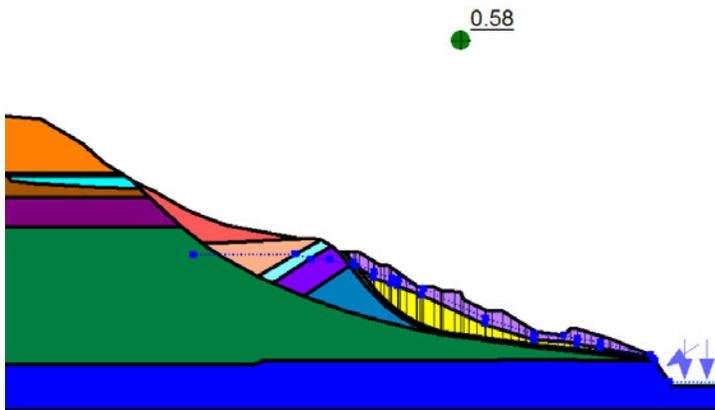
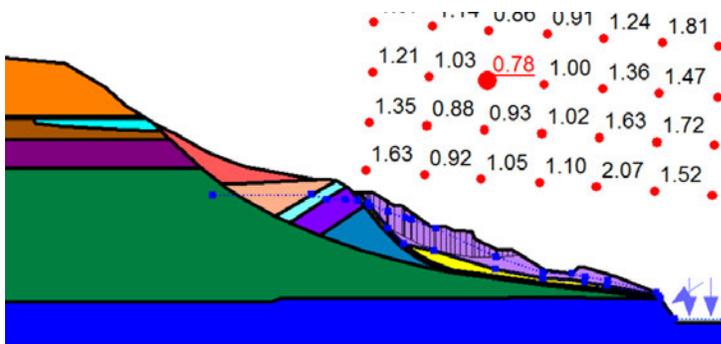
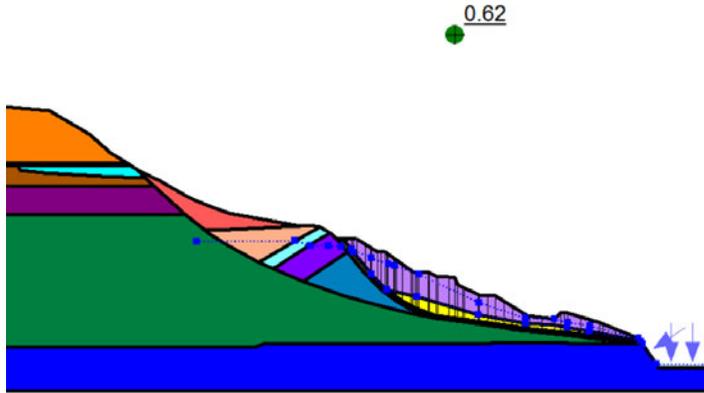
The analyses indicate that the critical surface of rupture includes a small part of the M2 debris. If a tension crack forms along the upper M1 interface, then the surface of rupture would follow this low-resistance path instead of intersecting M2 debris. To analyze the effects of a tension crack, the strength parameters for the upper M1 interface were reduced to zero. The tension crack was assumed to be filled with water by analyzing cases that include shallow, medium, and deep ponding with pore water pressures along the lower M1 interface resulting from a water level that coincides with the bottom of the ponded region. The results of these analyses are shown in Figures J.1-10a-d for shallow and medium ponding. The factors of safety are summarized in Table J.1-6. All of the calculated factors of safety are below 0.9, which indicate that the M1 debris would fail for these conditions.

Figure J.1-10a: Circular surface of rupture for shallow ponding with a tension crack formed along the upper M1 interface.

Figure J.1-10b: Optimized non-circular surface of rupture for shallow ponding with a tension crack formed along the upper M1 interface.

Figure J.1-10c: Circular surface of rupture for medium ponding with a tension crack formed along the upper M1 interface.

Figure J.1-10d: Optimized non-circular surface of rupture for medium ponding with a tension crack formed along the upper M1 interface.

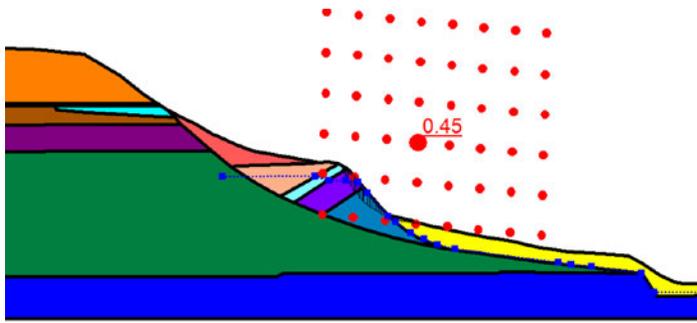
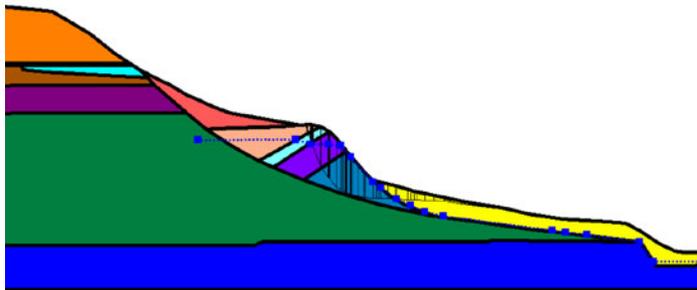
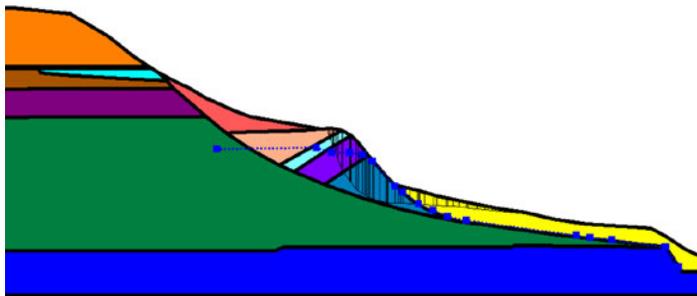
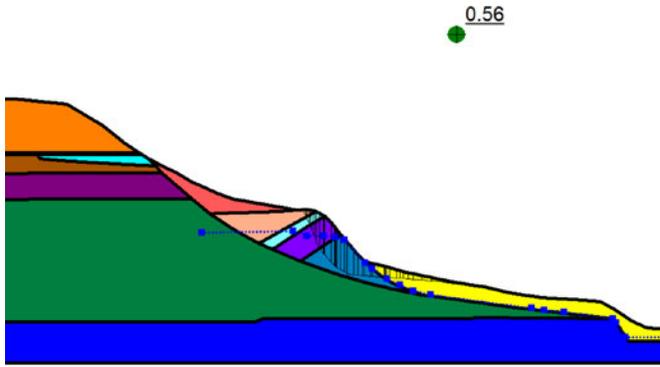
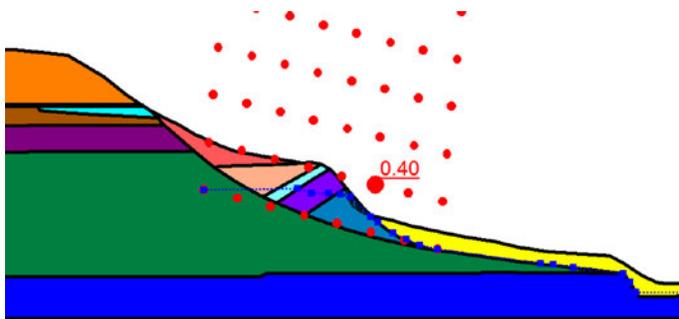
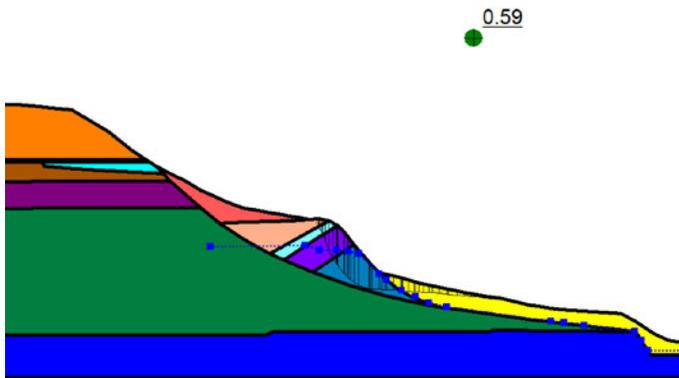
These slope stability analyses suggest that failure of part of the mid-slope bench likely occurred soon after the M1 slide material failed. This is consistent with the observations following the 2006 landslide. After the 2006 Hazel landslide, the mid-slope bench was marginally stable.

Figure J.1-11a: Critical circular surface of rupture with the groundwater level at the estimated high water level.

Figure J.1-11b: Optimized non-circular surface of rupture with the groundwater level at the estimated high water level.

Figure J.1-11c: Optimized non-circular surface of rupture with the groundwater level 10 feet below the estimated high water level.

Figure J.1-11d: Optimized non-circular surface of rupture with the groundwater level 20 feet below the estimated high water level.

Figure J.1-11e: Critical circular surface of rupture with the groundwater level 30 feet below the estimated high water level.

Figure J.1-11f: Optimized non-circular surface of rupture with the groundwater level 30 feet below the estimated high water level.

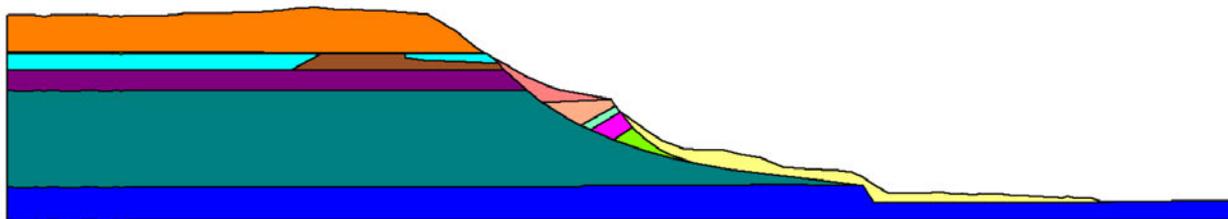
The generalized stratigraphy of the Whitman Bench and the Hazel slide as of the conclusion of 2013 is shown in Figure J.2-1. This cross section is approximately in the center of the slide area, and represents an average condition. To the east and west of this central section, both the un-failed strata and the post-2006 Hazel slide debris have varying cross sections and material makeup. The post-2006 Hazel slide debris is assumed to be disaggregated significantly and is modeled as one material type, initially using the strength properties defined in the Interpreted Strength Parameters table in Appendix E. The mid-slope bench is modeled as a heterogeneous zone consisting of different constituent materials from the same table of strength parameters. The materials in the mid-slope bench are somewhat disturbed due to previous episodes of movement. Their strength properties are reduced initially to 90% of their values listed in the Interpreted Strength Parameters table (i.e., 90% of c and $\tan \phi$). The remaining materials within the Whitman Bench were considered to be undisturbed materials with strength parameters corresponding to the values given in the Interpreted Strength Parameters table in Appendix E.

Figure J.2-1: Generalized stratigraphy of Whitman Bench and the Hazel slide as of 2013 (see legend in Table J.2-1 for the identification of specific soil units).

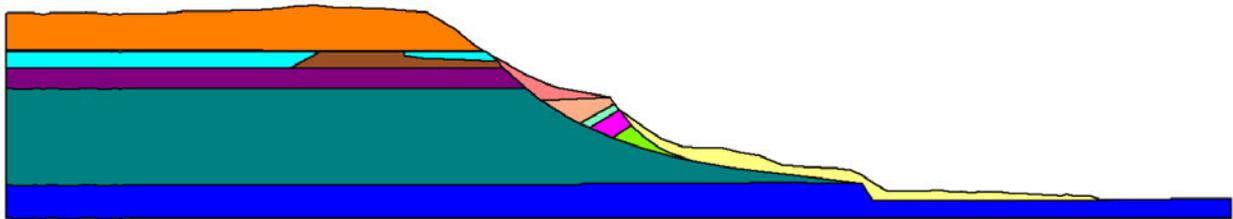
Stage 1 is shown in Figure J.2-2a. In this initial stage, failure was re-initiated in the 2006 Hazel landslide debris (effectively treated as M1 debris). The critical surface of rupture was expected to be located through the M1 debris, or through both the M1 and M2 debris. Shallow surfaces of rupture within the mid-slope bench were not considered in the Stage 1 failure analyses, because these shallow failures were assumed to be continuously occurring after the 2006 Hazel landslide. Although a shallow failure could cause a cascading effect that might trigger failure in a marginally stable slope, sufficient information is not available to confidently analyze this case.

Figure J.2-2a View of the slide debris material zones in Stage 1 (see legend in Table J.2-1).

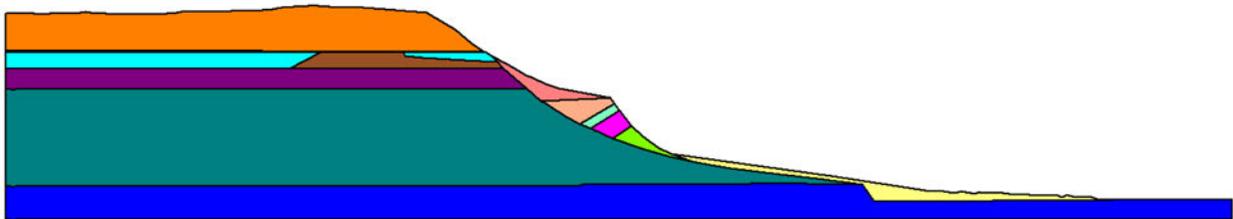
In the second stage of the analyses, the M1 debris was removed from the analyses so that the buttressing force it provided previously to the mid-slope bench would no longer be applied, as shown in Figure J.2-2b. This stage of analyses focuses on the stability of the M2 debris that makes up the mid-slope bench.

Figure J.2-2b: View of the slide debris material zones in Stage 2 (see legend in Table J.2-1).

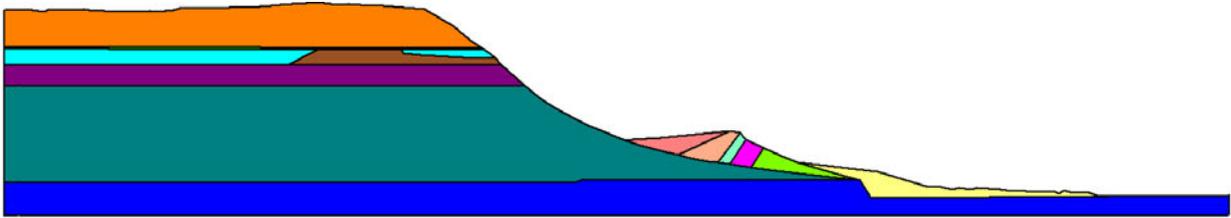
In the third stage of analysis, the M2 debris sections were moved downslope to the initial location of the M1 debris, as shown in Figure J.2-2c, and potential deep slope failures through Whitman Bench were analyzed. Drained and undrained lacustrine layer strengths were used in this stage of analysis.

Figure J.2-2c: View of the slide debris material zones in Stage 3 (see legend in Table J.2-1).

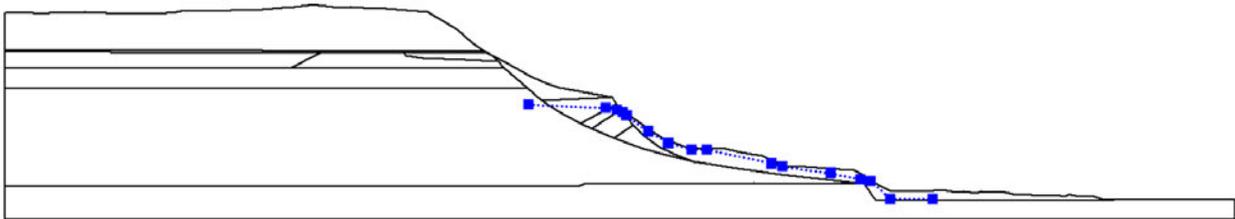
The high water level for the initial 2014 slide is based on our interpretation of the piezometer measurements and reasonable interpretations of groundwater conditions that likely existed immediately before the 2014 SR-530 landslide. The estimated water level is shown in Figure J.2-3a. A low water level that runs along the boundary of the undisturbed lacustrine layer was used as an estimated low water level, as shown in Figure J.2-3b. As mentioned previously, there are other mechanisms that are not captured by these analyses such as erosion of soil due to water flow from springs within the slide mass, which steepens the slope in places as soil is transported downslope.

Figure J.2-3a: Estimated high water level used in Stage 1 analyses.

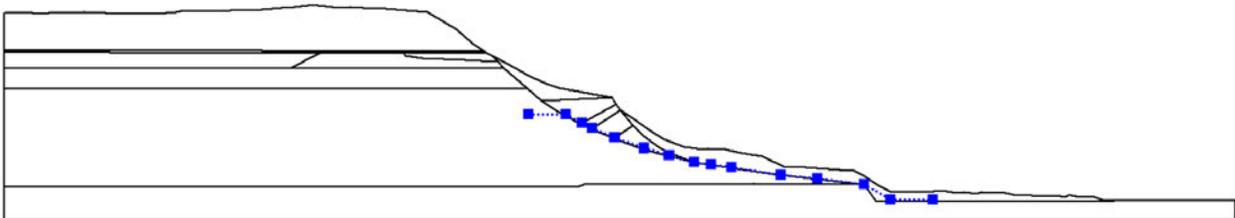
Figure J.2-3b: Estimated low water level used in Stage 1 analyses.

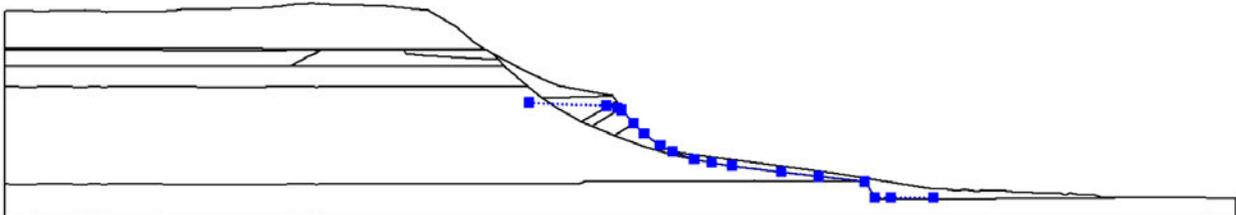
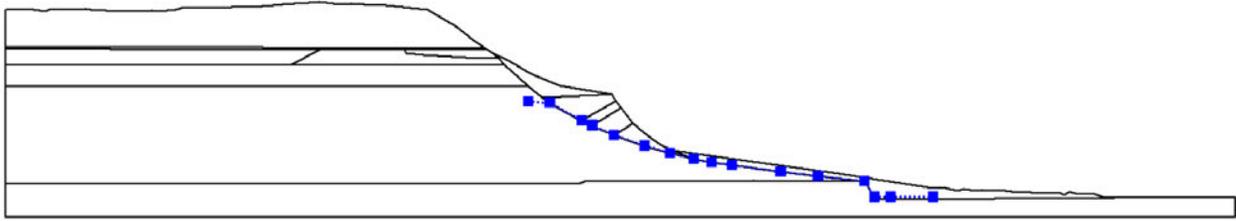
The estimated groundwater levels in Stage 2 analyses are lowered to the ground surface where the M1 debris was previously located, as shown in Figures J.2-4a-b.

Figure J.2-4a: Estimated high groundwater level used in Stage 2 analyses.

Figure J.2-4b: Estimated low groundwater level used in Stage 2 analyses.

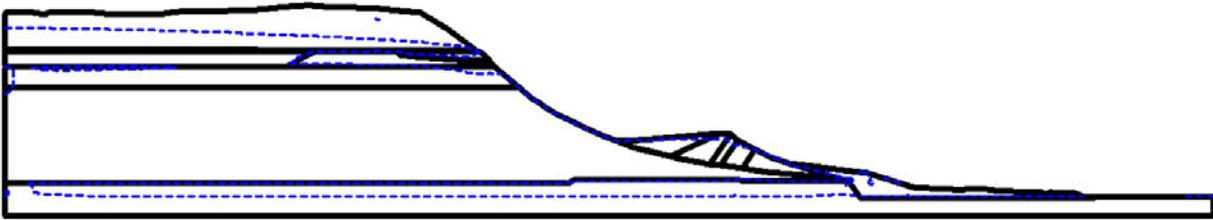
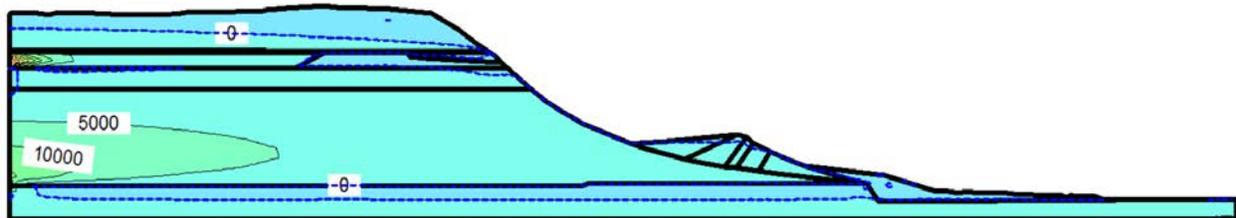
The pore water pressures within Whitman Bench were calculated from a seepage analysis for the Stage 3 analyses. This seepage analysis calculates pore water pressures based on a 1-year transient analysis using the annual average rainfall in the region surrounding Whitman Bench (i.e., 0.2 inches/day) followed by 22 days of heavier rainfall equivalent to the measured rainfall in regions surrounding Whitman Bench in the 22 days prior to the SR-530 landslide (i.e., 0.7 inches/day). The groundwater level calculated from these analyses represents locations of zero pore pressure as shown in Figure J.2-5a. Figure J.2-5b shows contours of pore pressures within Whitman Bench.

Figure J.2-5a: Calculated water levels in Stage 3 analyses (blue dashed lines show 0 pressure contours).

Figure J.2-5b: Pore water pressures in Whitman Bench (units of psf).

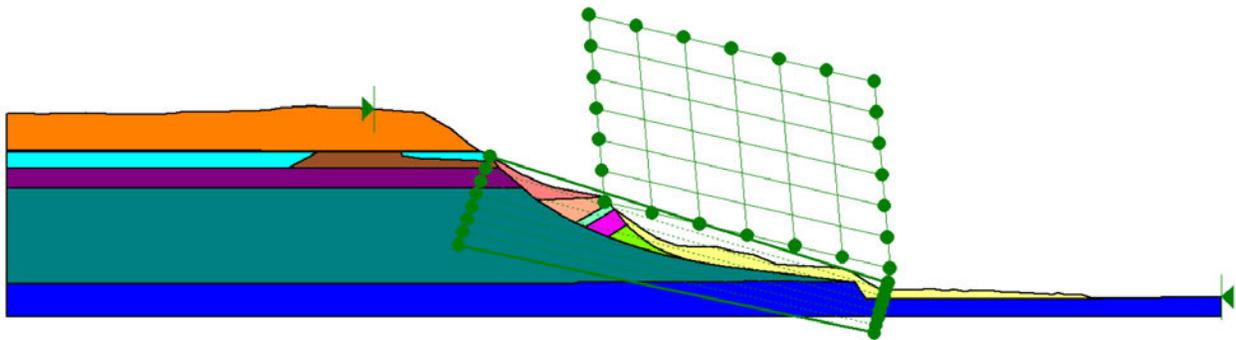
Circular surfaces of rupture using the grid and radius method in SlopeW were used to calculate a global minimum factor of safety, as shown in Figure J.2-6a. Non-circular surfaces of rupture using the fully specified method in SlopeW were used to calculate the factors of safety for

Figure J.2-6a: Circular surface of rupture search using the grid and radius method.

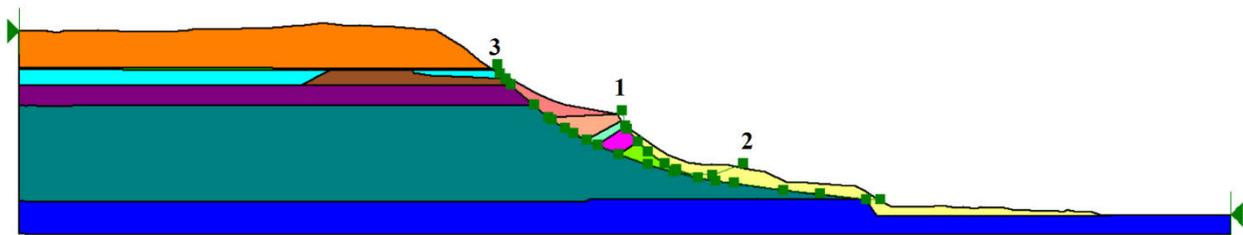
specific surfaces of rupture derived from field investigations. Fully specified, non-circular surfaces of rupture are shown in Figure J.2-6b. Non-circular surface of rupture1 corresponds to slip through the M1 debris. Non-circular surface of rupture2 corresponds to full failure of the mid-slope bench with a surface of rupture exit through the upper portion of the M1 debris. Non-circular surface of rupture 3 corresponds to slip along the inner boundary of the M1 and M2 debris. The most critical non-circular surface of rupture was optimized in SlopeW to search for any surface of rupture with a lower factor of safety within the vicinity of the estimated surfaces. Optimization is performed by randomly adjusting the points of the most critical fully specified surfaces of rupture for 2000 iterations to locate a lower factor of safety in the vicinity of the most critical fully specified, non-circular surface of rupture.

Figure J.2-6b: Fully specified, non-circular surfaces of rupture.

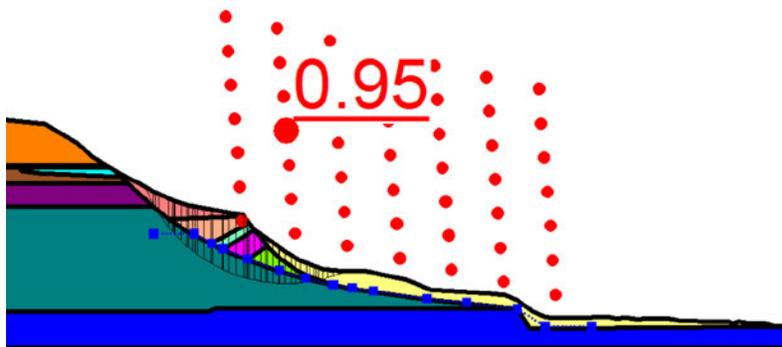
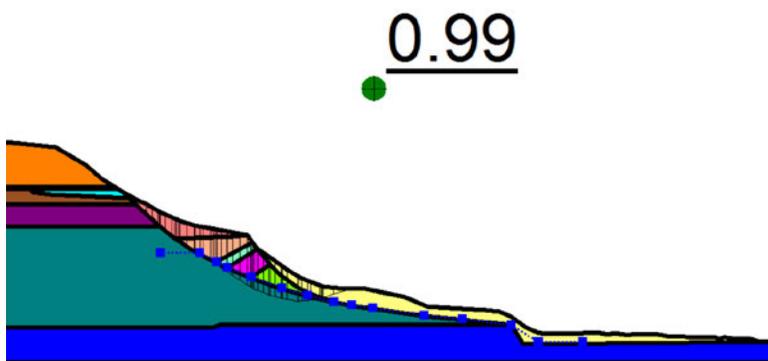
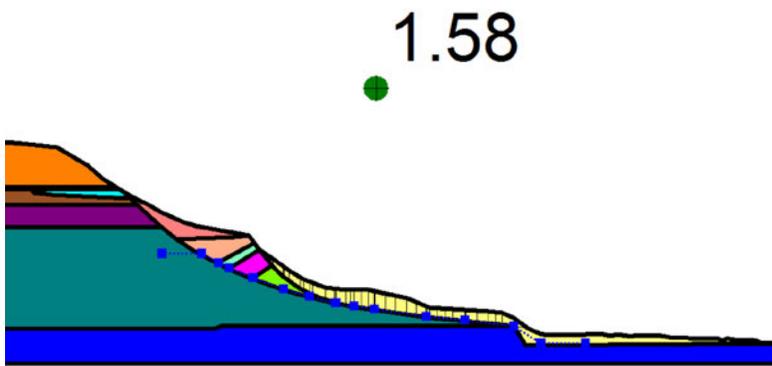
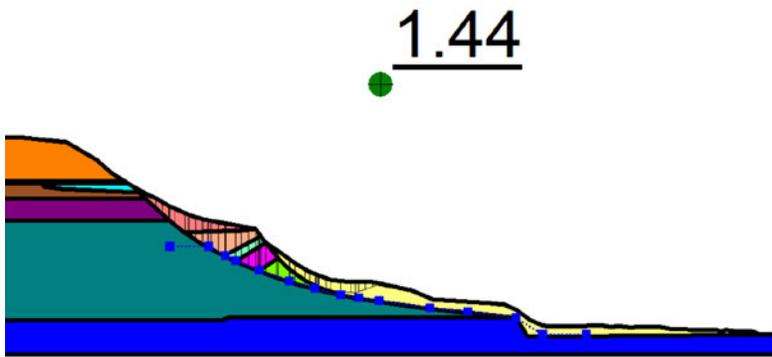
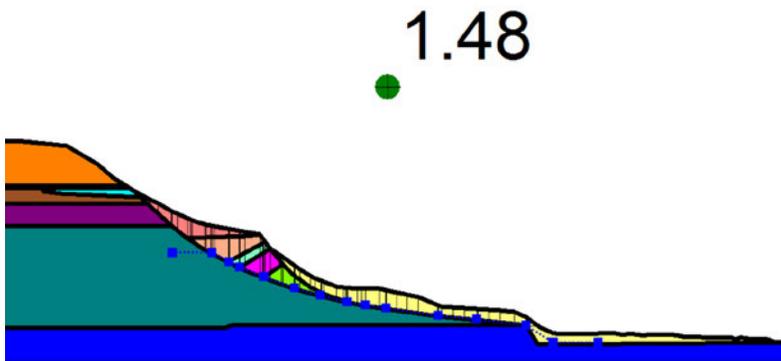
The potential surfaces of rupture shown in Figures J.2-7a-i were developed using the pre-failure strength and unit weight parameters (Table J.2-1). The deep circular surface of rupture for the estimated low groundwater level in Figure J.2-7a exhibited a marginally stable factor of safety. The optimized non-circular surface of rupture in Figure J.2-7b corresponds approximately to non-circular surface of rupture 2 and had a marginally stable factor of safety. The fully specified non-circular surfaces of rupture in Figures J.2-7c-e have factors of safety above 1.1, which indicate they are stable. Thus, for the low groundwater conditions, the slope is marginally stable or stable for the calibrated soil parameters and landslide geometry.

Figure J.2-7a: Critical circular surface of rupture with pre-failure strength parameters at the estimated low water level.

Figure J.2-7b: Optimized non-circular surface of rupture with pre-failure strength parameters at the estimated low water level.

Figure J.2-7c: Non-circular surface of rupture 1, with pre-failure strength parameters at the estimated low water level.

Figure J.2-7d: Non-circular surface of rupture 2, with pre-failure strength parameters at the estimated low water level.

Figure J.2-7e: Non-circular surface of rupture 3, with pre-failure strength parameters at the estimated low water level.

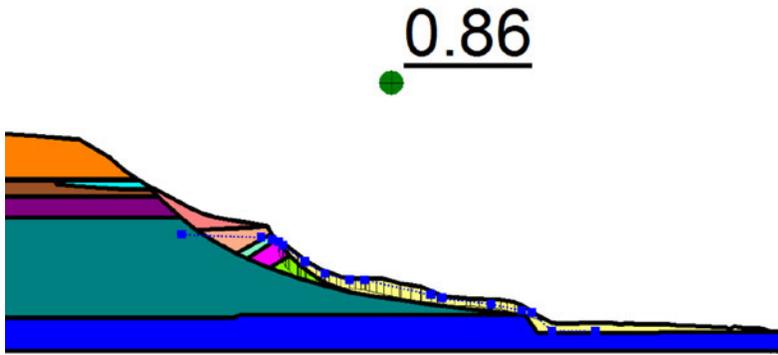
At the estimated high water level, a circular surface of rupture search indicated shallow failure of the mid-slope bench that is considered to be from continuous raveling of the steep slope face. The optimized non-circular surface of rupture in Figure J.2-7f has an unstable factor of safety and corresponds approximately to non-circular surface of rupture 1. Non-circular surface of rupture 1 before optimization is shown in Figure J.2-7g and exhibited a marginally stable factor of safety. The optimization procedure reduced the factor of safety for non-circular surface of rupture 1 by 0.18, which suggests that unstable non-circular surfaces of rupture may be near the assumed surfaces of rupture. Non-circular surfaces of rupture 2 and 3 in Figures J.2-7h and 7i have the same factor of safety, which suggests that including the M1 debris does not change the stability of the M2 slide significantly. Results are summarized in Table J.2-2.

Figure J.2-7f: Optimized non-circular surface of rupture with pre-failure strength parameters at the estimated high water level.

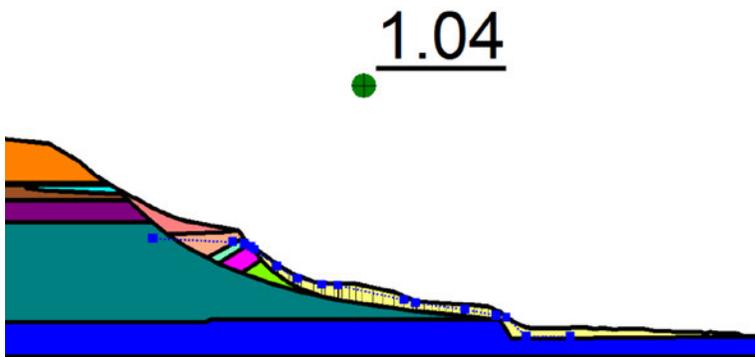
Figure J.2-7g: Non-circular surface of rupture 1 with pre-failure strength parameters at the estimated high water level.

Groundwater Level	Factor of Safety				
	Non-Circular Surface of Rupture 1	Non-Circular Surface of Rupture 2	Non-Circular Surface of Rupture 3	Optimized Non-Circular Surface of Rupture	Circular Surface of Rupture
High	1.04	1.06	1.06	0.86	0.62*
Low	1.58	1.44	1.48	0.99	0.95

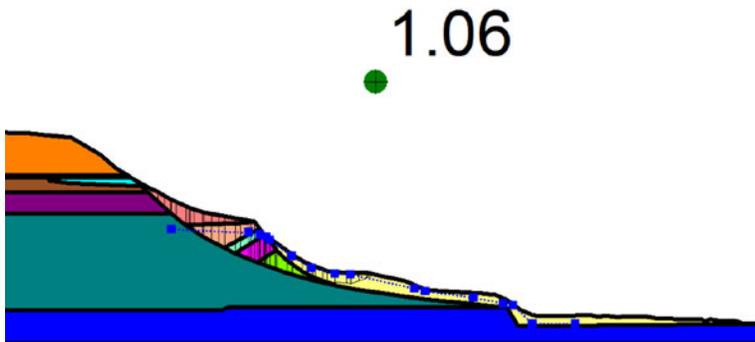
Figure J.2-7h: Non-circular surface of rupture 2 with pre-failure strength parameters at the estimated high water level.

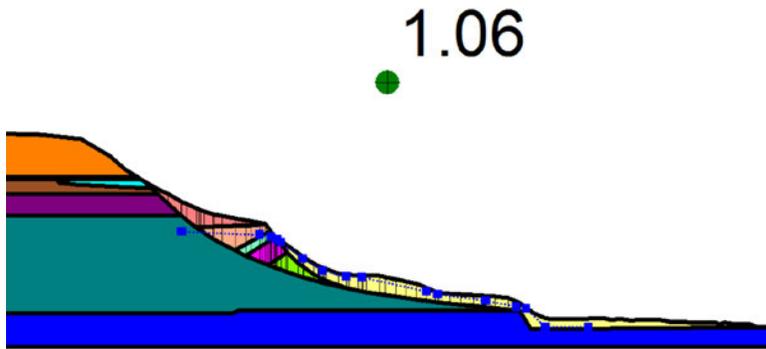
Figure J.2-7i: Non-circular surface of rupture 3 with pre-failure strength parameters at the estimated high water level.

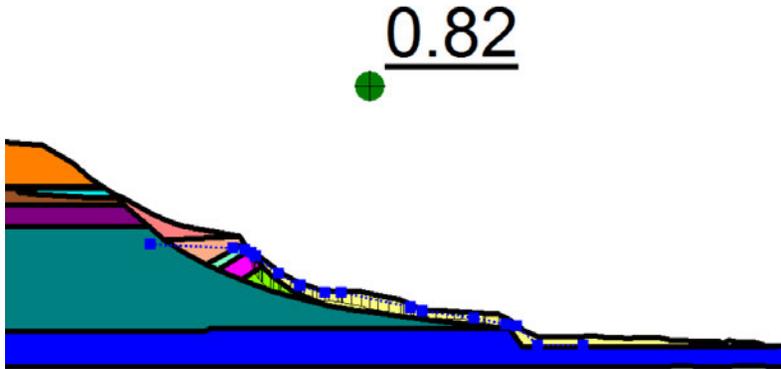
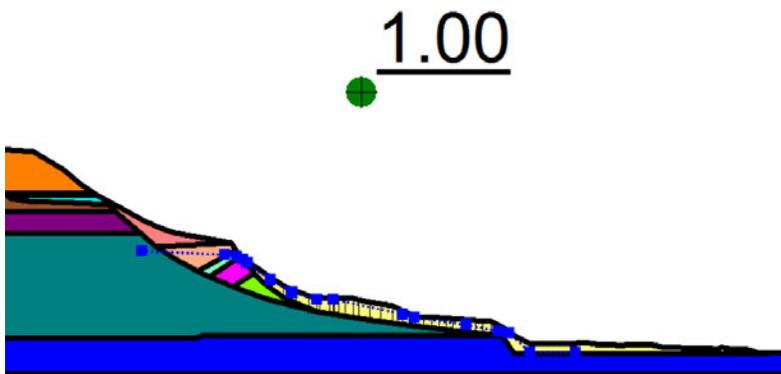
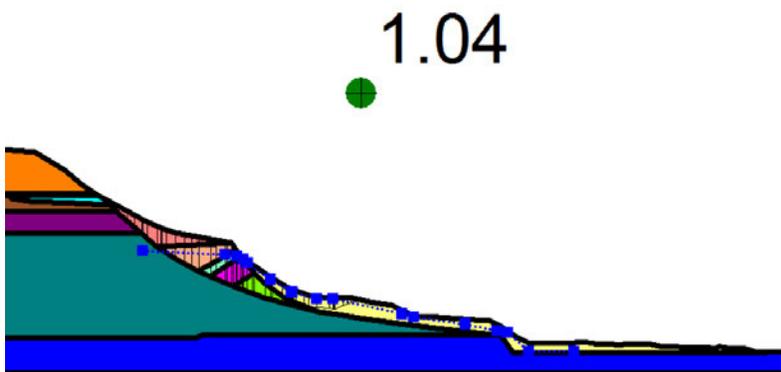
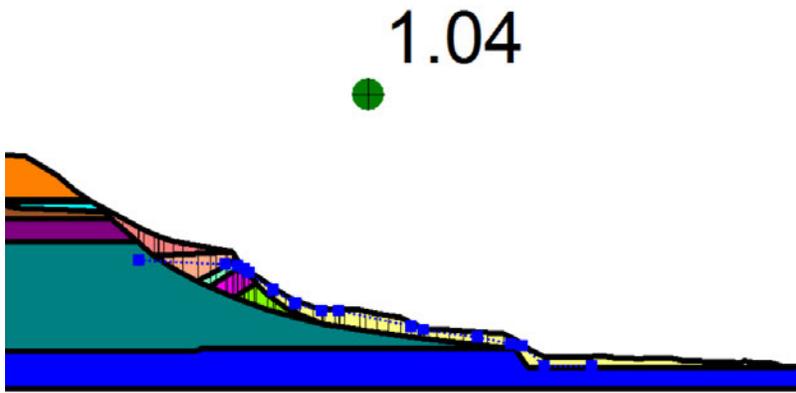
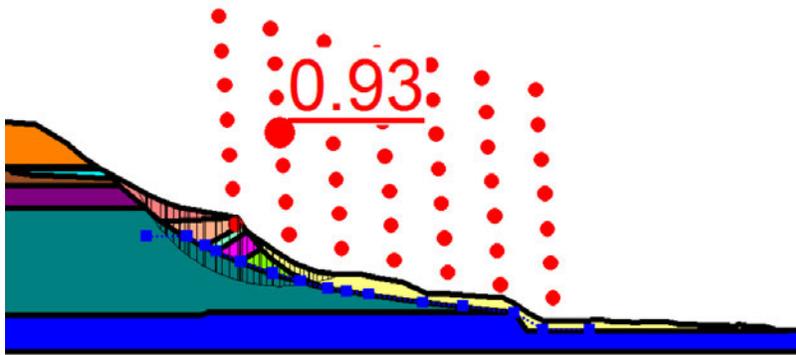
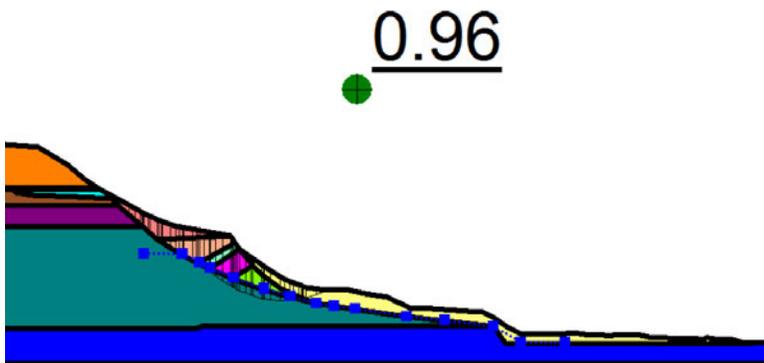
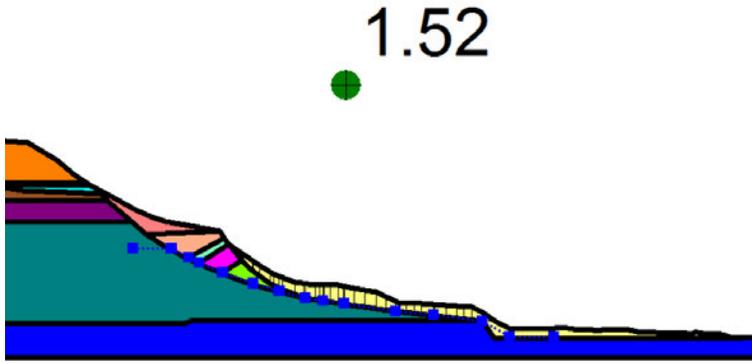
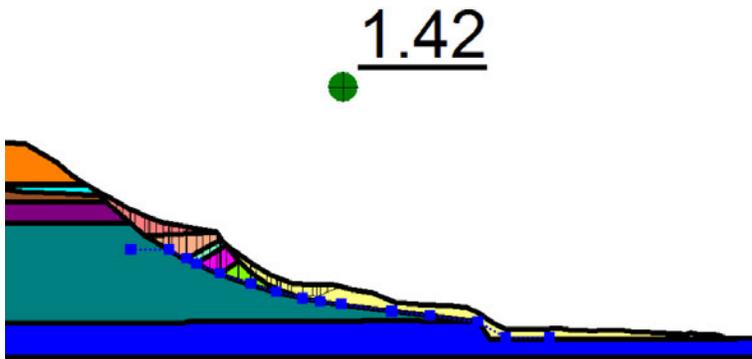
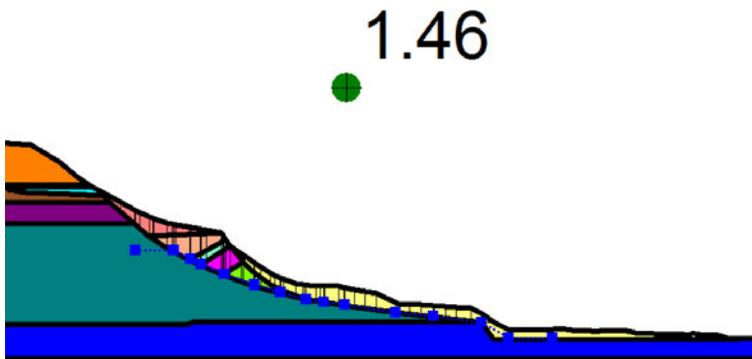
The strength and unit weight parameters provided in Table J.2-1 for the failure scenario are used in the Stage 1 –2014 SR-530 landslide analyses. The circular surfaces of rupture at the estimated high groundwater level indicate shallow failures. The optimized non-circular surface of rupture at the estimated high groundwater level shown in Figure J.2-8a corresponds approximately to non-circular surface of rupture 1 and has an unstable factor of safety of 0.82. The non-circular surfaces of rupture in Figures J.2-8b through 8d exhibited factors of safety close to those obtained using pre-failure strength parameters for the case with the high groundwater level. At the estimated low groundwater level, the deep circular failure surface in Figure J.2-8e encompasses most of the mid-slope bench and suggests a marginally stable factor of safety. The optimized non-circular surface of rupture in Figure J.2-8f again corresponds approximately to non-circular surface of rupture 2 and had a marginally stable factor of safety. The fully specified surfaces of rupture in Figures J.2-8h to 8i have stable factors of safety. The fully specified surface of rupture results obtained using the strength parameters at failure show marginal stability at the estimated high groundwater level, while the optimized non-circular failure surface at the estimated high groundwater level indicates failure when the at-failure strengths are used. Results are summarized in Table J.2-3.

Groundwater Level	Factor of Safety				
	Non-Circular Surface of Rupture 1	Non-Circular Surface of Rupture 2	Non-Circular Surface of Rupture 3	Optimized Non-Circular Surface of Rupture	Circular Surface of Rupture
High	1.00	1.04	1.04	0.82	0.59*
Low	1.52	1.42	1.46	0.96	0.93
