SUPERIOR COURT OF WASHINGTON FOR KING COUNTY

EXPERT OPINION REPORT OF

DR. MARVIN R. PYLES, Ph.D., P.E.

JUNE 30, 2016

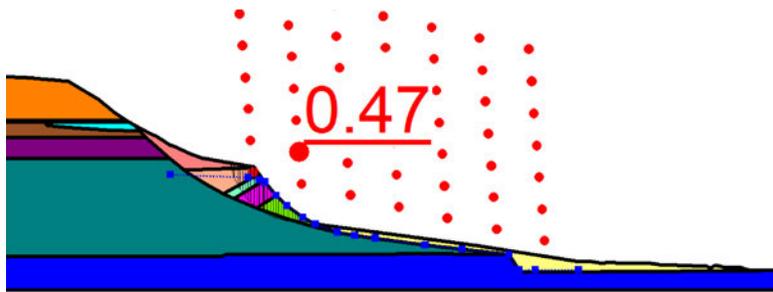
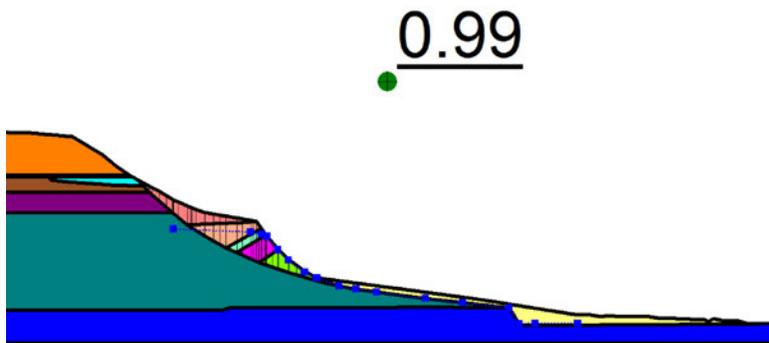
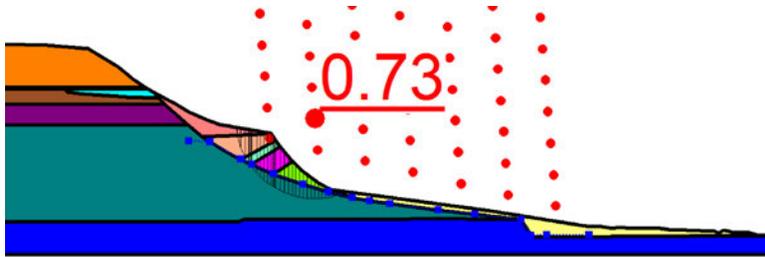
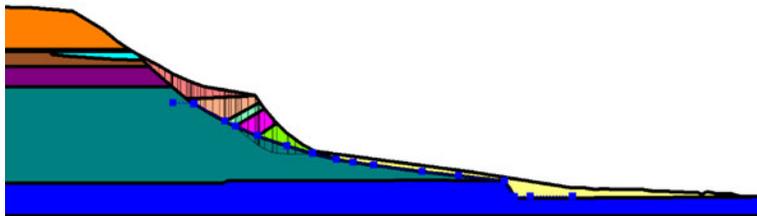
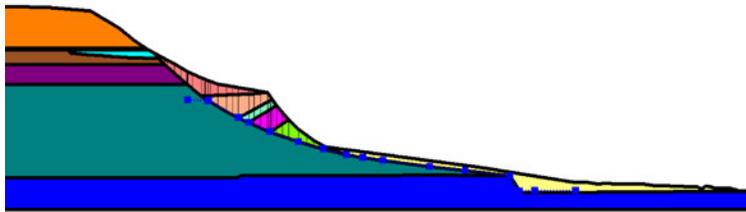
The strength and unit weight parameters at failure listed in Table J.2-1 were used in the Stage 2 analyses after the M1 debris was lowered to simulate the effects of the Stage 1 landslide movement. At the estimated high groundwater level, the critical circular surface of rupture shown in Figure J.2-9a indicates a partial failure in the mid-slope bench. Non-circular surface of rupture 2 in Figure J.2-9b exhibited a marginally stable factor of safety. The curvature of the optimized surface of rupture changed direction dramatically for the high groundwater conditions and was judged to be unrealistic, so it is not reported.

At the estimated low groundwater level, the critical circular surface of rupture penetrates into the lacustrine clay and silt unit (Figure J.2-9c). The optimized surface of rupture (shown in Figure J.2-9d) produced a lower factor of safety than the non-circular surface of rupture 2 shown in Figure J.2-9e, but the optimized surface of rupture had an unrealistic, abrupt change in curvature, so it was judged to be unreliable. Figure J.2-9d is shown only to illustrate how the optimization scheme in SlopeW can sometimes produce surfaces of rupture with unrealistic shapes.

Overall, these results suggest that the critical surface of rupture in Stage 2 likely penetrates into the lacustrine clay and silt unit. These results are summarized in Table J.2-4.

Estimated Water Level	Factor of Safety		
	Non-Circular Surface of Rupture 2	Optimized Non-Circular Surface of Rupture	Circular Surface of Rupture
High	0.99	-**	0.47*
Low	1.32	0.88**	0.73

**Judged to be unrealistic due to abrupt changes in the curvature of the surface of rupture.

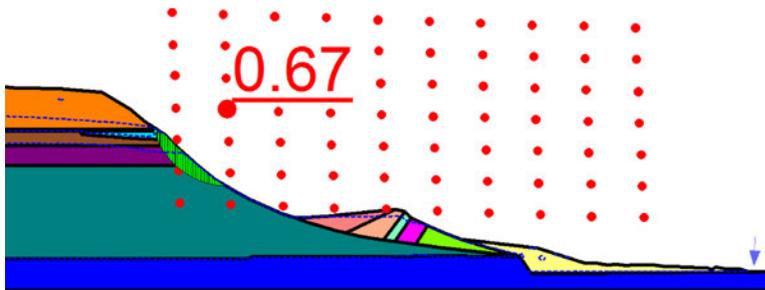
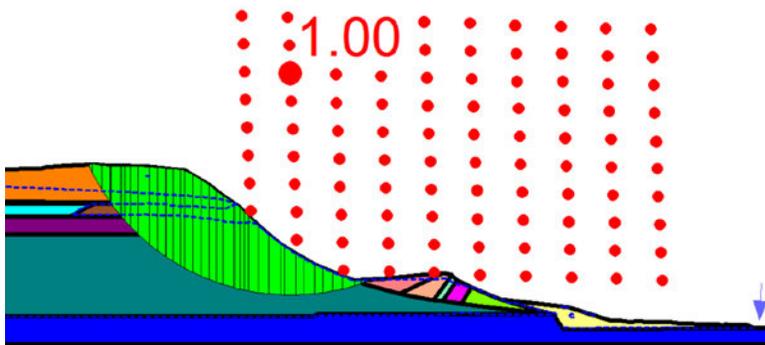
Slope stability analyses were initially performed using a fully softened friction angle for the lacustrine clay and silt unit, which is appropriate for an analysis of a first-time slide. Figures J.2-10a and 10b show the results obtained using the best estimate of the fully softened friction angle of 20° for the lacustrine clay and silt unit. A shallow circular surface of rupture is found to have the lowest calculated factor of safety. The shape and size of the circular surface of rupture that has a factor of safety of 1.0 is similar to the surface of rupture of the deep failure within Whitman Bench identified in the field.

Figure J.2-10a: Critical circular surface of rupture within the lacustrine layer using a friction angle of 20 degrees.

Figure J.2-10b: FS=1.0 circular surface of rupture within the lacustrine layer using a friction angle of 20 degrees.

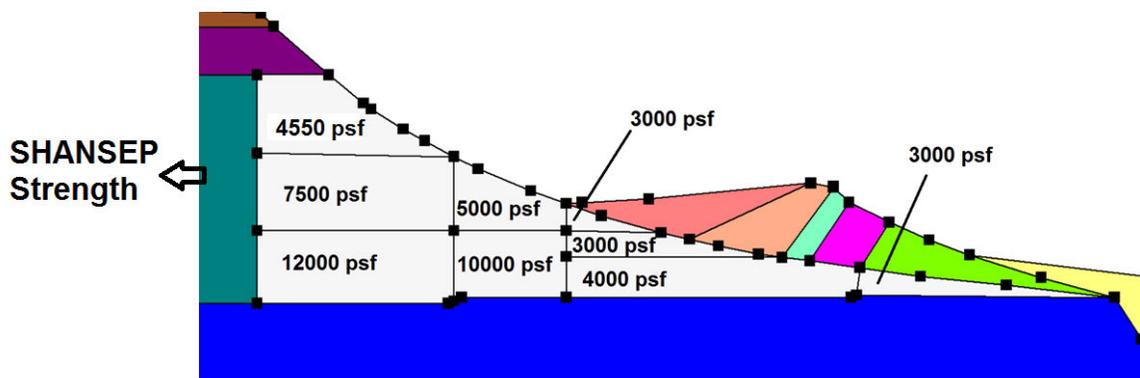
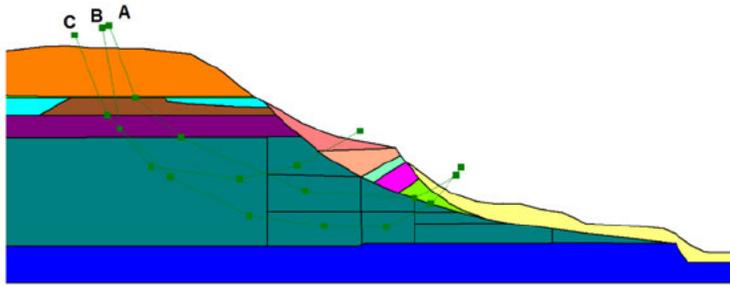
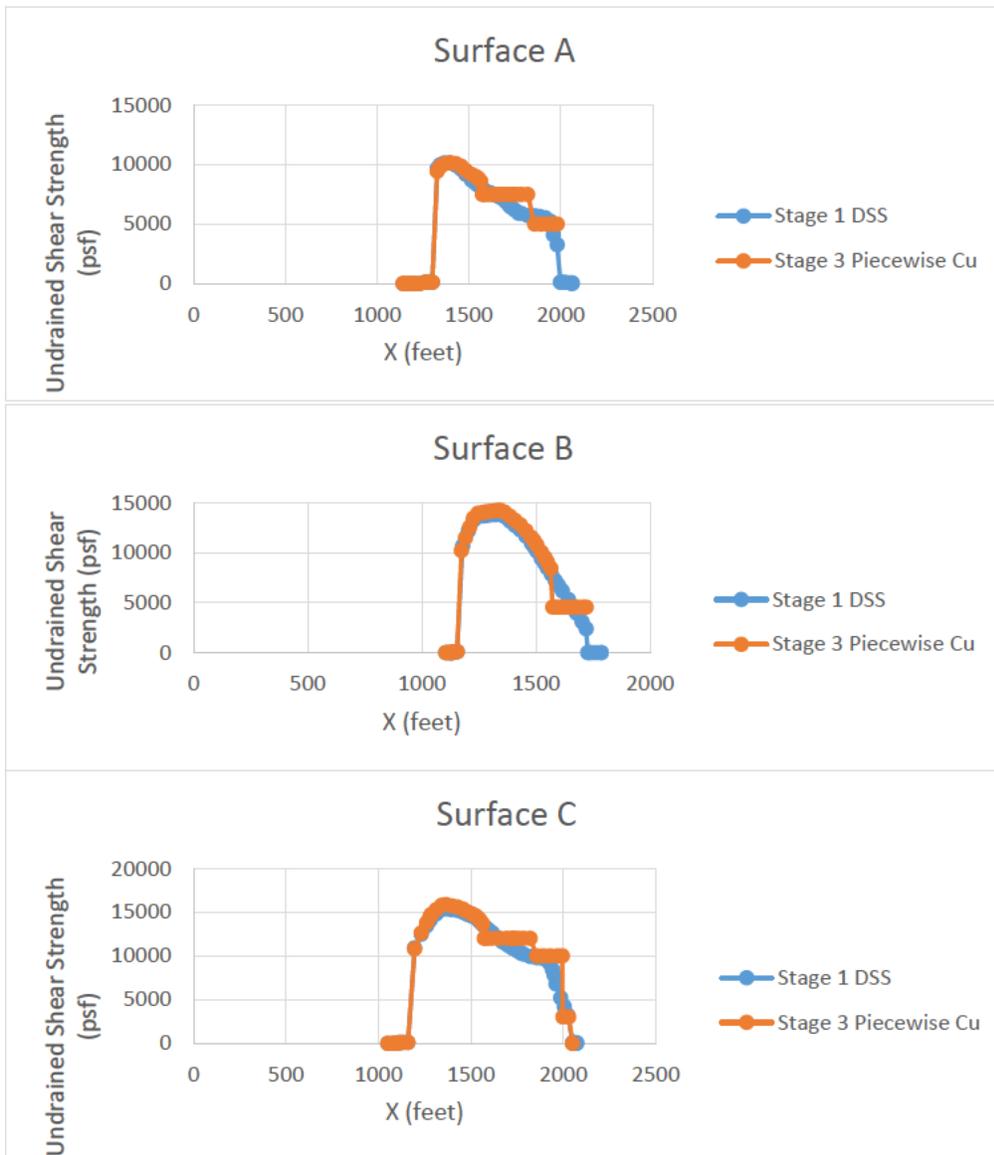
Assuming the lacustrine layer underlying the mid-slope bench in Stage 1 will fail under direct simple shear conditions in Stage 3, c_u values were estimated for different zones of the lacustrine clay and silt unit as shown in Figure J.2-11a. The remaining part of the lacustrine clay and silt unit was analyzed using SHANSEP parameters within the program SlopeW, because the vertical effective stresses do not change appreciably in the part of the lacustrine unit under Whitman Bench. The c_u values shown in Figure J.2-11a were verified by comparing the shear strengths along the 3 surfaces of rupture shown in Figure J.2-11b with the same surfaces in the Stage 1 geometry using the SHANSEP parameter $c_u/\sigma_v' = 0.35$ all throughout the lacustrine layer. Figure J.2-11c shows that the c_u values in Figure J.2-11a capture accurately the 2013 undrained shear strengths in a piecewise manner when the lacustrine layer is assumed to fail under direct simple shear conditions. The shear strength characterization in the zones shown in Figure J.2-11a overestimate the strength of the unit in these zones for the triaxial extension strength characterization and underestimate the strength of the unit in these zones for the triaxial compression strength characterization. However, the overall effect of these differences are negligible, because a large part of each surface of rupture for the FS = 1.0 case passes through the lacustrine clay and silt that is under Whitman Bench, where the vertical effective stress is unaffected by the mid-slope bench failure.

Figure J.2-11a: Estimated undrained shear strengths (c_u) for zones of the lacustrine clay and silt unit which are not under Whitman Bench. SHANSEP strength parameters are used in the lacustrine unit underneath Whitman Bench.

Figure J.2-11c: Comparison of slip surfaces A, B, and C (shown in Figure J.2-11b) for the Stage 1 geometry with $c_u/\sigma_v' = 0.35$ (direct simple shear strengths) in the lacustrine layer and the Stage 3 geometry using the zoned undrained shear strengths of Figure J.2-11a.

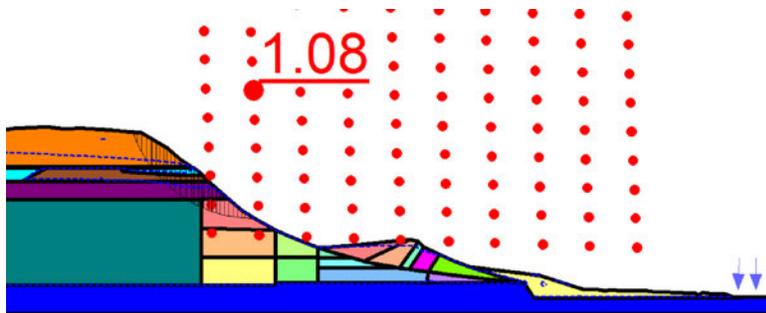
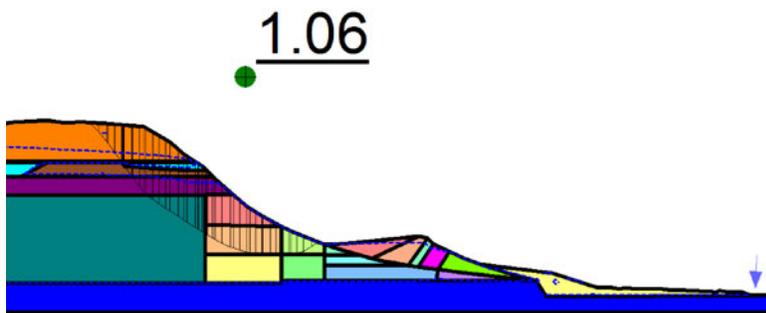
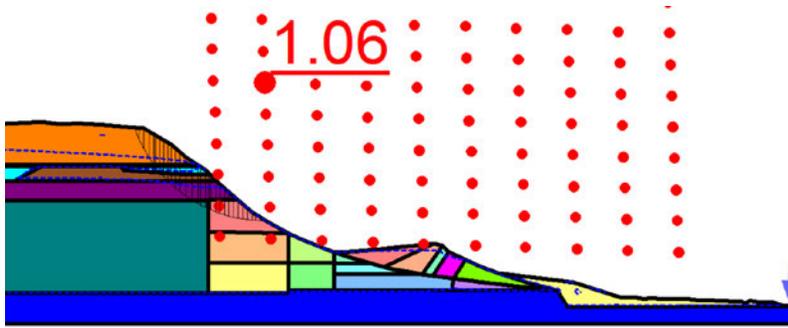
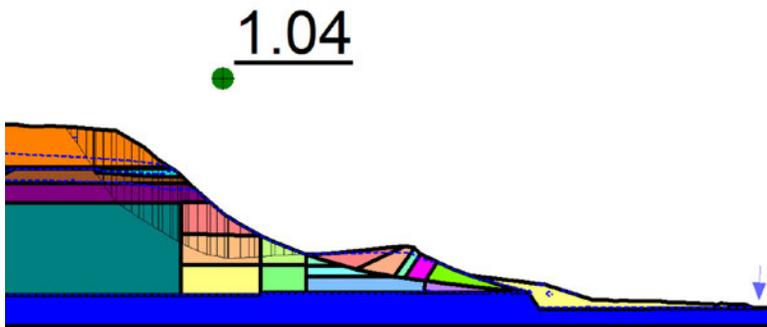
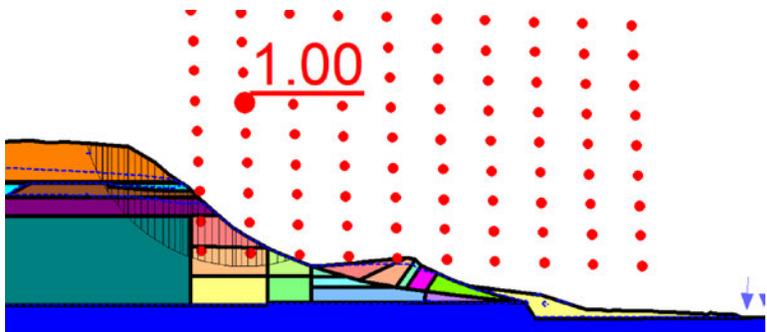
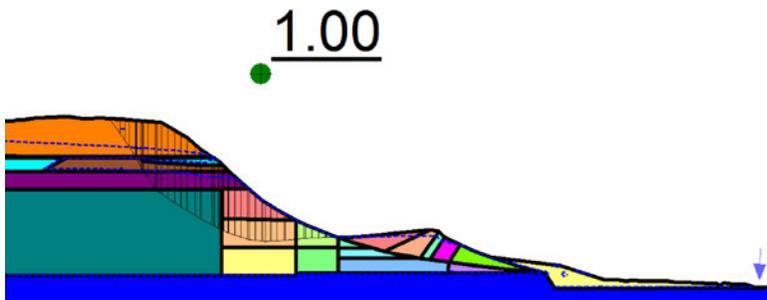
The results presented in Figures J.2-12a-f show critical circular and optimized non-circular surfaces of rupture for the Stage 3 slope stability analyses using the undrained shear strength characterization shown in Figure J.2-11a in that part of the lacustrine clay and silt unit under the slope and using the undrained shear strength parameters derived from the SHANSEP strength parameters for each shear mode in that part of the lacustrine unit under Whitman Bench. Figures J.2-12a and 12b show the results obtained with triaxial compression strength characterization under Whitman Bench. Figures J.2-12c and 12d show the results obtained with direct simple shear strength characterization under Whitman Bench. Figures J.2-12e and 12f show the results obtained with triaxial extension strength characterization under Whitman Bench.

All of the factors of safety are between 1.0 and 1.1, which indicates marginal stability for the Stage 3 slope assessment. The parts of the surfaces of rupture within the lacustrine unit constant undrained shear strength zones are nearly horizontal, which support the assumption that the surface of rupture fails under direct simple shear conditions underneath the original location of the mid-slope bench. The factors of safety for the critical circular and optimized non-circular surfaces of rupture are summarized in Table J.2-5. The deeper critical surfaces of rupture are similar to what was observed in the field.

Analysis	Drained Analysis Factor of Safety	Undrained Analysis Factor of Safety		
		$c_u/\sigma'_v = 0.31$	$c_u/\sigma'_v = 0.35$	$c_u/\sigma'_v = 0.41$
Strength Characterization	$\phi' = 20^\circ$			
Critical Circular Surface of Rupture	0.67	1.00	1.06	1.08
Optimized Non- Circular Surface of Rupture	-	1.00	1.04	1.06

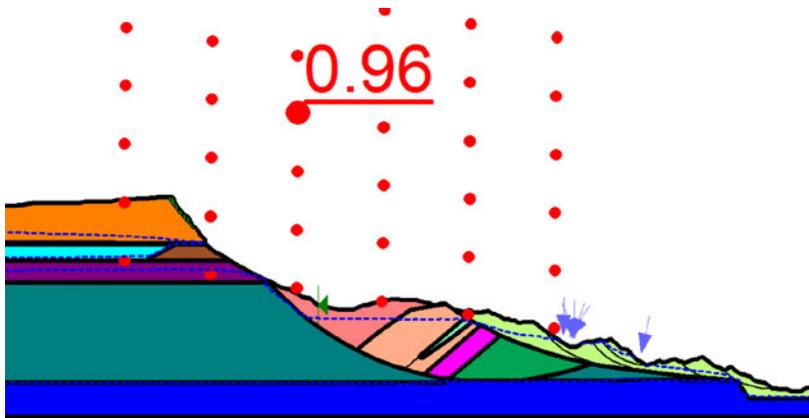
The stability of the Whitman Bench after the 2014 SR-530 landslide was analyzed based on the 2016 geometry. The pre-failure strengths of Table J.2-1 were used for the materials underneath Whitman Bench. As shown in Figure J.2-13, the critical circular surface of rupture indicates a marginally stable shallow failure along the southeastern slope face of the recessional sand and gravel layer. These results are consistent with field observations of continuous raveling failures on the face of the slope following the 2014 landslide. As with the Stage 3 analysis of the 2014 landslide, SeepW was used to calculate the pore water pressures within Whitman Bench.

Figure J.2-13: Critical circular surface of rupture for the 2016 Whitman Bench geometry. A shallow surface of rupture can be seen on the slope face of the recessional sand layer.

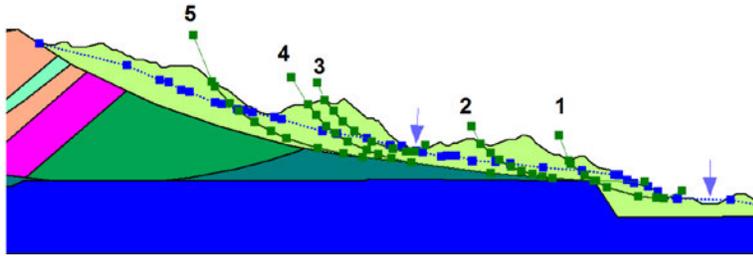
Back-analyses of two known failures and three partial ground movements within the slide mass in 2016 were performed using the slide debris geometry shown in Figure J.2-14. Five fully specified non-circular surfaces of rupture that were known to slide partially or to fail are shown with the groundwater level estimated from observations of surficial ponding in the debris at that time. Surfaces 1 and 3 (which are shown in Figure J.2-14) failed in 2016, and surfaces 2, 4, and 5 only slipped partially. The stability of the highly disrupted M2 slide debris is back-analyzed assuming the slide debris is one material with a unit weight of 115 pcf, a friction angle of 26

degrees, and a cohesion of 100 psf. Marginally stable factors of safety between 0.9 and 1.0 are calculated for surfaces of rupture 1 and 3, which is consistent with the field observations (e.g., inclinometer data) of these slide masses failing completely in 2016. The factors of safety calculated for the other three surfaces are above 1.1, which suggests that these potential slide masses were significantly more stable than the failed surfaces of rupture 1 and 3. The calculated factors of safety for surfaces of ruptures 2, 4, and 5 are sufficiently high wherein the observed ground movements would have likely been due to creep movements or a result of shallow failures in the vicinity of these slopes that reduced their stability. These results are summarized in Table J.2-6.

Figure J.2-14: Fully specified, non-circular slip surfaces analyzed in the 2016 slide debris.

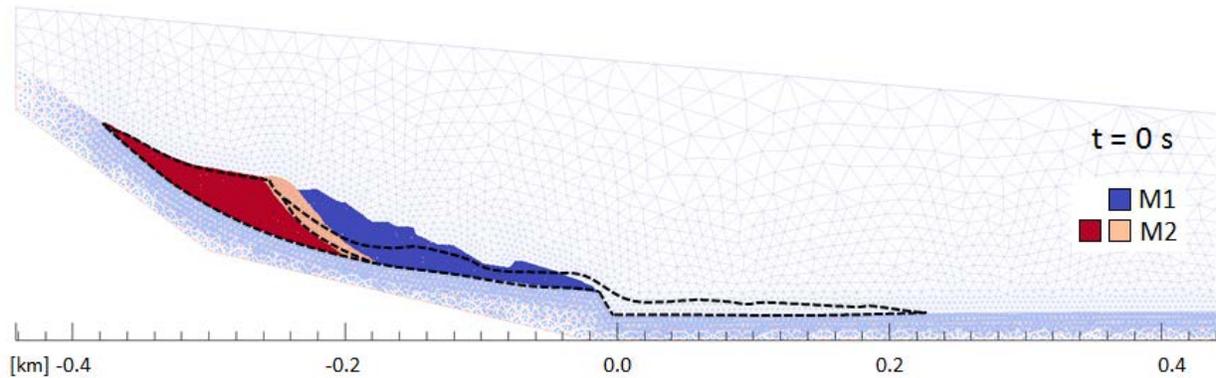
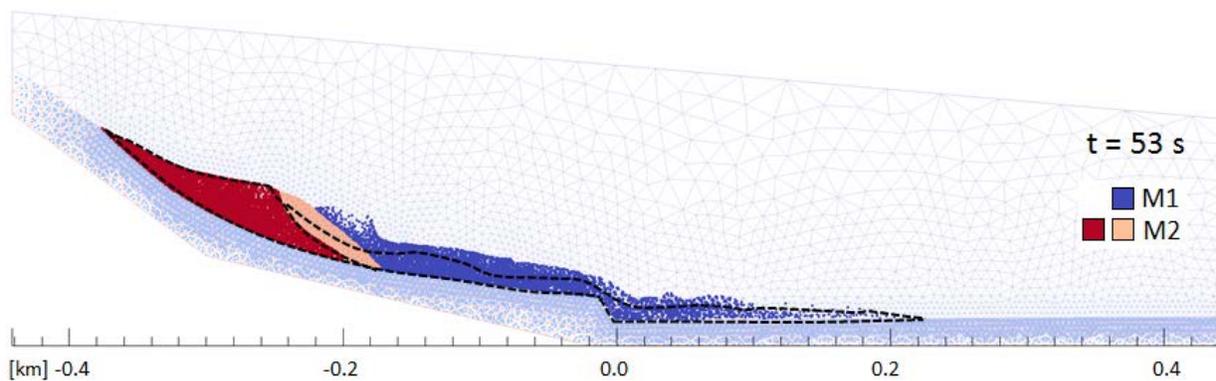
Figure K-5 (a) shows the initial distribution of the material points, whereas Figure K-5 (b) shows the final distribution of the material points at $t = 53$ seconds when the movement of the material points became small. The calculated debris field is higher than what was observed in the field, because these simulations are for plane strain conditions; whereas in the field, the debris displacement has a 3D aspect that enables material to move out of the cross section that was drawn down its middle. Additionally, a refined mesh would be necessary to capture the height of the debris field more accurately, but this would have led to excessive computational time.

Figure K-5. (a) Initial distribution of the material points ($t=0$ s), and (b) final distribution of the material points ($t=53$ s) for the 2006 Hazel landslide runout. The observed final topography of the 2006 Hazel slide runout is indicated with a dashed line.

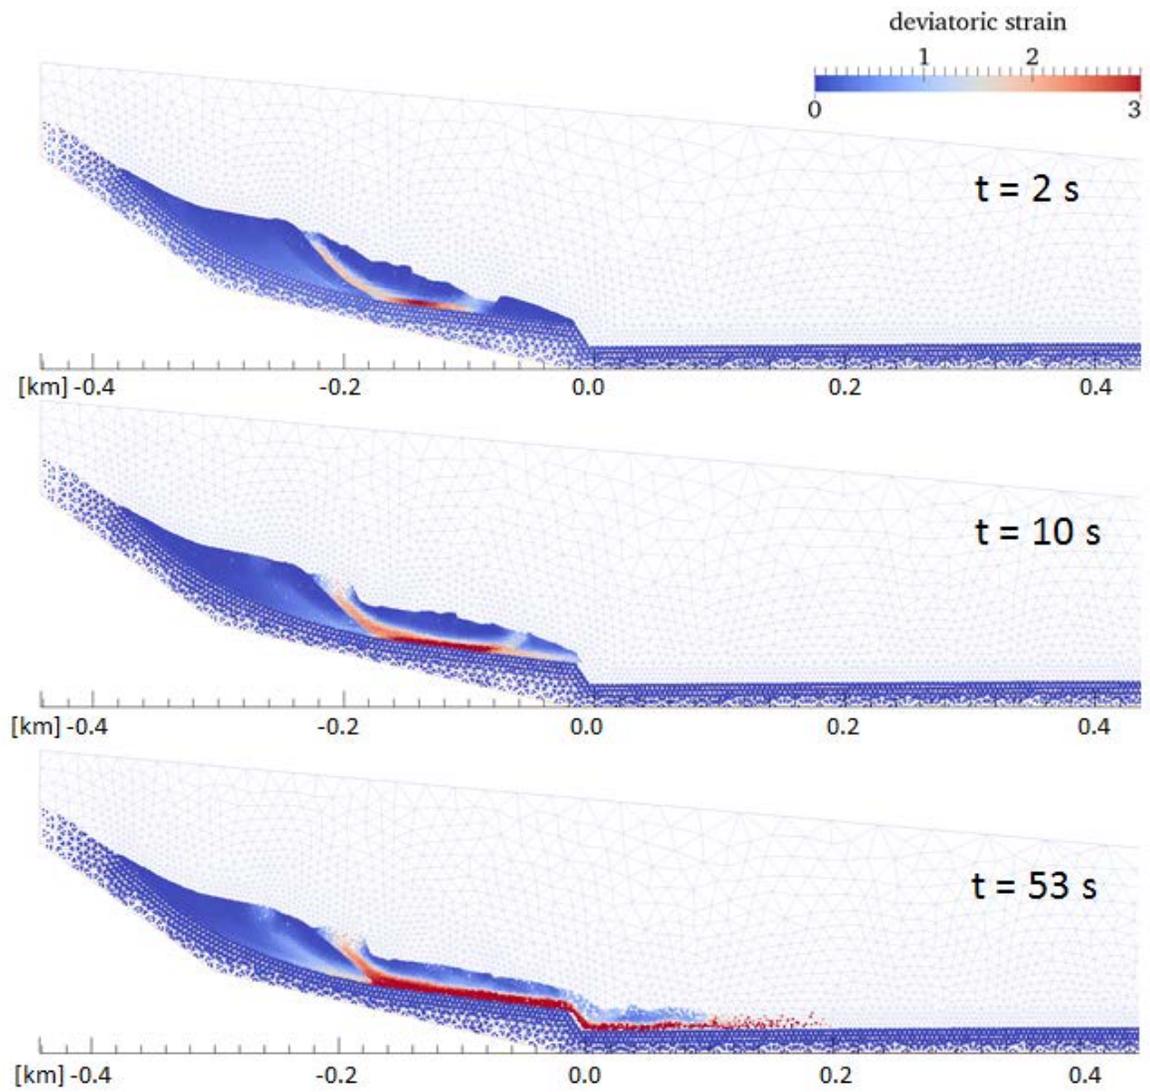
The evolution of shear strain, which is shown in Figure K-6, indicates that different stages can be distinguished during the motion. Initially, the upper and center part of M1 is mobilized along a shear band. Then, this part pushes the toe of M1. Finally, the lower part of M2 also slides. However, the movement of M2 is limited, as observed in the field. The simulated extent of M1 movement matches with the field observation, which is shown by the dotted line in Figure K-5 (b).

Figure K-6. Evolution of shear strain at 3 different moments during the 2006 Hazel landslide runout.

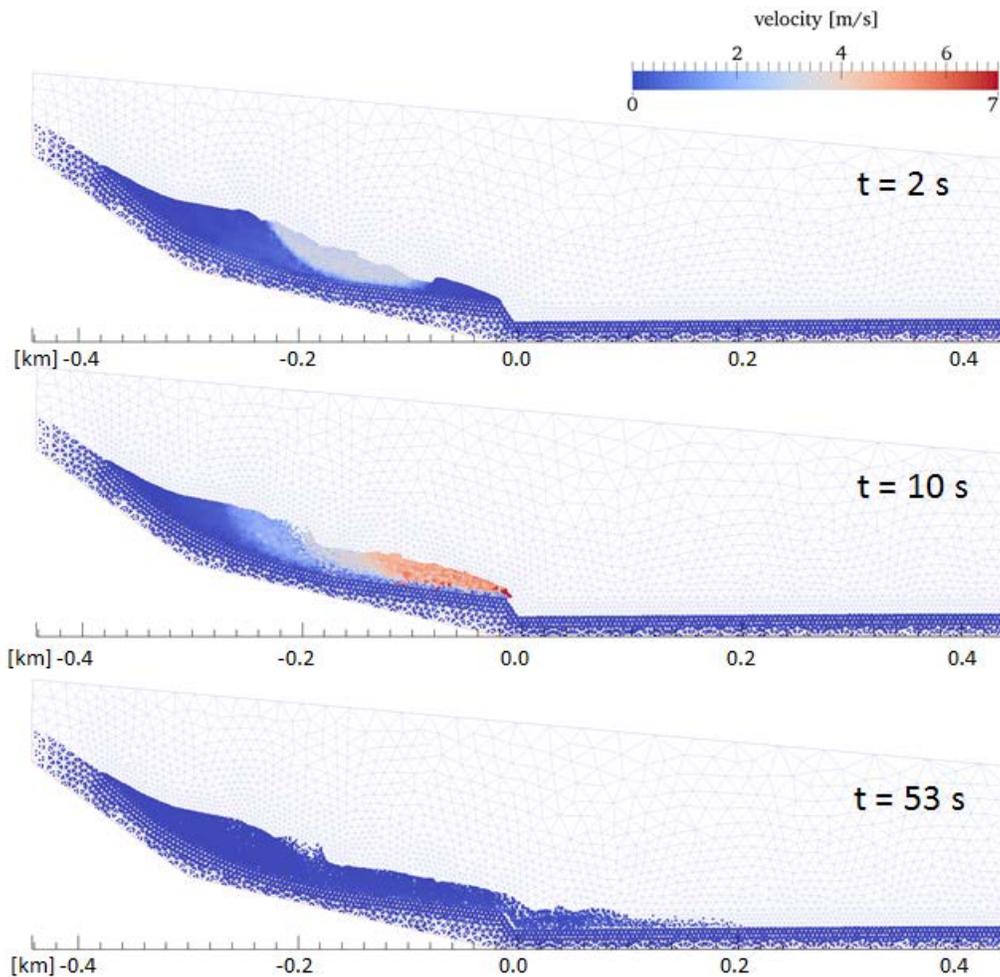
The velocity field at three different times ($t = 2, 10$ and 53 seconds) is presented in Figure K-7. The maximum velocity is approximately 7 m/s.

Figure K-7. Kinematics of the 2006 Hazel landslide runout. Velocity field at 3 different moments.

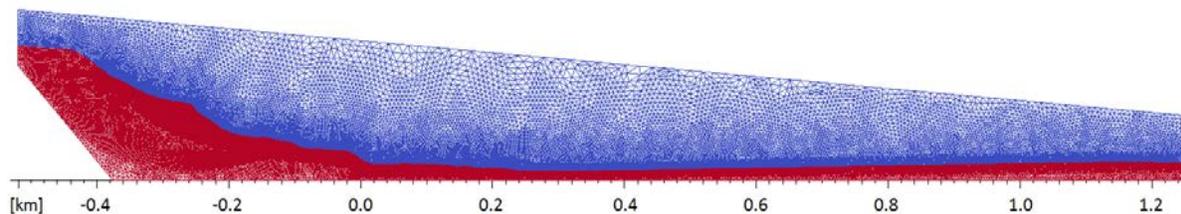
As was done in the previous runout analysis, the computational mesh of the plane strain SR-530 landslide is formed by linear tetrahedral elements. The thickness of model is one element and out-of-plane deformation is restricted to ensure plane strain conditions. The mesh is refined and made homogeneous in the region where the mobilized mass will move to optimize the computational time and to obtain more accurate results. The minimum edge of the elements is 3 m. A general view of the mesh is shown in Figure K-8. Note that elements indicated in red color are initially fully filled with material, while elements in blue are initially empty.

Figure K-8. General view of the computational mesh of the 2014 SR-530 landslide model with the 2006 debris field. Elements in red indicate that initially are fully filled with material, while elements in blue are initially empty.

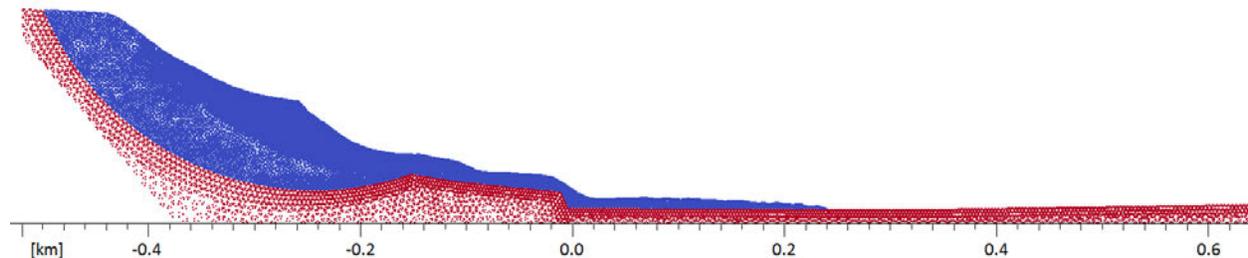
Initially 4 material points are distributed within each element and are initially located at the corresponding integration points of a four-point Gaussian quadrature. Figure K-9 shows the initial location of the material points in the slope. This model has 49,674 elements and 98,448 material points.

Figure K-9. Initial distribution of the material points in the 2014 SR-530 landslide model with the 2006 debris field. Materials located above the contact surface are indicated in blue, while material points below the contact surface are in red.

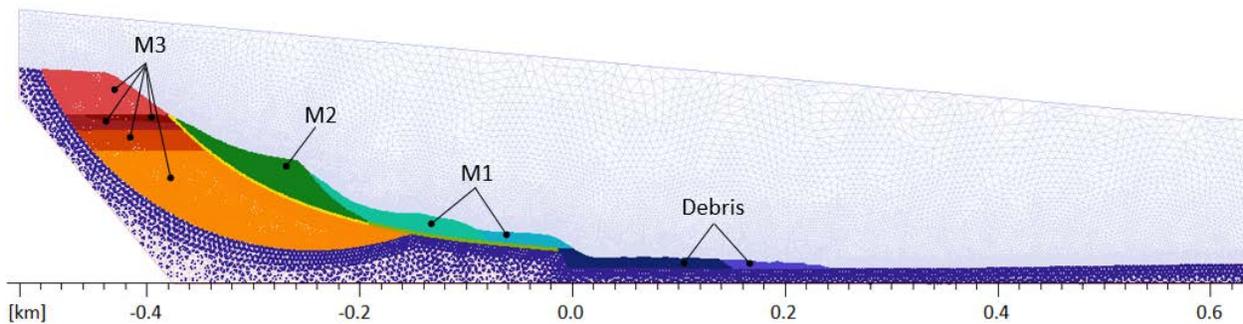
A geometry and stratigraphy adopted in the MPM runout analyses of the 2014 SR-530 landslide is based on Figure J-1 of Appendix J as shown in Figure K-10, which is in turn based on the available pre-2014 landslide LiDAR and topographic data. In addition to the M1 and M2 slide masses modeled in the 2006 Hazel landslide, the M3 slide mass is added because field observations indicated this mass displaced which is consistent with the slope failure initiation analyses presented in Appendix J. The 2006 debris field material that was deposited below the toe of the surface of rupture of the landslide during the 2006 Hazel landslide is modelled at the bottom of the slope between the toe of the surface of rupture and the north edge of the North Fork of the Stillaguamish River.

Figure K-10. Initial location of M1, M2, M3 and debris material in the 2014 SR-530 landslide model with the 2006 debris field.

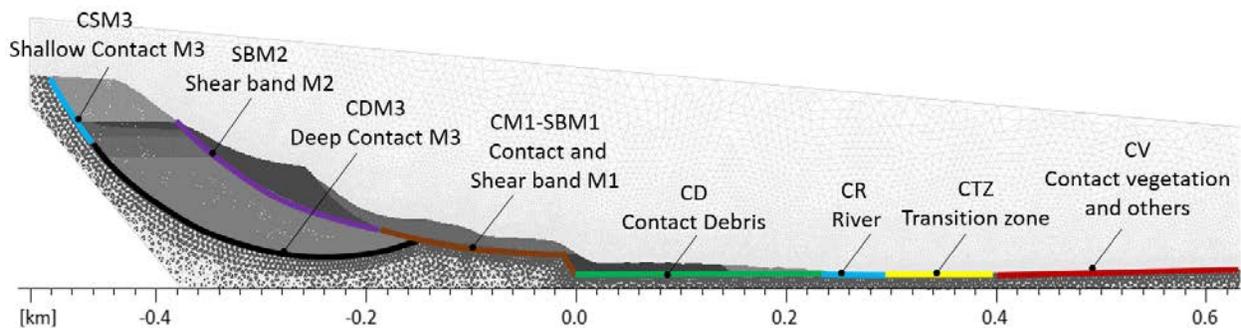
Similar to the 2006 Hazel landslide runout analysis, the 2014 SR-530 sliding masses displace over predefined contact slip surfaces in these analyses. The surface of rupture contour shown in Figure K-11 is maintained fixed during the calculation, which means that the material below the contact surface cannot be eroded. The contact is divided into different sections to simulate changes in lithology and surface type. In addition, to perform the two stages of the runout, the initial contact between M1/M2 and M3 has been simulated by means a shear band of two elements thick material (SBM1 and SBM2). This contact cannot be a fixed surface since M1, M2, and M3 all slide independently and move relative to each other. The saturated unit weight of the shear band material is 18.05 kN/m³.

The shear band strength under M2 (the purple section in Figure K-11, SBM2) and the contact and shear band strength under M1 (the brown section in Figure K-11, SBM1) are varied as either 50 kPa or 25 kPa. These values are considered to represent the possible degrees of strength softening along the sliding plane during the slide mobilization of M1 and M2.

Figure K-11. Zones of the contact surface (C) and shear band (SB) in the 2014 SR-530 landslide model with the 2006 debris field.

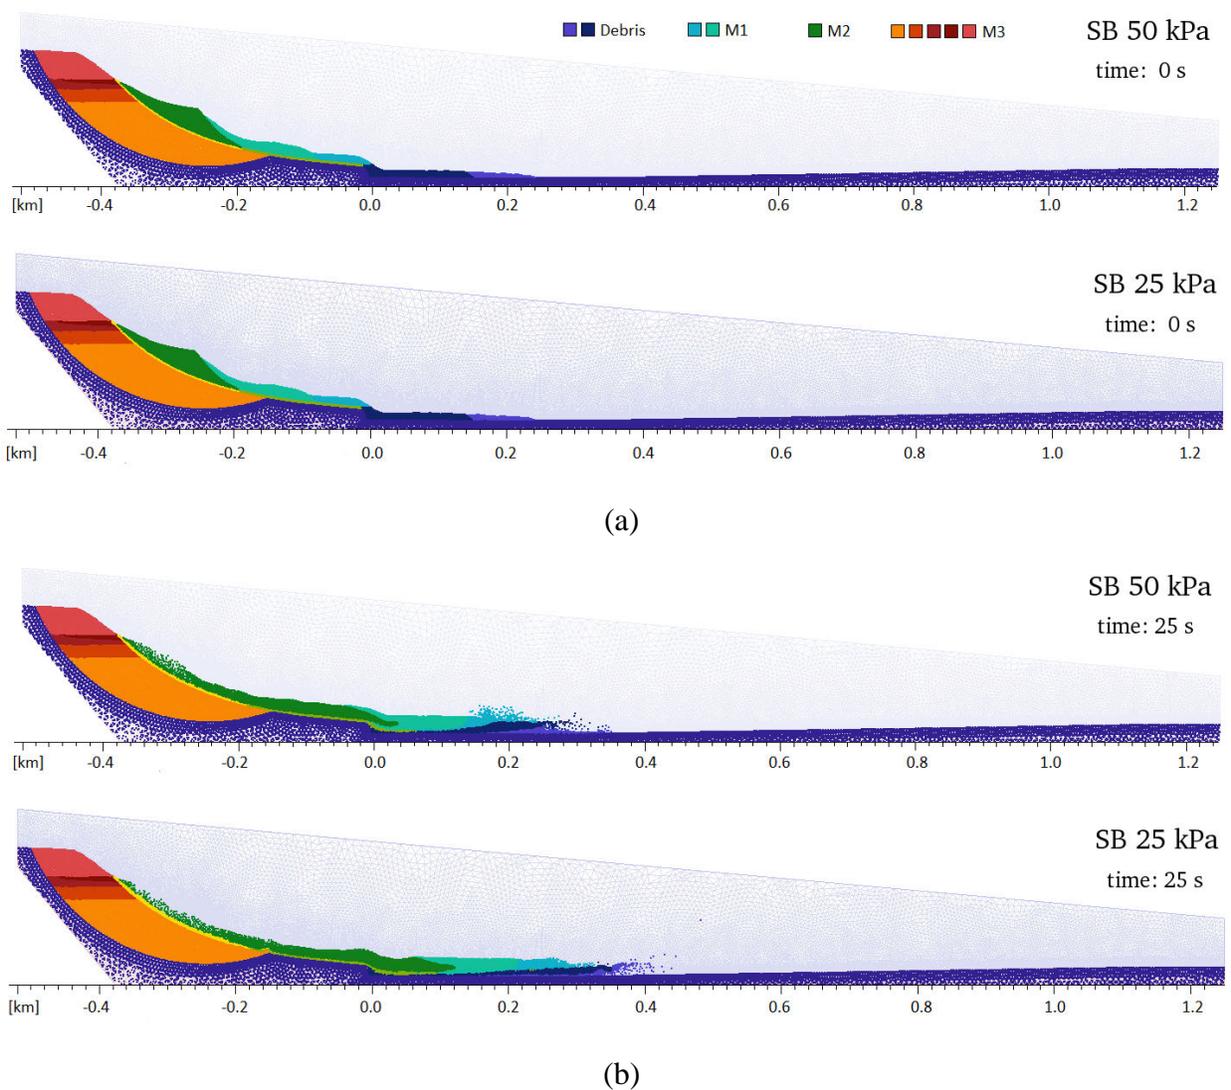
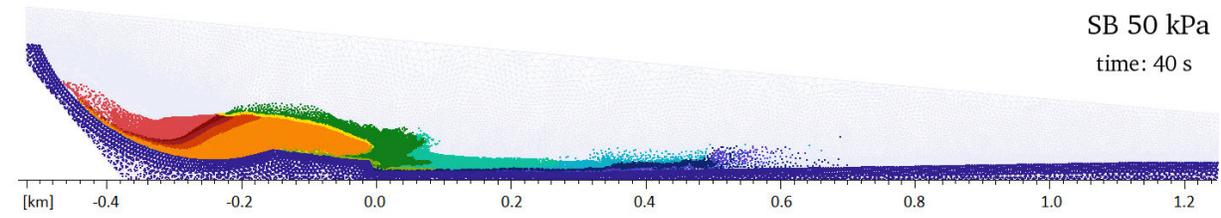
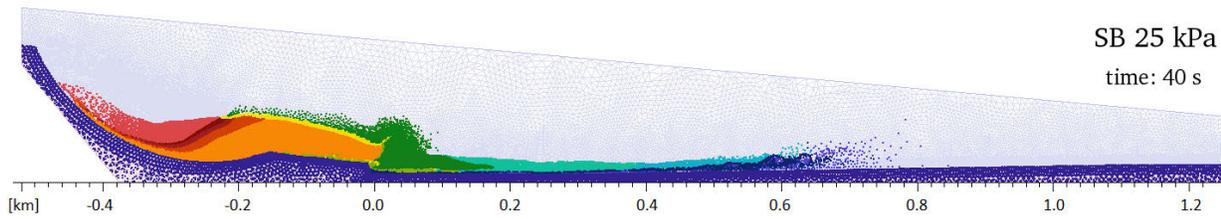
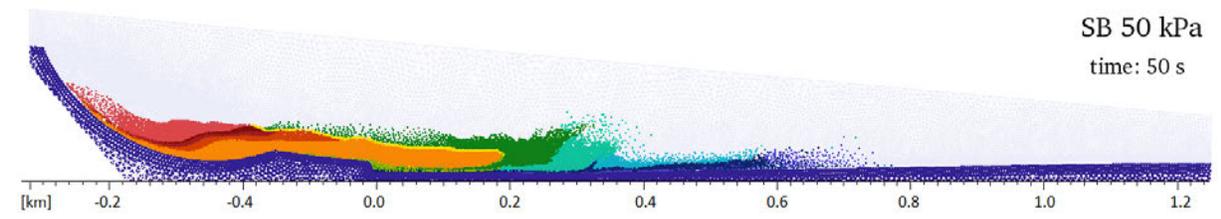
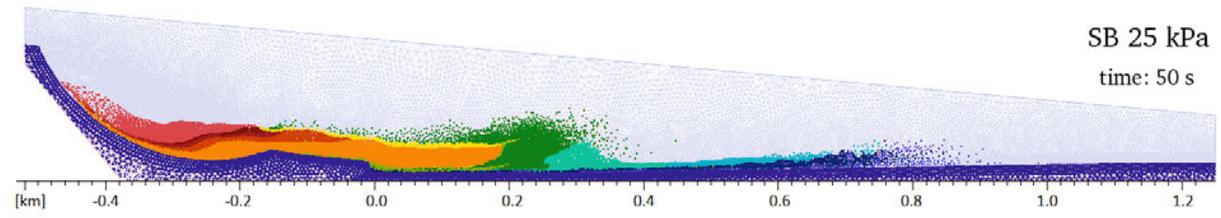
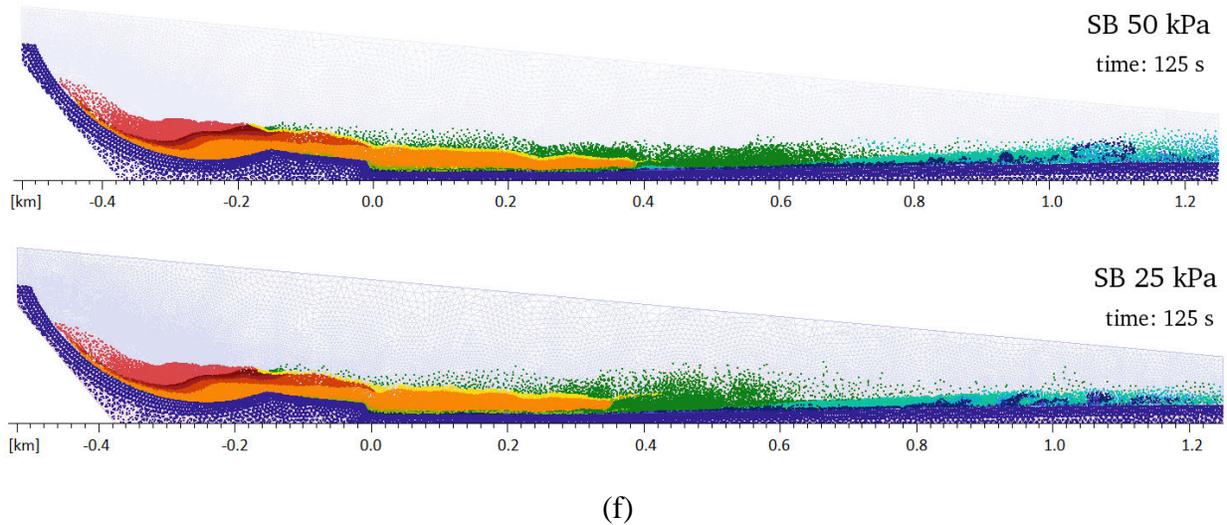
Figure K-12 shows the runout behavior at different times for the two cases of different adhesion and shear band strengths under M1 and M2 (i.e., 50 kPa and 25 kPa cases). From the results, the runout distances of the different units are evaluated and the evaluated values are compared to the field observation in Table K-4. The temporal behavior of each unit is different. For example, the movements of M1 and M2 prior to the initiation of M3 at $t = 25$ seconds are different and more movement of M1/M2 is observed when the adhesion and shear band strengths reduces from 50 kPa to 25 kPa. After M3 initiation, M1/M2 are pushed by M3 and the runout distances of M1/M2 increase. The position of the leading edge of M3 varies between 150 m and 190 m from the origin (the river location in 2006). The computed positions are similar to those observed in the field.

Figure K-12. MPM results of the 2014 SR-530 landslide model with the 2006 debris field considering different adhesions in the shear band (SBM1 and SBM2): 50 and 25 kPa. (a) $t = 0$ s, (b) $t = 25$ s, (c) $t = 40$ s, (d) $t = 50$ s, (e) $t = 60$ s, (f) $t = 125$ s.

The MPM model that was calibrated to capture the observed distance of the 2006 Hazel landslide runout was able to capture the general characteristics and runout distance of the 2014 SR-530 landslide. The results of the parametric MPM study of the 2006 Hazel landslide indicated that its observed runout is best captured when the undrained shear strength and adhesion along the surface of rupture are for slide masses of the size of M1 or M2 should be 50 kPa. Accordingly, this undrained shear strength value was used for M1 and M2 in the 2014 runout analyses. Likewise, the estimated undrained shear strength of the fully mobilized M3 slide mass was similarly reduced to a value of 100 kPa, which was judged to be appropriate for its larger size (and hence larger initial effective stresses, etc.). As suggested by the field evidence and seismic signal analysis, the M3 slide mass was released 25 seconds after the 2014 SR-530 landslide commenced. The calculated runout distance of the 2014 SR-530 landslide is captured well with these analyses, which are in turn consistent with the 2006 Hazel landslide analyses that captured its observed behavior well.

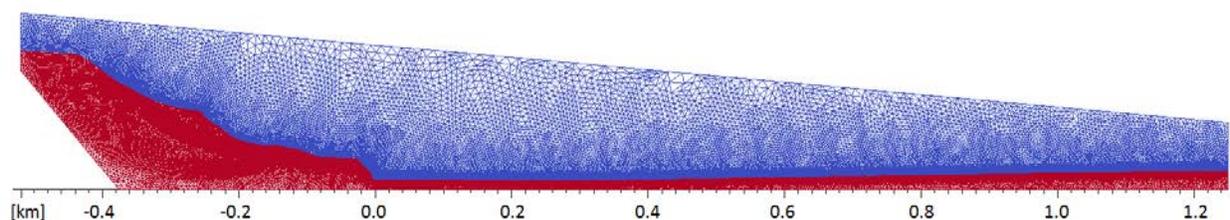
The previously calibrated MPM model is redeveloped without the 2006 debris field material below the toe of the surface of rupture of the 2014 SR-530 landslide. The North Fork of the Stillaguamish River is repositioned at its position before the 2006 Hazel landslide. Figure K-13 shows the computer mesh, whereas Figure K-14 shows the initial distribution of material points. There are no material points at locations where the debris field material existed in the previous case, because it has been removed for these analyses.

Figure K-13. General view of the computational mesh of the hypothetical 2014 SR-530 landslide model without the 2006 debris field. Elements in red indicate that initially are fully filled with material, while elements in blue are initially empty.

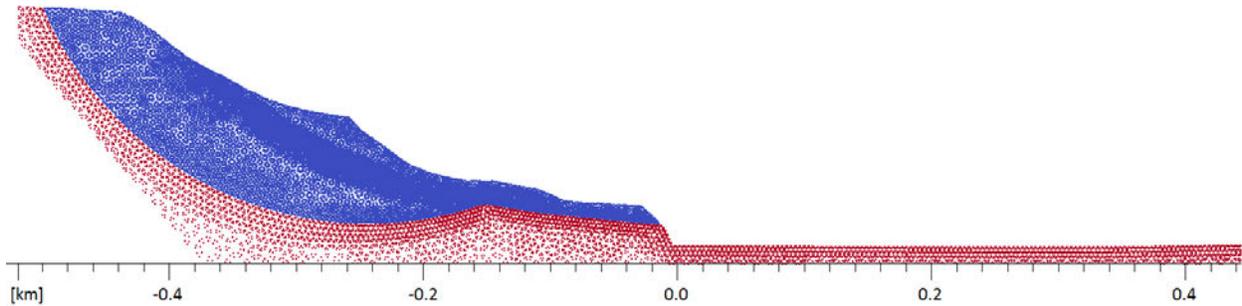
Figure K-14. Initial distribution of the material points in the hypothetical 2014 SR-530 landslide model without the 2006 debris field in place. Materials located above the contact surface are indicated in blue, while material points below the contact surface are in red.

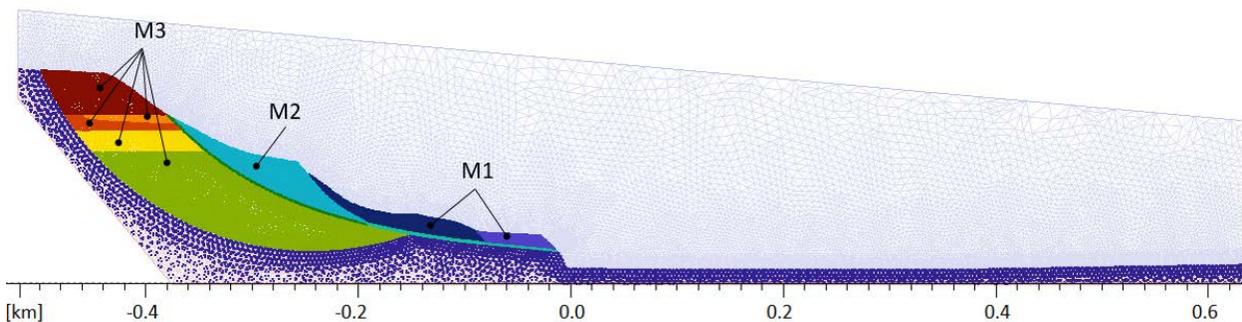
Figure K-15 shows the initial locations of M1, M2, and M3. There is no debris field located below the toe of M1. The undrained shear strengths of M1, M2, and M3 as well as the adhesion and shear band strengths below M1, M2 and M3 are exactly the same as used in the previous runout analysis of the 2014 SR-530 landslide.

Figure K-15. Initial location of M1, M2, M3 in the hypothetical 2014 SR-530 landslide model without the 2006 debris field.

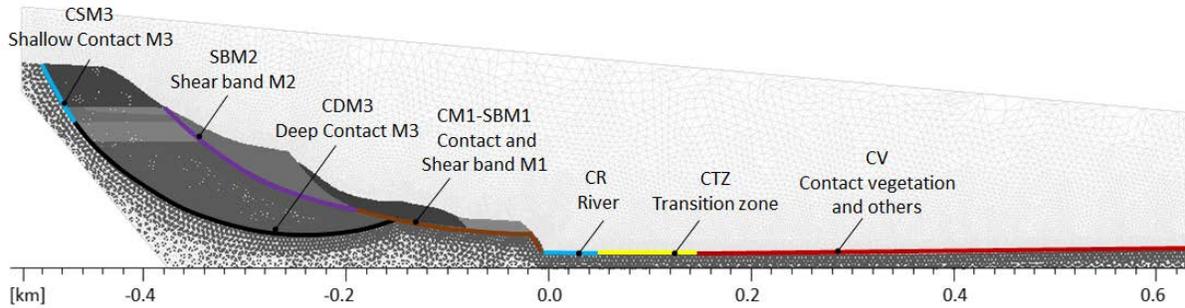
The contact surfaces and shear bands are shown in Figure K-16. The river position is placed to be the location where the river existed prior to the 2006 Hazel landslide. The adhesion values of the contact surfaces and the shear strength values of the shear bands are exactly the same as the 2014 SR-530 landslide case presented in Section 5. Again, the sensitivity of the adhesion and shear band strength values under M1 and M2 is examined by varying the values to be 50 kPa or 25 kPa.

Figure K-16. Zones of the contact surface (C) and shear band (SB) in the hypothetical 2014 SR-530 landslide model without the 2006 debris field.
