SUPERIOR COURT OF WASHINGTON FOR KING COUNTY

EXPERT OPINION REPORT OF

DR. MARVIN R. PYLES, Ph.D., P.E.

JUNE 30, 2016

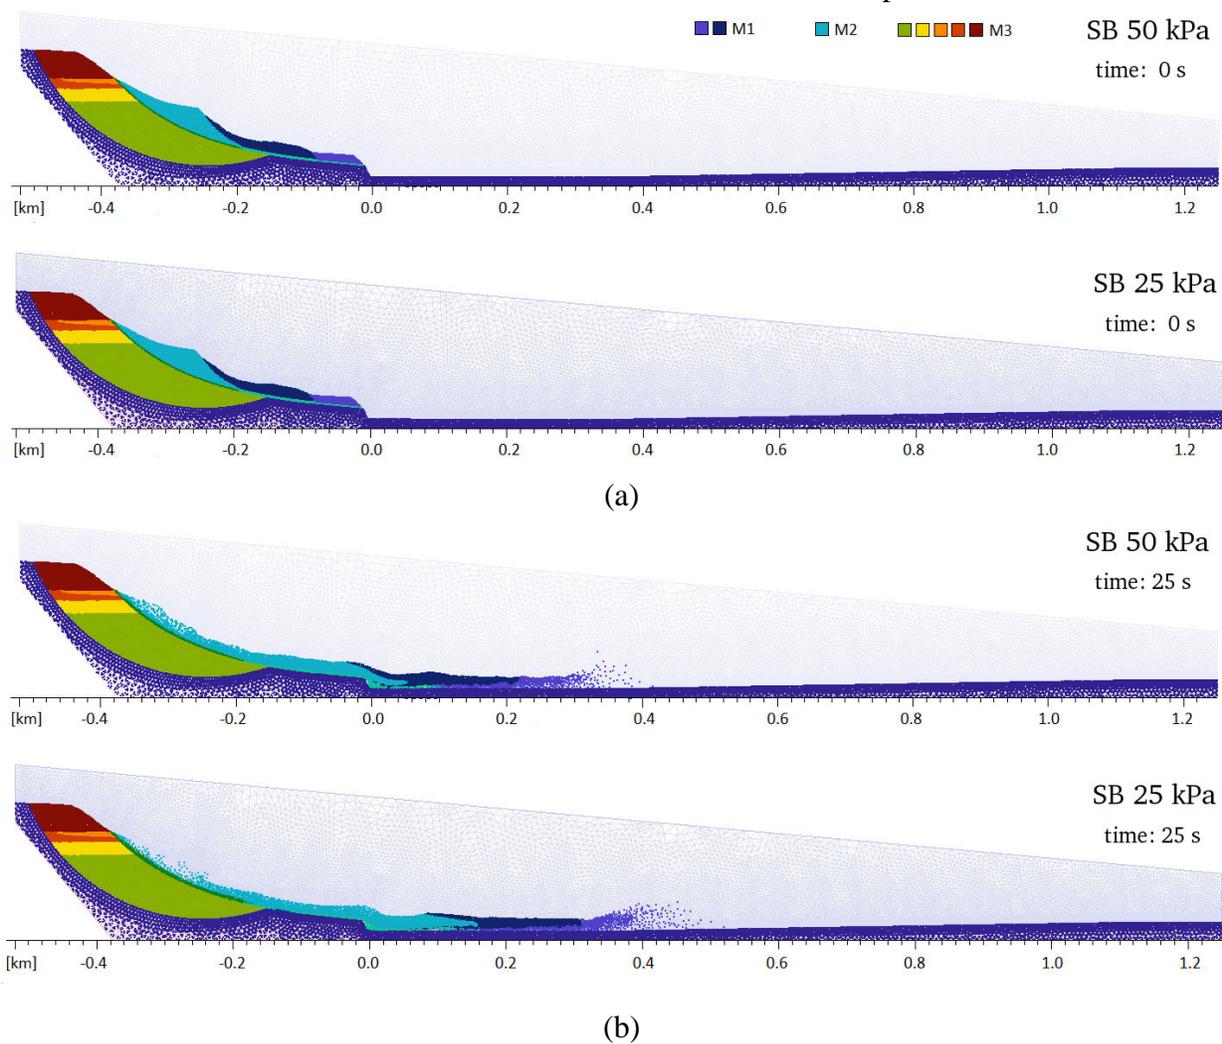
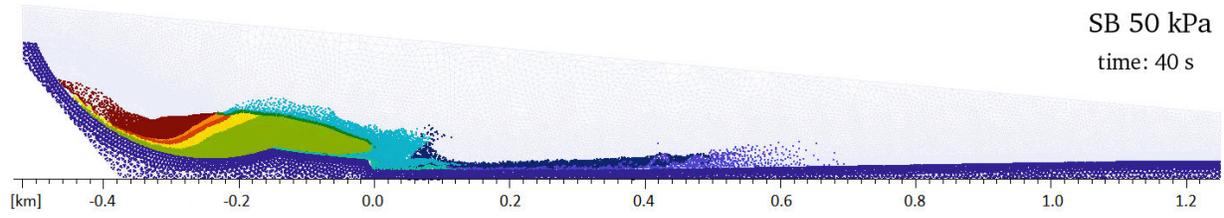
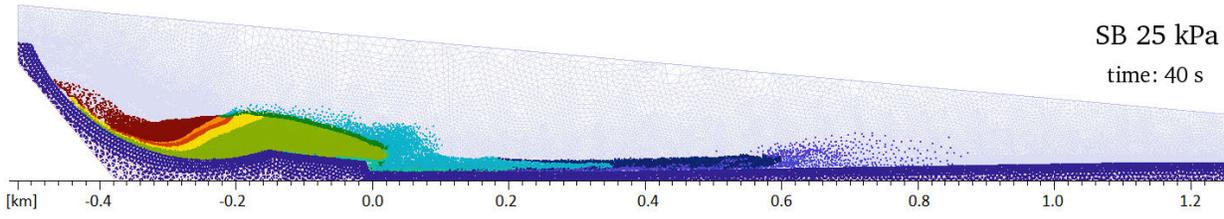
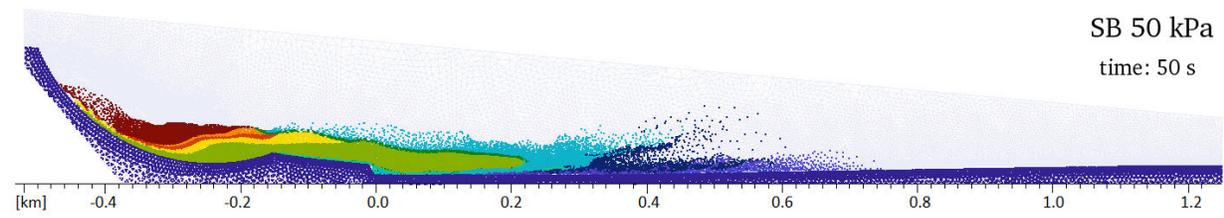
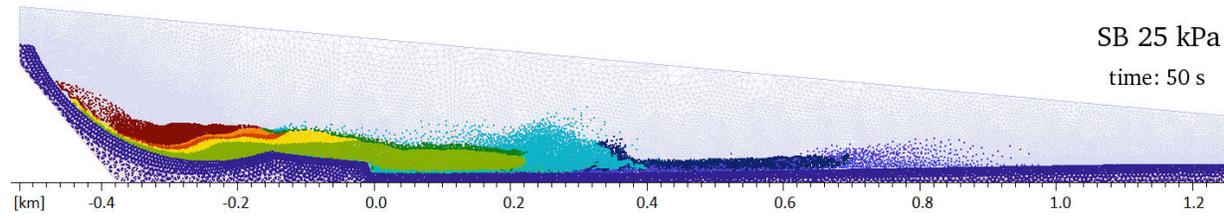
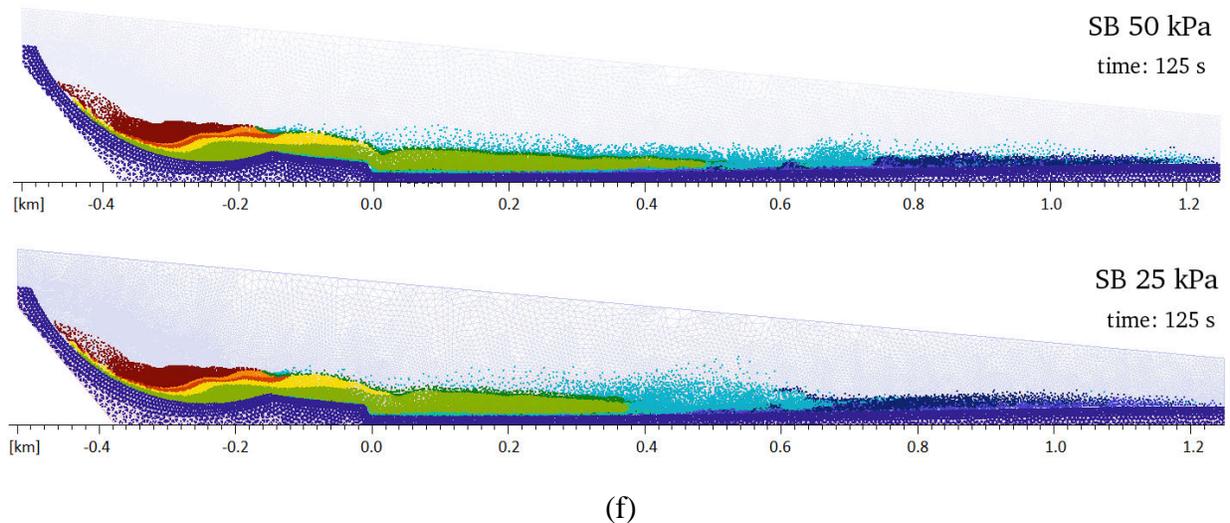
Figure K-17 shows the runout behavior at different times for the two cases of different adhesion and shear band strengths under M1 and M2 (i.e., 50 and 25 kPa cases). The runout behavior of the two hypothetical cases where there is no 2006 debris field are similar to the cases which simulated the actual 2014 SR-530 landslide, which had the 2006 debris field in place.

Figure K-17. MPM results of the hypothetical 2014 SR-530 landslide model without the 2006 debris field considering different adhesions in the shear band (SBM1 and SBM2): 50 and 25kPa. (a) $t = 0$ s, (b) $t = 25$ s, (c) $t = 40$ s, (d) $t = 50$ s, (e) $t = 60$ s, (f) $t = 125$ s.

The MPM model that was calibrated to capture the observed distance of the 2006 Hazel landslide runout and the general characteristics and observed runout distance of the 2014 SR-530 landslide was rerun with only one change relative to the 2014 SR-530 landslide MPM model (i.e., the 2006 debris field located between the toe of the landslide and the river was removed) to investigate the potential effects of the absence of the 2006 debris field at the bottom of the slide. The simulated runout behavior of the hypothetical case where there is no debris field below the toe of the landslide is similar to the simulated runout behavior of the actual 2014 SR-530 landslide case.

The key difference between the runout distances of the 2006 Hazel landslide and the actual 2014 SR-530 landslide appears to be due to the larger and higher combined mass of the M1/M2 sliding mass and the push from the much larger and much higher M3 sliding mass. The larger mass of the combination of M1, M2, and M3 coupled with M2 and M3 initiating from a higher starting elevation produces the long runout of the 2014 SR-530 landslide. Removal of the 2006 debris field does not change the calculated results appreciably; that is, the presence or absence of the debris field is found to be relatively unimportant in these runout analyses.

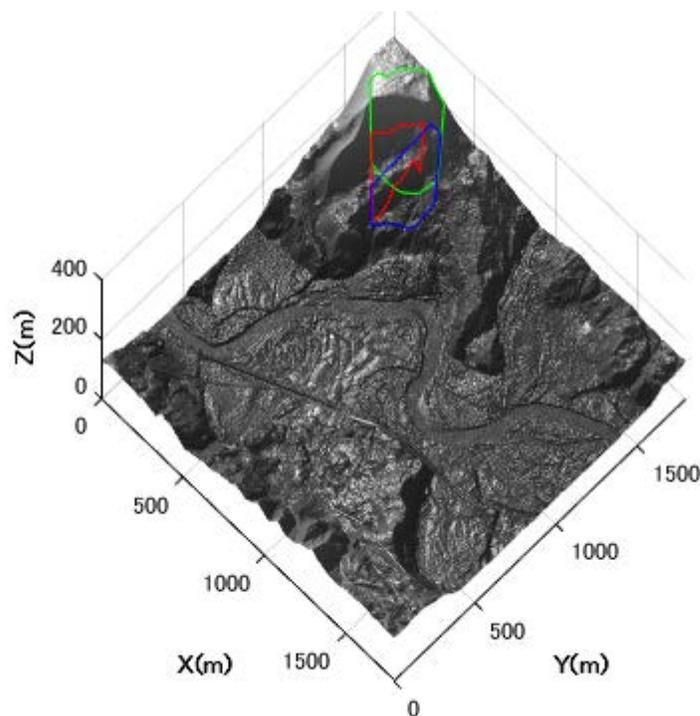
Figure K-18 is the bathymetry obtained by the LiDAR showing the area in 2013, before the 2014 SR-530 landslide. The areas shown by blue, red, and green lines indicate the estimated areas of M1, M2, and M3 slide masses, respectively. Based on the LiDAR data, the computational meshes are formed by quadrilateral elements whose size is $20\text{ m} \times 20\text{ m}$, as shown in Figure K-19. The total number of elements is 8,100.

Figure K-18. Bathymetry based on 2013 LiDAR data (before the 2014 SR-530 landslide). The blue, red, and green lines indicate the estimated source areas of M1, M2 and M3 landslides, respectively.

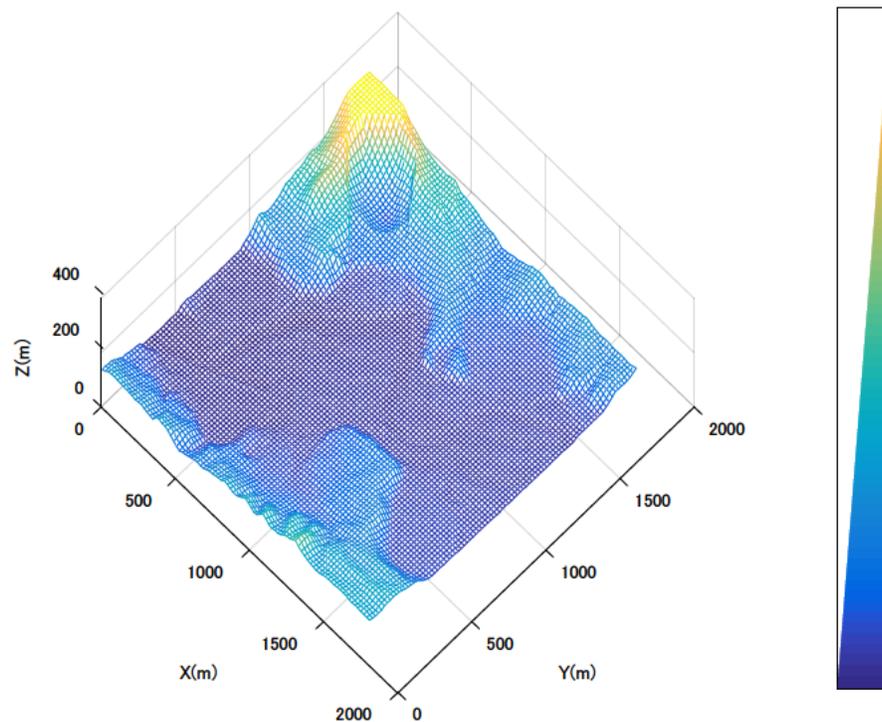
Figure K-19. Computational mesh with a 20 m resolution ($90 \times 90 = 8100$ elements)

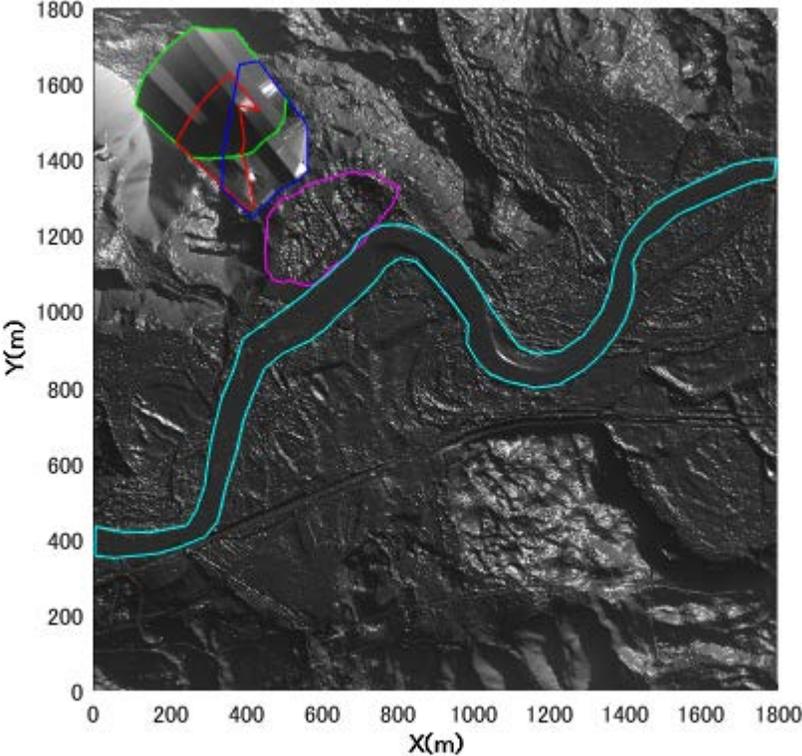
After the initiation of each landslide, the yield strength varies depending on the positions reflecting the surface conditions of the bathymetry. In Scenario 1, the surface state of the location where the 2006 debris field material exists has a yield strength of 2 kPa. That is, when M1/M2/M3 material points move to this location, the yield strength of these material points becomes 2 kPa. Similarly, when the material points move on top of the river, the yield strength becomes a very small value of 1 Pa. As the material points then move on top of the area of vegetation, the yield strength becomes 5 kPa. In Scenario 2, there is no debris field condition and the North Fork of the Stillaguamish River is placed at the pre-2006 location.

Figure K-20. Material parameters for Scenario 1: The debris from the 2006 Hazel landslide remain near the toe of the slope (corresponding to the actual scenario). M1 (Blue): $T_y = 25 \text{ kPa}$, M2 (Red): $T_y = 25 \text{ kPa}$, M3 (Green): $T_y = 50 \text{ kPa}$, Debris from 2006 Hazel landslide (Magenta): $T_y = 2 \text{ kPa}$, River (Cyan): $T_y = 1 \text{ Pa}$, and South of river: $T_y = 5 \text{ kPa}$

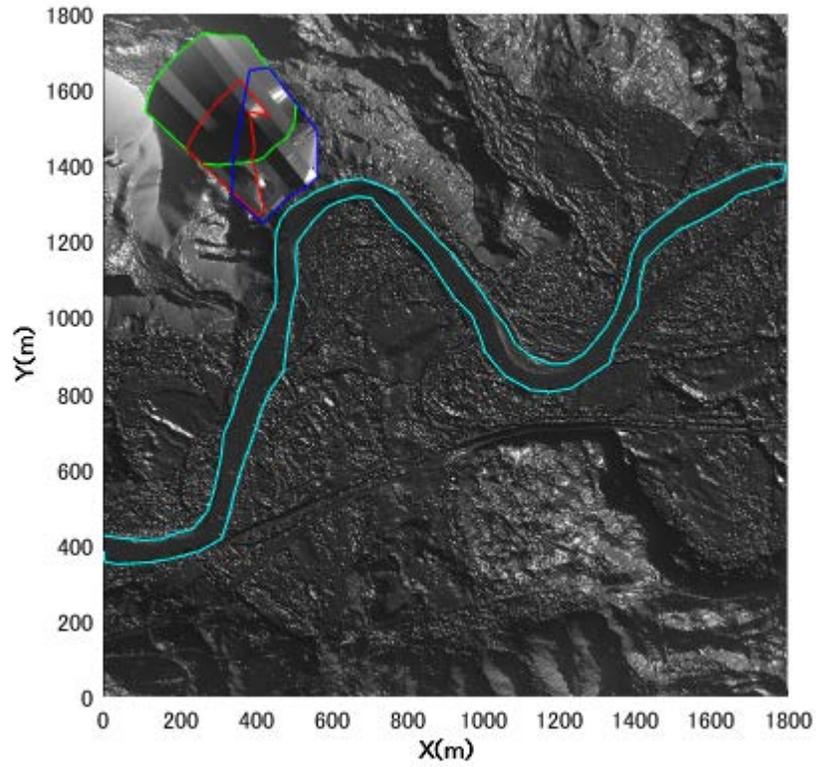
Figure K-21. Material parameters for Scenario 2: The 2006 debris field from the 2006 Hazel landslide has been removed and the river moved back to its original position. M1 (Blue): $T_y = 25 \text{ kPa}$, M2 (Red): $T_y = 25 \text{ kPa}$, M3 (Green): $T_y = 50 \text{ kPa}$, River (Cyan): $T_y = 1 \text{ Pa}$, and South of river: $T_y = 5 \text{ kPa}$.

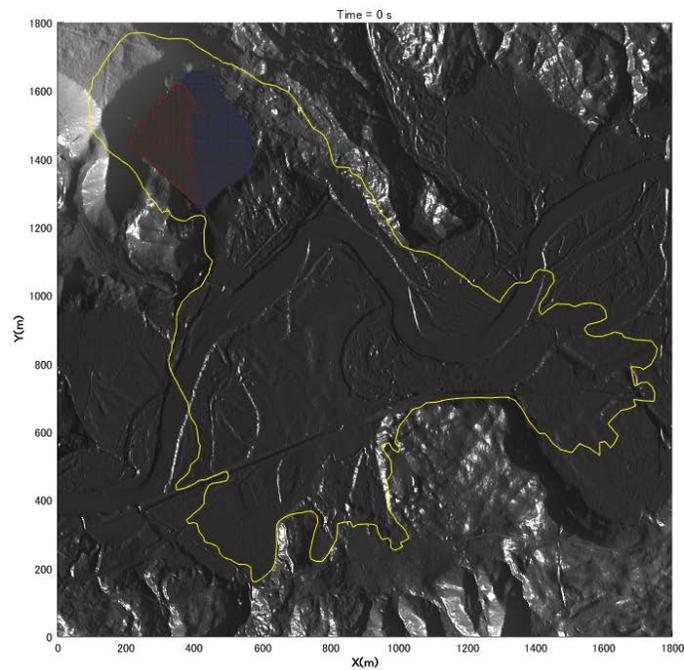
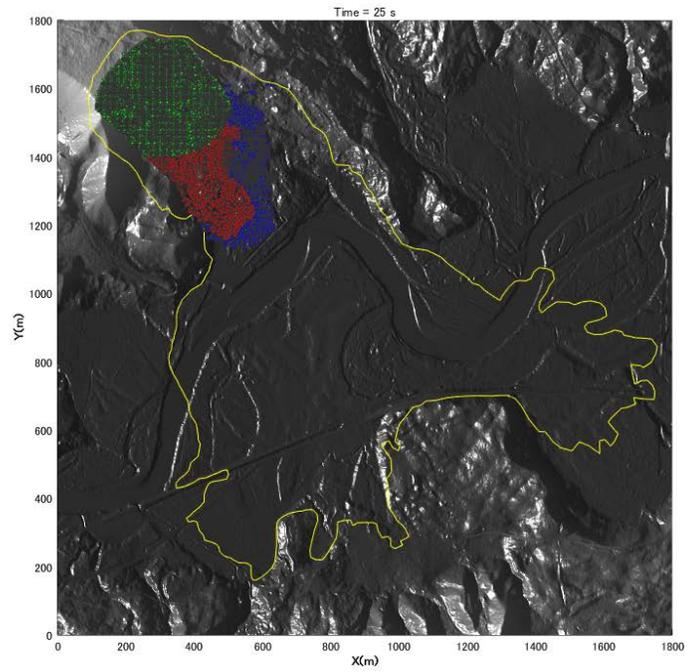
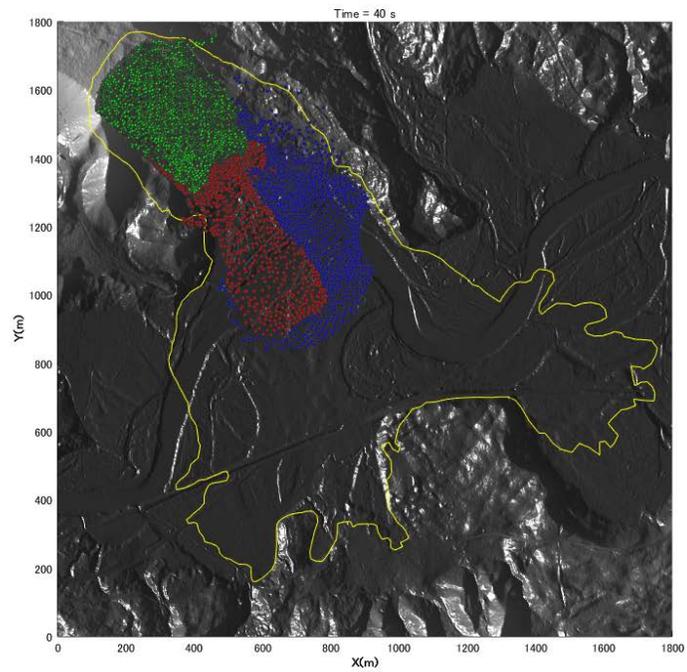
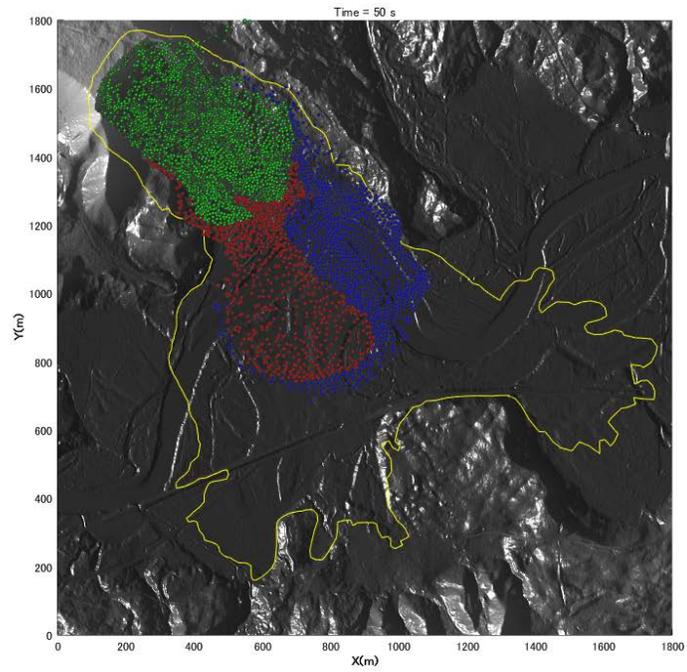
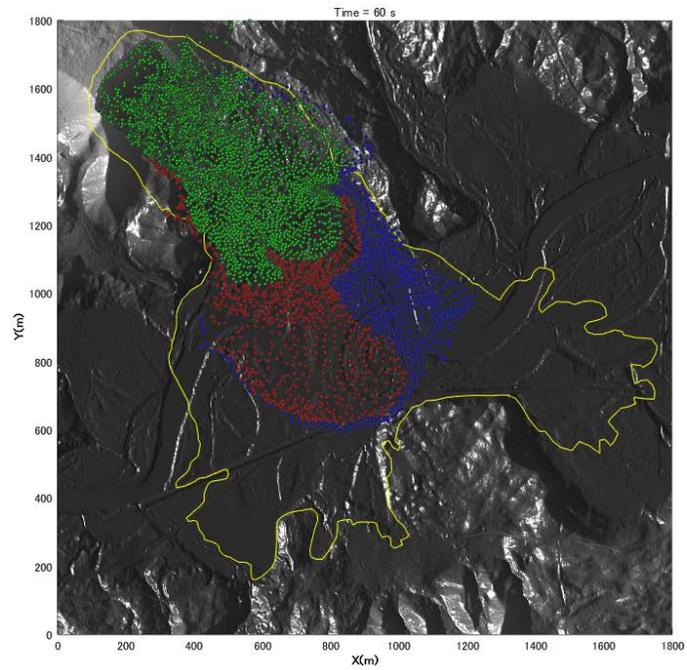
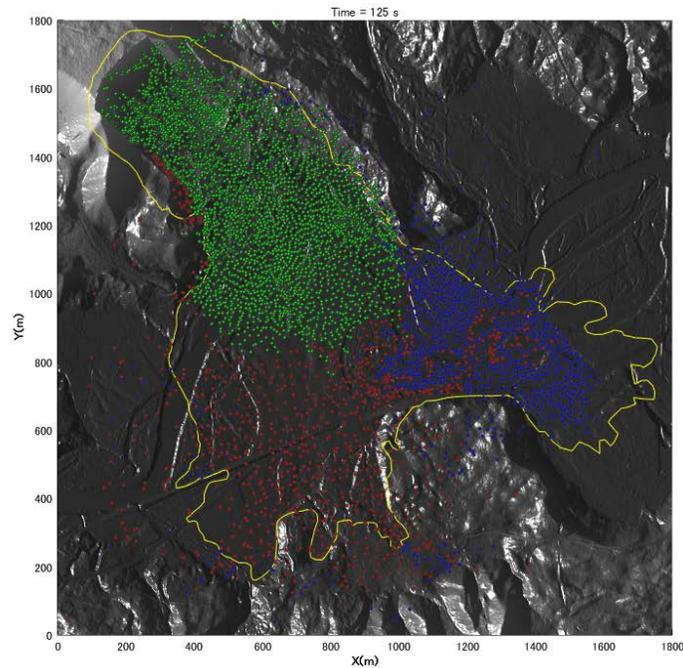
The results of the 3D runout analyses of the actual 2014 SR-530 landslide with the 2006 debris field in place are shown in Figure K-22.

M1 and M2 landslides are represented by the blue and red material points. M3 landslide represented by the green material points is initiated at 25 seconds. Furthermore, the yellow solid line indicates the estimated flow extent of the 2014 SR-530 landslide event given in the GEER report (Keaton et al., 2014).

Figure K-22. *DA-MPM* result for Scenario 1: (a) $t = 0$ s, (b) $t = 25$ s, (c) $t = 40$ s, (d) $t = 50$ s, (e) $t = 60$ s, (f) $t = 125$ s.

In the Scenario 1 case, the spreading pattern of the material points after $t = 125$ seconds is in general similar to the extent of the final spreading observed in the field, which is shown by the yellow line in Figure K-22. This indicates that the undrained shear strength values evaluated from the plane strain analysis runout simulations presented in the previous sections can be adopted to produce reasonable behavior of the 2014 SR-530 landslide with the depth-averaged analysis. Furthermore, the movement pattern with time is similar to that reported in Iverson and George (2016) even though a direct comparison of results was not attempted in this study.

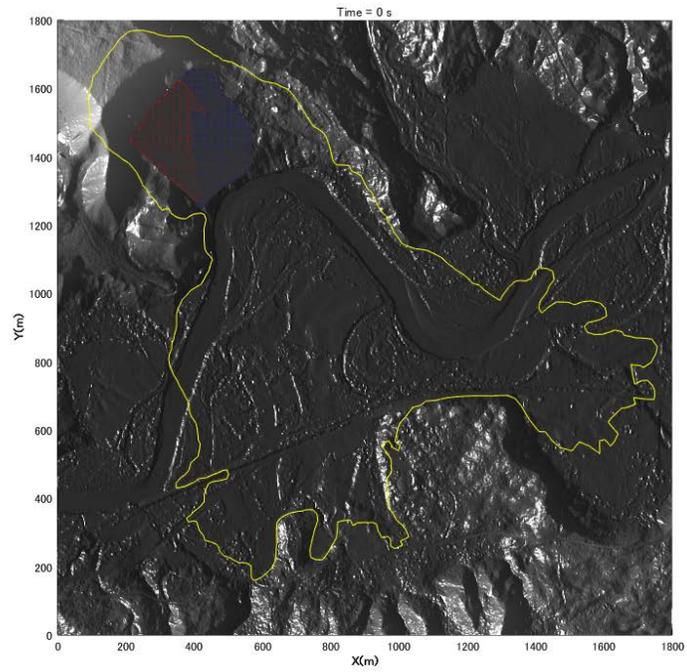
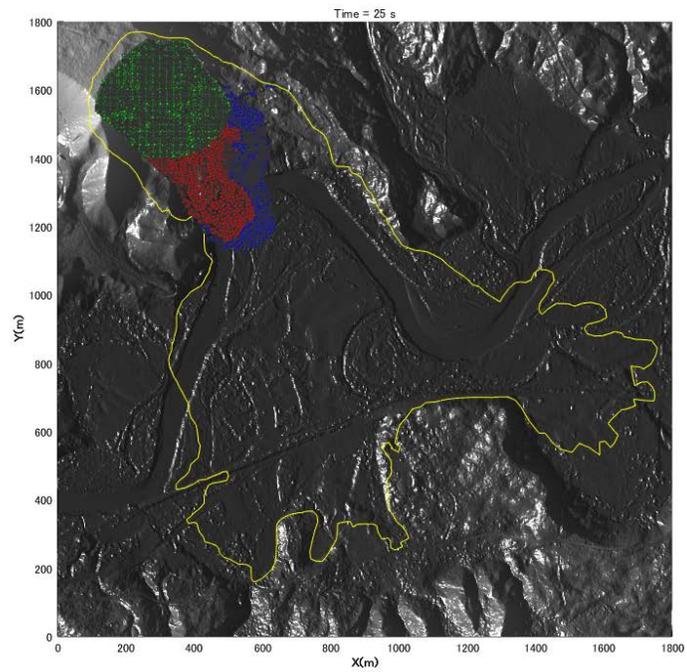
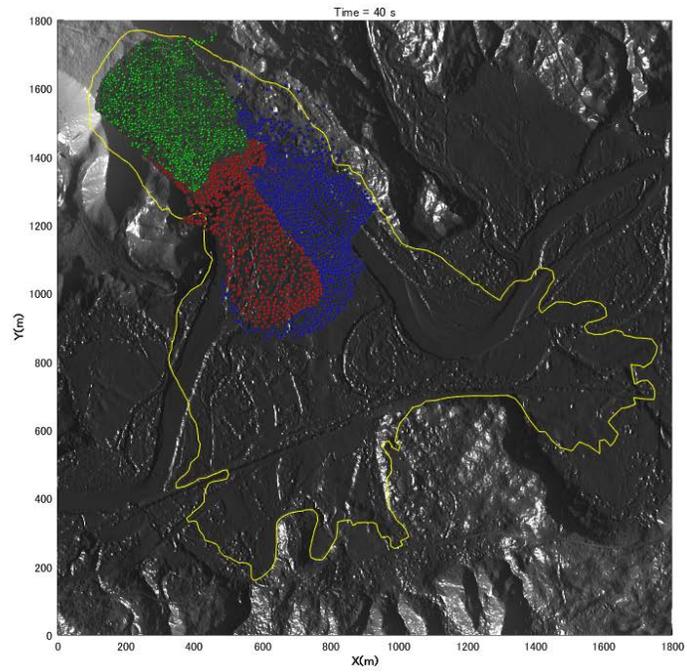
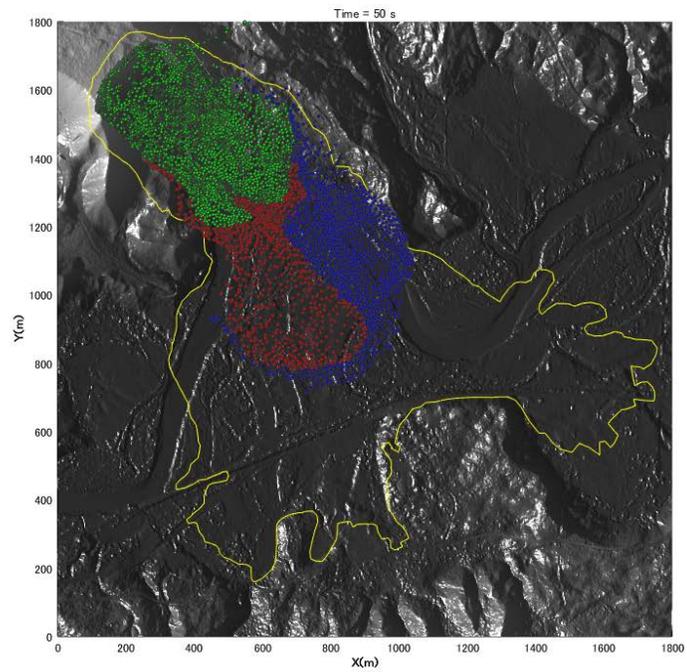
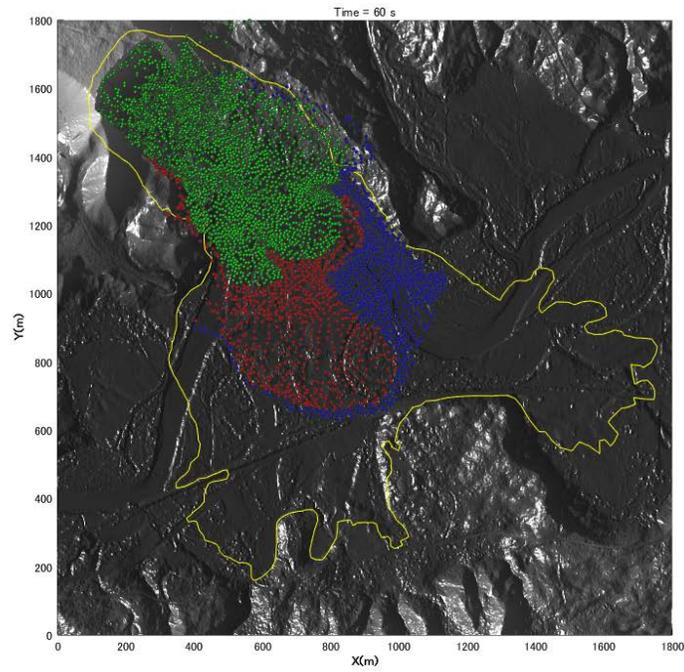
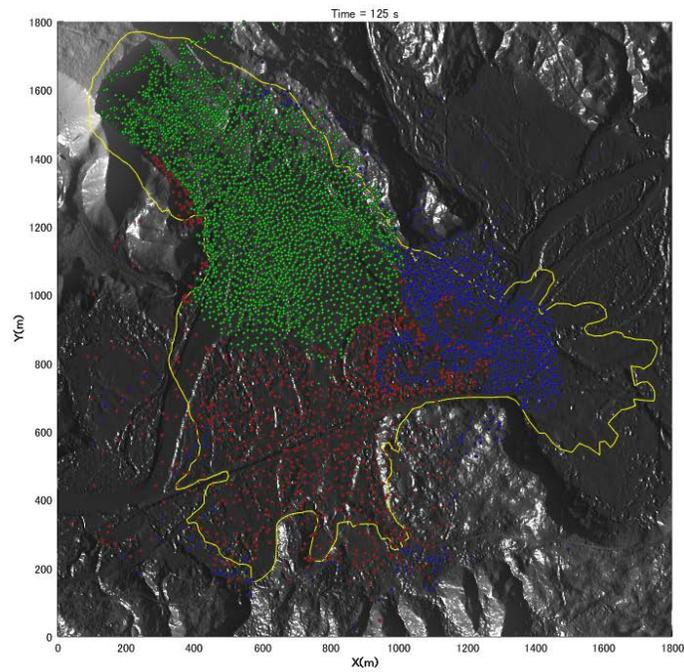
The results of the 3D runout analyses of a hypothetical 2014 SR-530 landslide without the 2006 debris field are shown in Figure K-23.

M1 and M2 landslides are represented by the blue and red material points. M3 landslide represented by the green material points is initiated at 25 seconds. Furthermore, the yellow solid line indicates the estimated flow extent of the 2014 SR-530 landslide event given in the GEER report (Keaton et al., 2014).

Figure K-23. *DA-MPM* result for Scenario 2: (a) $t = 0$ s, (b) $t = 25$ s, (c) $t = 40$ s, (d) $t = 50$ s, (e) $t = 60$ s, (f) $t = 125$ s.

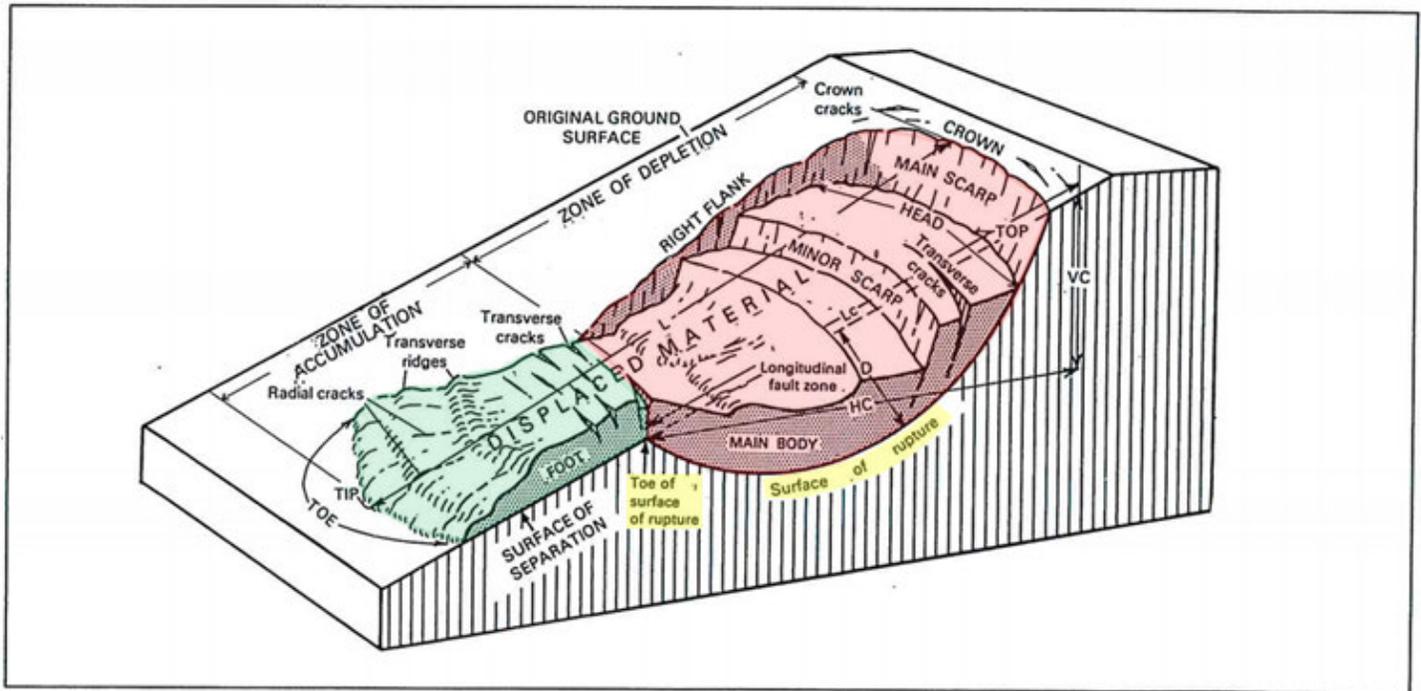
Table 3-3
Definitions of Landslide Features

NUMBER	NAME	DEFINITION
1	Crown	Practically undisplaced material adjacent to highest parts of main scarp
2	Main scarp	Steep surface on undisturbed ground at upper edge of landslide caused by movement of displaced material (13, stippled area) away from undisturbed ground; it is visible part of surface of rupture (10)
3	Top	Highest point of contact between displaced material (13) and main scarp (2)
4	Head	Upper parts of landslide along contact between displaced material and main scarp (2)
5	Minor scarp	Steep surface on displaced material of landslide produced by differential movements within displaced material
6	Main body	Part of displaced material of landslide that overlies surface of rupture between main scarp (2) and toe of surface of rupture (11)
7	Foot	Portion of landslide that has moved beyond toe of surface of rupture (11) and overlies original ground surface (20)
8	Tip	Point on toe (9) farthest from top (3) of landslide

9	Toe	Lower, usually curved margin of displaced material of a landslide, most distant from main scarp (2)
10	Surface of rupture	Surface that forms (or that has formed) lower boundary of displaced material (13) below original ground surface (20); mechanical idealization of surface of rupture is called <i>slip surface</i> in Chapter 13
11	Toe of surface of rupture	Intersection (usually buried) between lower part of surface of rupture (10) of a landslide and original ground surface (20)
12	Surface of separation	Part of original ground surface (20) now overlain by foot (7) of landslide
13	Displaced material	Material displaced from its original position on slope by movement in landslide; forms both depleted mass (17) and accumulation (18); it is stippled in Figure 3-4
14	Zone of depletion	Area of landslide within which displaced material (13) lies below original ground surface (20)
15	Zone of accumulation	Area of landslide within which displaced material lies above original ground surface (20)

16	Depletion	Volume bounded by main scarp (2), depleted mass (17), and original ground surface (20)
17	Depleted mass	Volume of displaced material that overlies surface of rupture (10) but underlies original ground surface (20)
18	Accumulation	Volume of displaced material (13) that lies above original ground surface (20)
19	Flank	Undisplaced material adjacent to sides of surface of rupture; compass directions are preferable in describing flanks, but if left and right are used, they refer to flanks as viewed from crown
20	Original ground surface	Surface of slope that existed before landslide took place

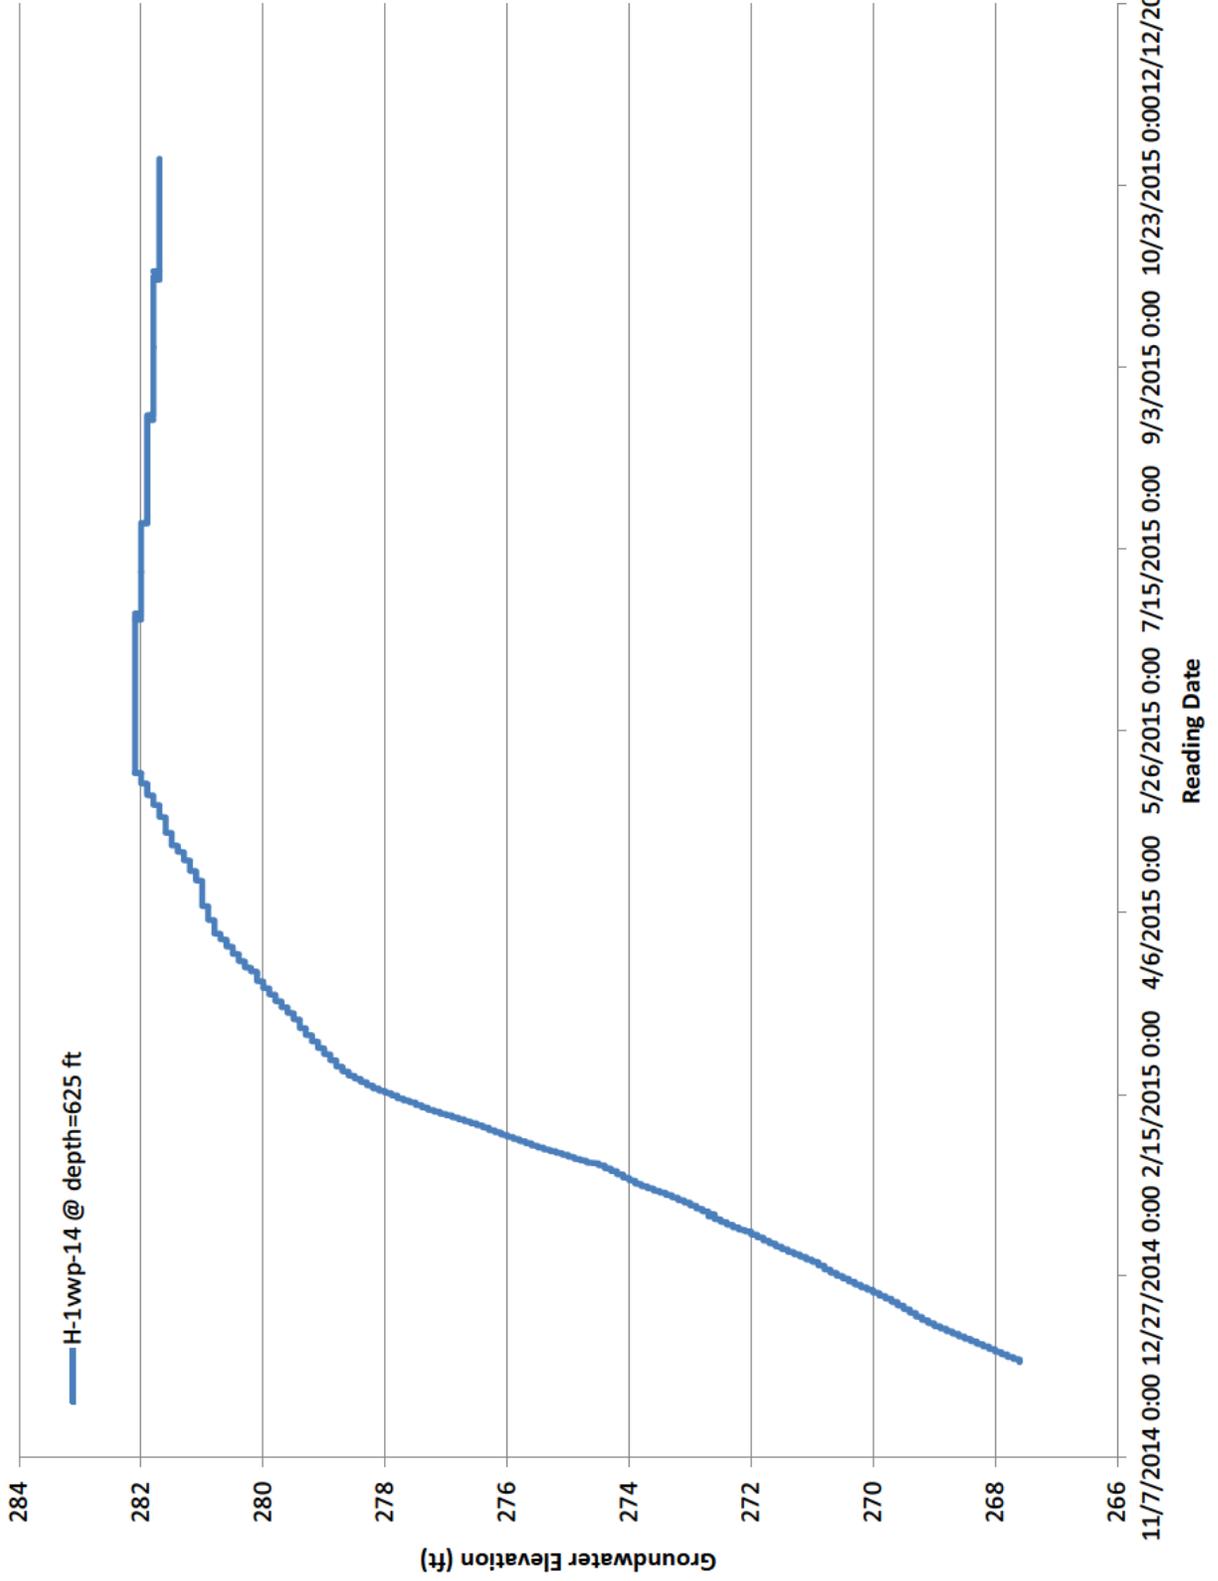
Piezometer H-1vwp-14 @ depth=625 ft

21 c. Permeable “Olympia” Sands beneath Surface of Rupture– The 2014 SR530
22 Landslide surface of rupture is underlain by fine-grained, cross-bedded sand.
23 This sand was encountered in EB-04-15, EB-09-15, EB-12-15, and H-1vwp-14
24 (which was performed by WSDOT in October of 2014. The sand is also visible
25
26
